Access audit at West Dene Family Centre, Birch Road, Pendlebury

Conducted on 6th August 2013

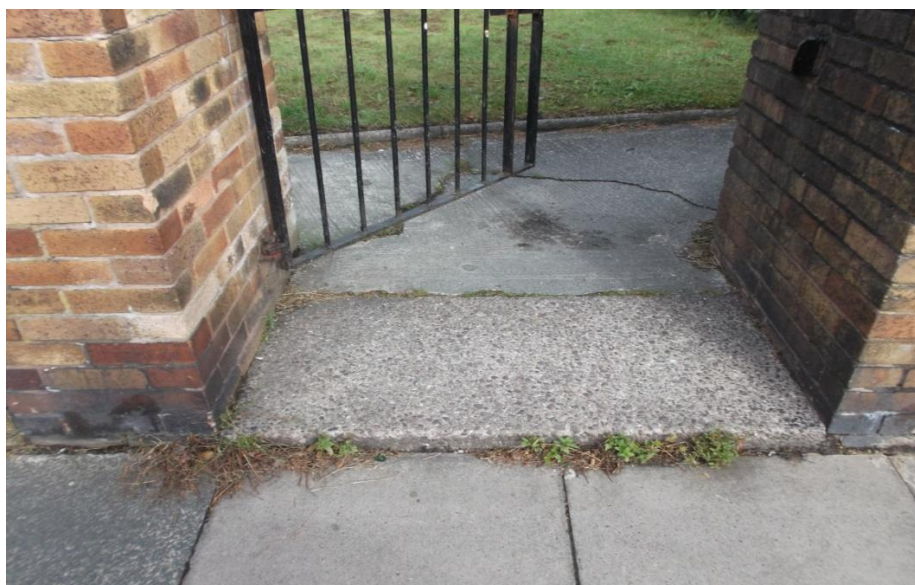
A gate provides access to the building where there is a small step which is difficult to negotiate for unassisted wheelchair users. There is an alternative entrance to the building via the car park which does not have steps. There was no sign indicating the route of the alternative access.

Entrance to Centre via gate and small step

Both the steps (at the front gate entrance and the entrance to the building) could be improved by a ramp. However the more pressing priority would be at the building entrance itself. Unassisted wheelchair users would not be able to press the bell. A ramp here with some form of shelter over the entrance would really benefit access. The installation of a CCTV monitor would also enable staff to view who is waiting at the door and make sure a member of staff lets them in as quickly as possible.

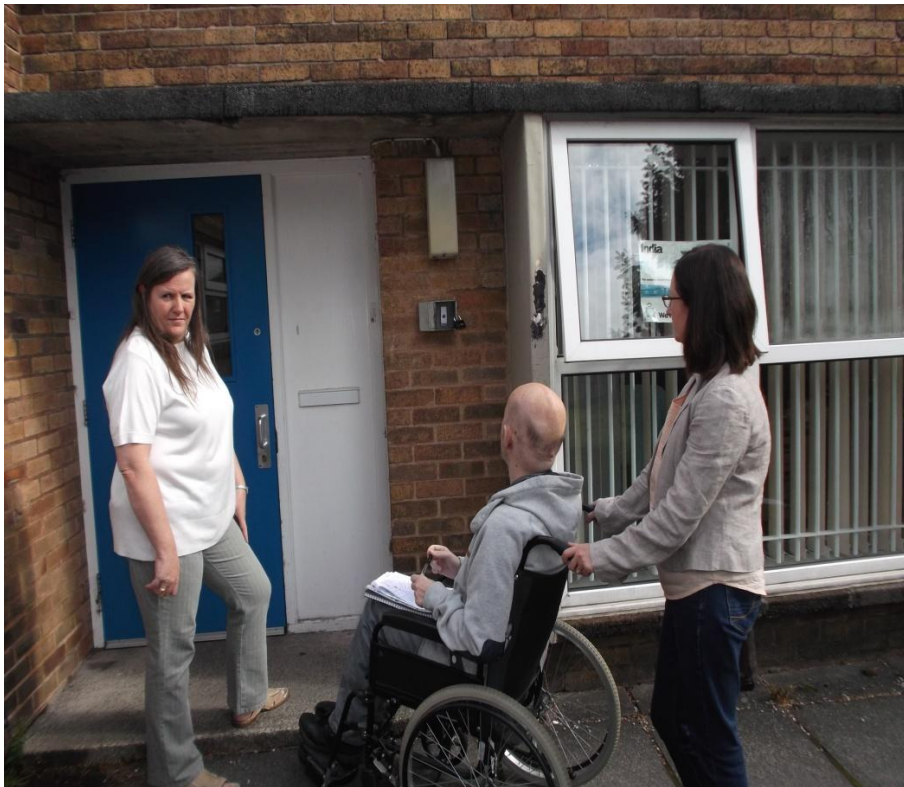
The main entrance to the building was very difficult to access for wheelchair users. In particular the entrance had a small step from where it was impossible for any unassisted wheelchair users to reach the bell.

The bell was a simple device that alerts staff to come to the entrance. In the event that staff have not heard the bell, visitors have to wait. There is limited shelter at the entrance so that in inclement weather wheelchair visitors will be exposed to the elements.

**Main entrance
step and bell**

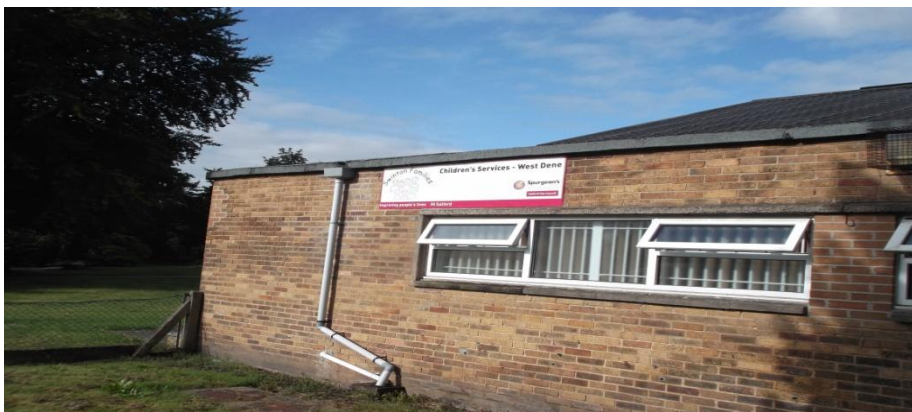
Signage to the premises was quite discreet but Joanne assured us that most people will be referred by a social worker who would give clear instructions about where the building is situated.

The signage to the centre could benefit from being more visible from the outside. This would aid those visitors with visual impairments. A sign directing to an alternative entrance to the building should also be considered.

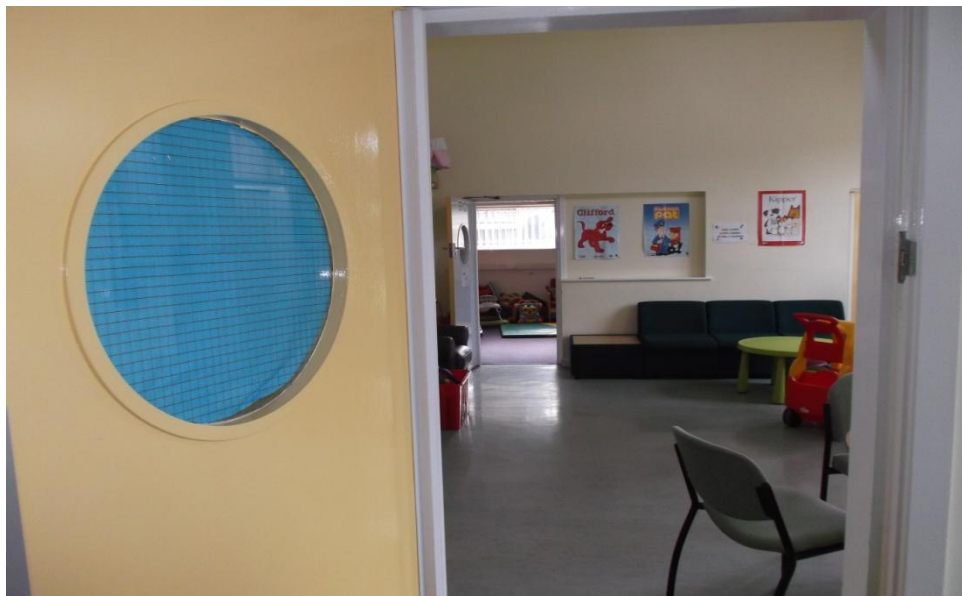
The contact areas were all accessible to disabled people with enough width between the door frames. Seating was provided in all of the rooms, particularly for children who use the facilities. The furniture had rounded edges (in the main) with very few sharp edges except for tables.

Entrance to one of the contact areas

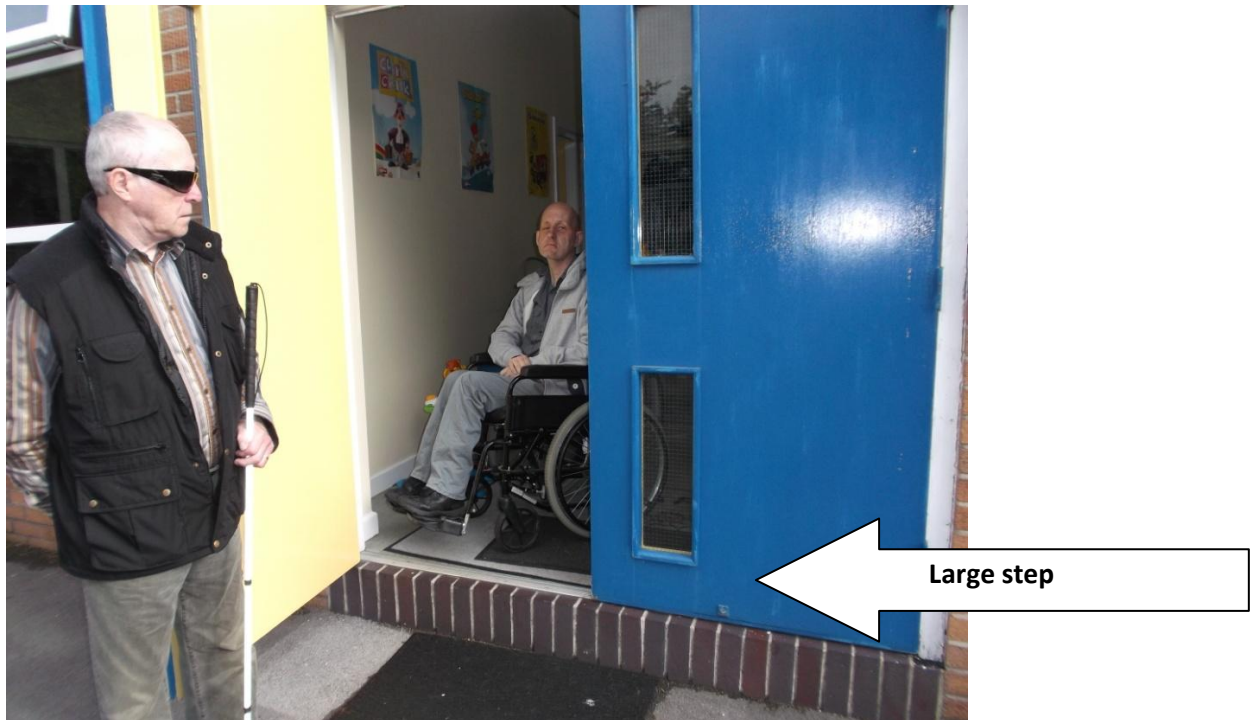
One of the exits from the centre had a very big step which would be very difficult for a wheelchair user to negotiate. The group felt however that there were so many alternative exits this would not pose too much difficulty.

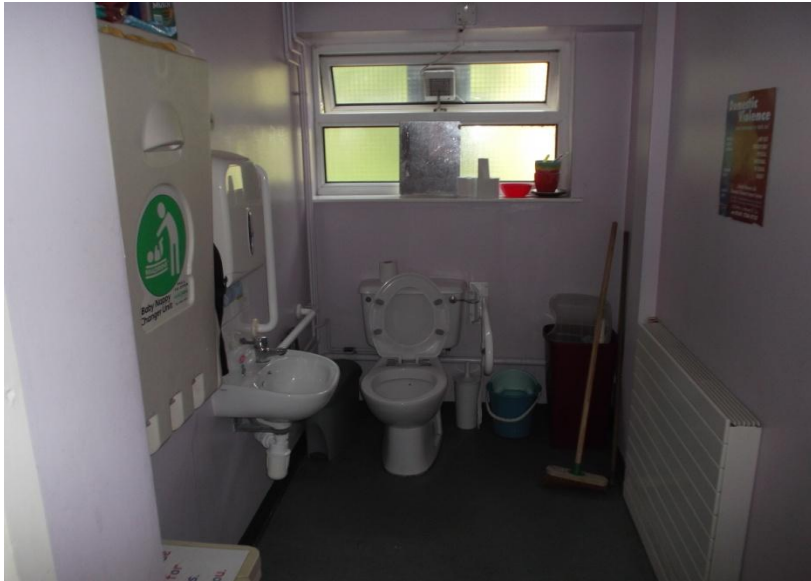
There were both able bodied and disabled toilet facilities. Tommy felt that the disabled toilets were suitable for wheelchair users, however there were bins on either side of the door and Tommy felt it might be difficult for a wheelchair user to reverse out.

Disabled toilet

Re-locating the two bins in the accessible toilet would make it easier for a wheelchair user to exit.

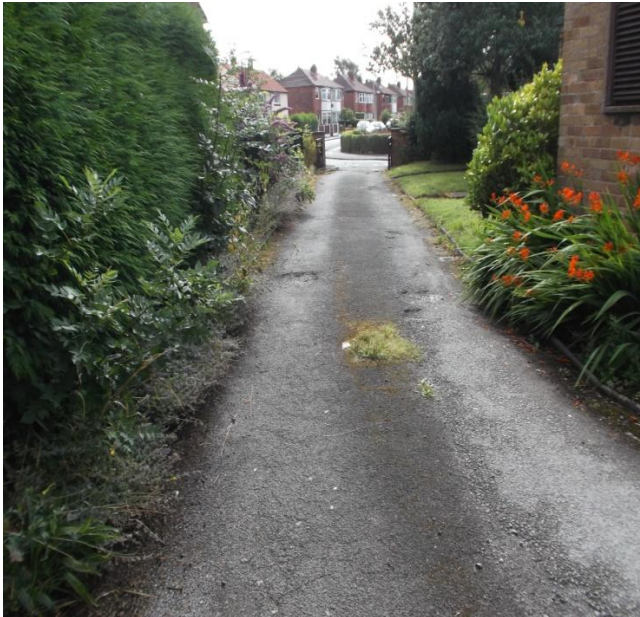
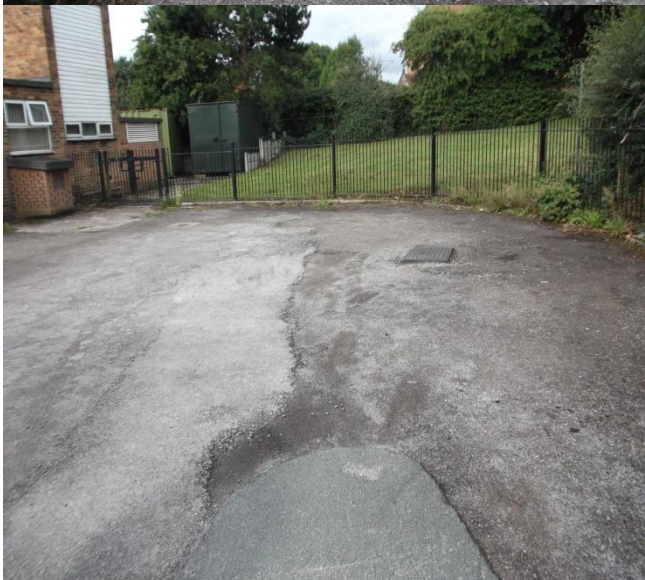
The car park was reached from Birch Drive but the driveway was rutted with pot holes. It was accessible for wheelchair users but could be improved. There were a limited number of car parking spaces but there is also on street parking on Birch Drive.

Driveway and car park

The car park and driveway to the centre is in need of maintenance. The filling of pot holes would help all visitors to the centre using a vehicle but also be of benefit to wheelchair users.
