Access audit at Guild Hall, Walkden

Conducted on 23rd February 2015

Introduction: Access 2 All Areas were invited to conduct an audit at the Guild Hall, Walkden

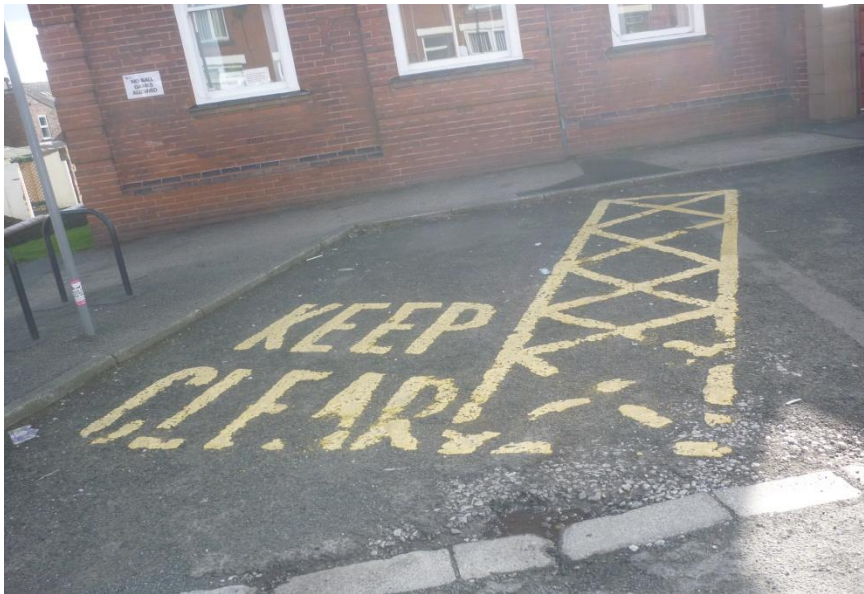
Dropped kerb

Access to the Guild Hall is off Guild Avenue. There is one disabled parking bay situated at the main entrance to the Guild Hall. When we visited there was a car parked in the disabled bay which was difficult to negotiate for wheelchair users as it obscured the dropped kerb.

The Keep Clear area of parking was occupied by a vehicle when we visited which made wheelchair access to the main entrance more difficult as the dropped kerb could not be accessed.

2. The corridor floor surfaces could be painted in bright colours to assist those with a visual impairment.
3. Parking at the front of the building is extremely limited and there is only one disabled space. If this space is occupied it means access to the dropped kerb is very difficult. We would recommend that the disabled parking space be re-located to the right or the left of the current bay.

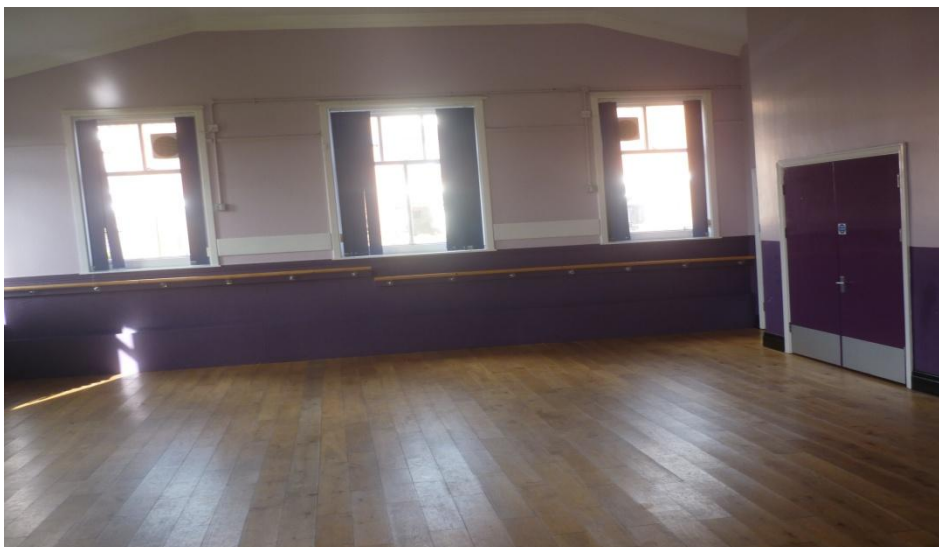
Main Hall

The main hall was spacious and didn't pose any problem for wheelchair users. The surface was smooth and the room was well lit. We were told by staff that the whole of the premises benefited from a loop system for the hard of hearing.

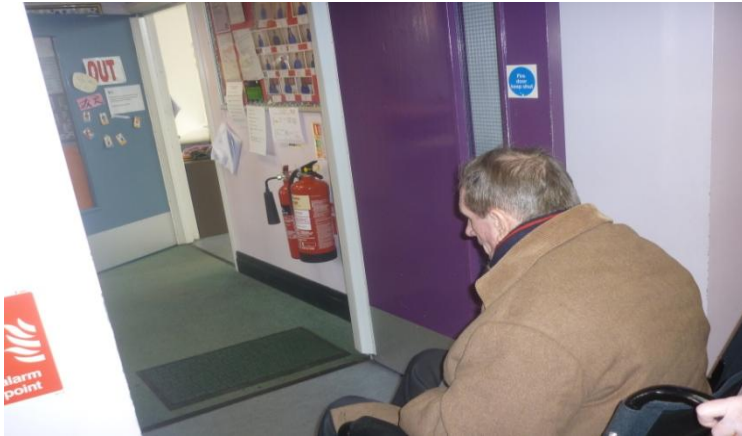
Access through the corridors was relatively easy to negotiate as they were wide enough even for larger wheelchairs. The door handles were within reach of unassisted wheelchair users. The floor was smooth although it could be improved for those with a visual impairment if it were to be a brighter colour.

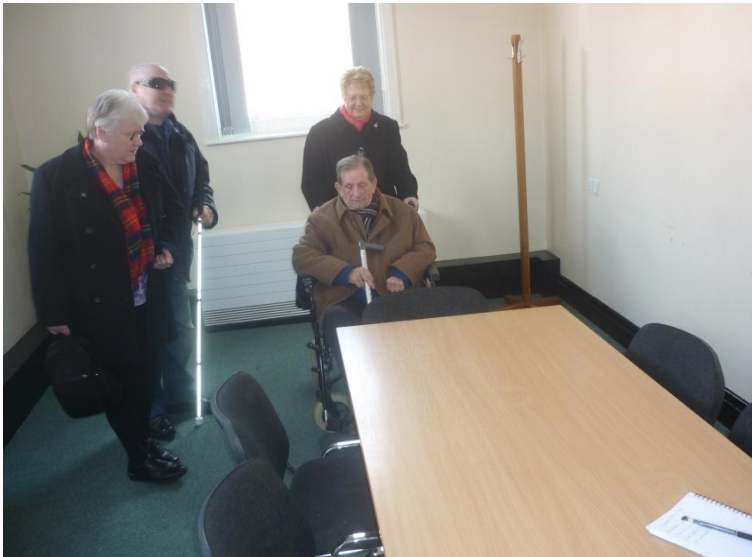
Meeting room

The meeting room was again a good height for wheelchair users and posed no difficulty in terms of access.

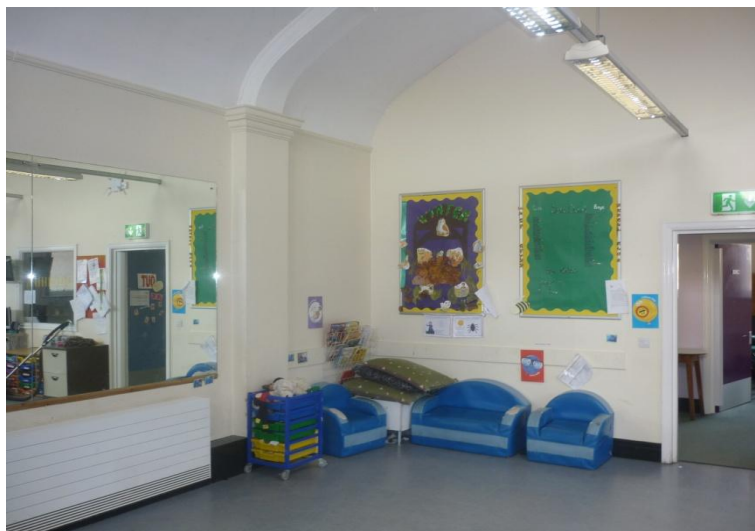
Smaller hall

The Smaller Hall was again accessible but one of the door handles to exit the hall was too high for an unassisted wheelchair user to reach. However, as the room was intended for young children we understood that the door handle was positioned there so children couldn't leave the room of their own accord.

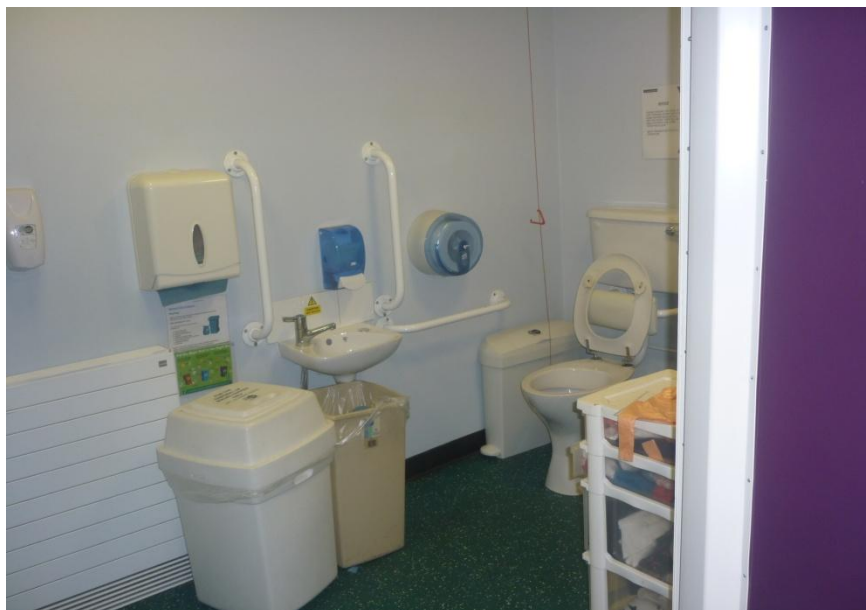
Disable toilet

The disabled toilet was well equipped and Roy was able to access the facility without any problem.

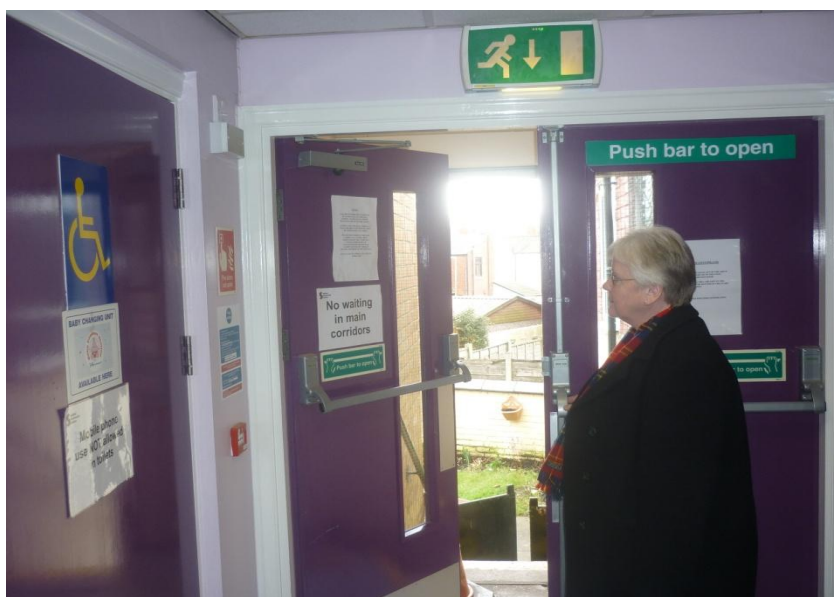
Fire exit

Entrance to the fire exit

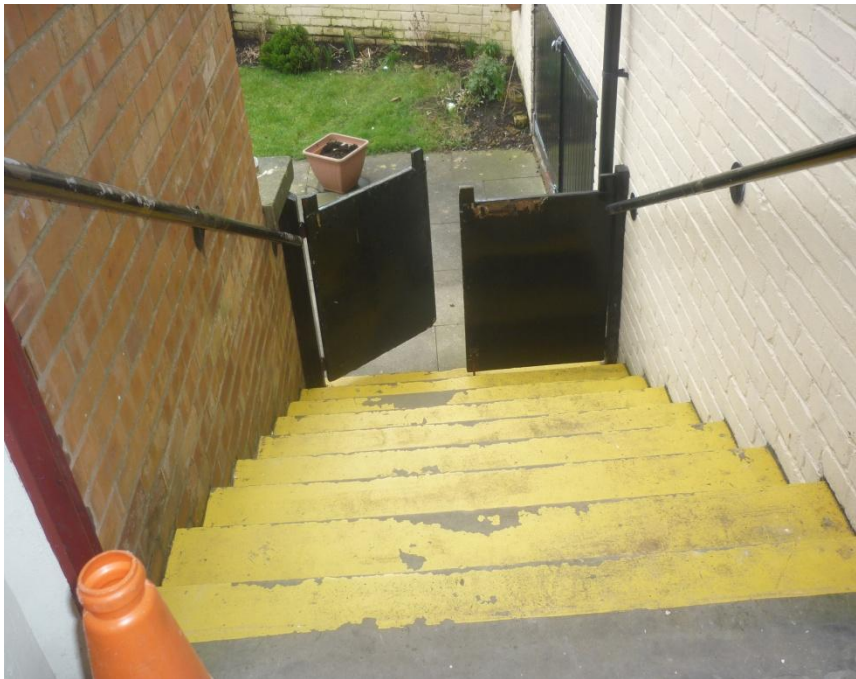
Steep steps

The fire exit was very problematic. The only means of exiting were down a steep flight of steps. In the event of a fire anyone with mobility issues would be in real difficulty. Even if someone were to get down the steep steps there were other steps to get down to reach the road at the back of the building.

The Guild Hall is a valuable community asset. In the main it is accessible and inclusive. The major problem is the fire exit which is completely unsuitable for anyone with mobility issues or those people in a wheelchair. It poses a threat to life in the event of a fire.

1. The fire exit needs to be completely redesigned. This does not comply with the requirements of the Equality Act. We felt that the best (and most viable) alternative would be to re-site the fire exit to the main hall. This would still present some difficulties as there is no current means of exit. If a door and ramp could be installed (To the grassed area) this would mitigate the risk and provide wheelchair users with an exit if the front entrance were to be inaccessible due to fire.

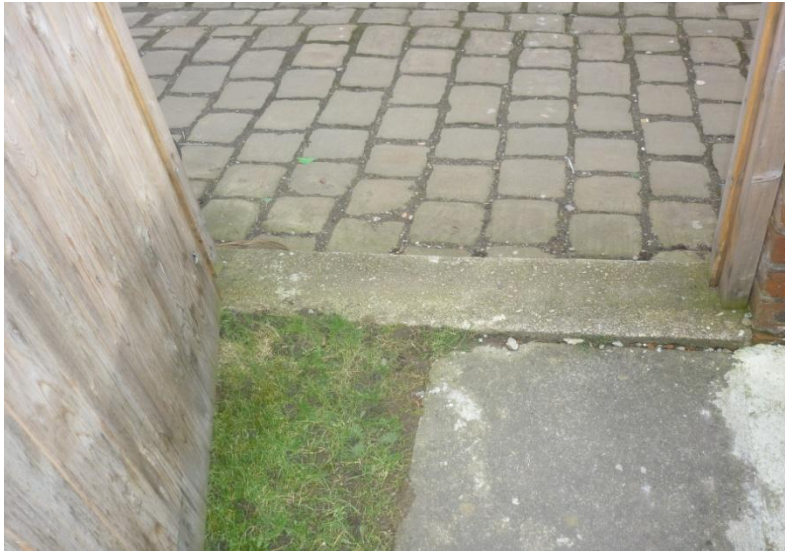
Step to access cobbled road at the rear of the building

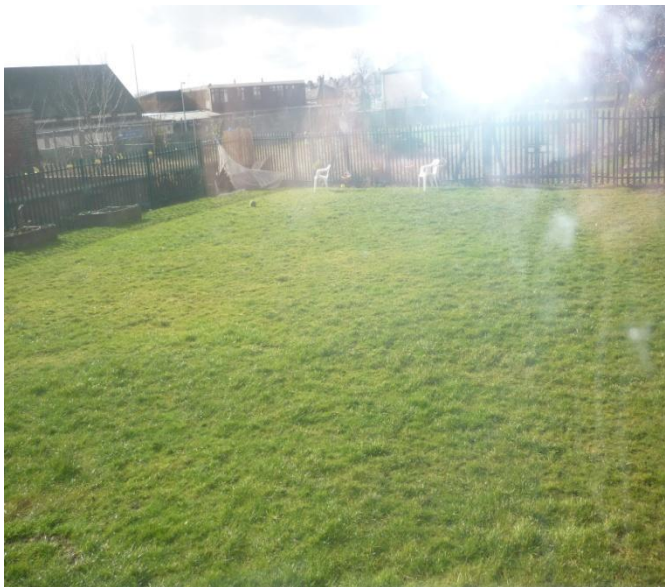
Grassed area

We considered other alternatives to the existing fire exit as we thought that it would be impossible to replace the steps with a ramp because of the steep and narrow steps. We therefore went back to the main Hall. The Hall looks out to a grassed area used by the children. However this is not currently accessible from the Hall as there is no door. There is also a (Approximately) four foot drop from the Hall to the grassed are.

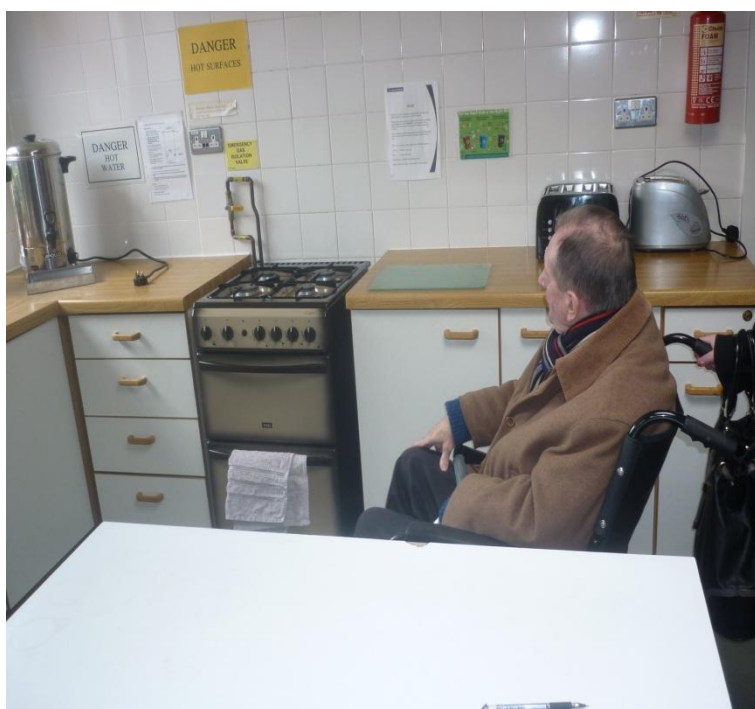
Kitchen

The kitchen was a good size and fully accessible. Appliances could also be reached by wheelchair users.
