Building Conservation Services

East Worlington Parish Hall Architectural Conservation Report

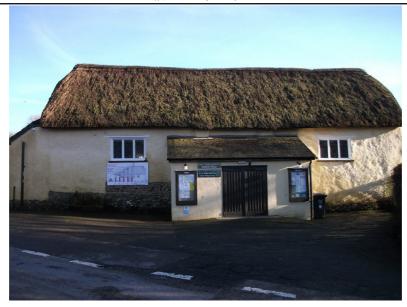
Photograph 1 - West Elevation

- 2.1 The Parish Hall lies within the curtilage of the former rectory adjacent to East Worlington Parish Church of St Marys. The front elevation faces west on to a nearby lane (Photo 1) and the rear elevation faces east on to an enclosed yard to the back of the former rectory (Photo 2 & 3).

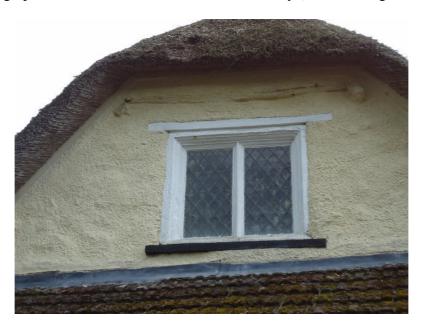
- 3.1.5 More recent changes made to the barn include the insertion of three ovolo mullion windows complete with matching ovolo moulded frames. The windows and frames would appear to date from the 16th or 17th Century (Alcock and Hall, 1994). The Rev H.A. Halls stated that they were acquired from cottages within the village. The sheer decorative quality of the mouldings suggest a high status building and it is tempting to suppose that they may have come from the adjacent Rectory, a 16th Century building which has undergone a complete re-fenestration sometime during the 19th and 20th Centuries.

Photograph 4 - 16/17 Century ovolu moulded window

- 6.1.5 All of the existing windows will be assessed for decay and where required repaired in a suitable matching timber, spliced in a way which maximise the amount of original material retained. Secondary internal aluminium glazing is proposed throughout and will be installed in such a way that it is easily removable without damaging the fabric of the building.

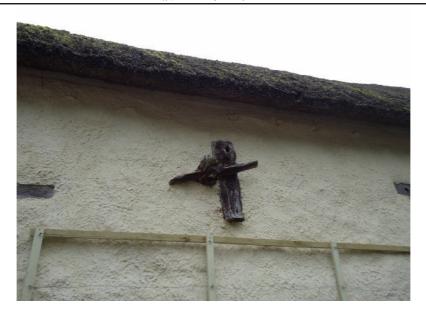
- 4.1.2 The earliest surviving attempt to prolong the life of the building appears to be the insertion of a pair of large undecorated timber cross beams. These pass straight through the rear wall and are tied against the outside face of the wall with large timber pegs which pass through the end of the beam and are secured against planks of wood (Photo 5). The insertion of these beams was presumably deemed necessary to prevent the walls from moving outwards; perhaps a result of the roof structure spreading under the weight of consecutive layers of thatch the normal practice in Devon being to re-thatch over the top of the old thatch, a process that results in a progressive thickening of the thatch over time. The thatch roof now appears to be quite thin and therefore one might assume that it has been stripped back to the roof structure at sometime in the recent past.

Photograph 5 - Timber tie beams

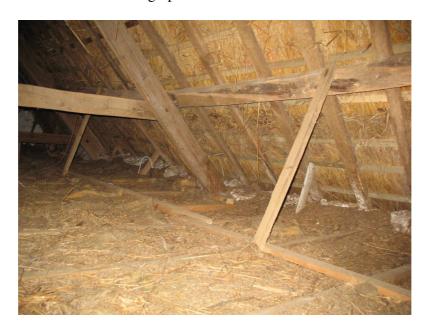
- 4.1.3 Southwest Archaeology's report revealed that the roof principles have been altered and repaired on a number of occasions. The two principle trusses at the lower end of the barn are thought to have been replaced during the late 20th Century with three new trusses, dividing the barn in to 6 bays (Photo 6). The remaining trusses and purlins are thought to be original.

Photograph 6 - Typical truss, purlin and rafter arrangement

- 6.1.4 It is proposed that the late 20th Century ceiling be taken down in order to reveal the A-framed roof trusses. The trusses will be repaired, including the removal of some late 20th century softwood repairs.

6.2.6 The roof trusses are to be repaired in matching timber. All new work to be distinguishable form the original timbers and free from artificial ageing (Refer to Surveyor's design drawings C053/009- Appendix 1).

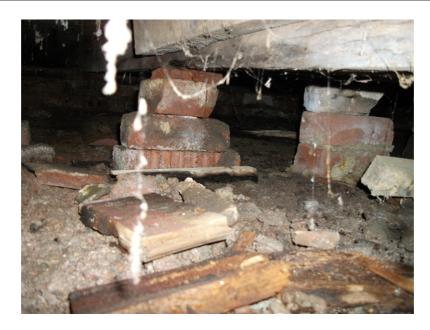
- 4.1.5 A raised timber floor supported on brick piers is thought to have been inserted during the time of the conversion to a Parish Hall. The void has in the past been subject to flooding and issues relating to damp (Photo 7). Recent repairs have included the insertion of vents to aid drying out of the undercroft (Photo 8); however, these have not fully resolved the damp issues and associated wet rot affecting the raised floor.

Photograph 7 - Existing undercroft showing raised floor supported on brick piers

- 6.1.1 It is proposed that the existing 20th Century raised timber floor and stage be removed and a new insulated floor incorporating under-floor heating be laid down and finished with a modern timber strip board. The new stage will incorporate a gallery and will largely self supporting off the new floor slab (Refer to Surveyor's design drawings C053/010 and C053/006 Appendix 1).
- 6.1.2 Following a full option appraisal it was decided that a Oil fired condensing boiler would provide the most suitable from of heating (Appendix 2). It is proposed that the boiler and oil tank will be housed within the existing structure. An existing cupboard will be adapted within the 20th Century leanto to provide a fire resistant enclosure to house the oil tank.

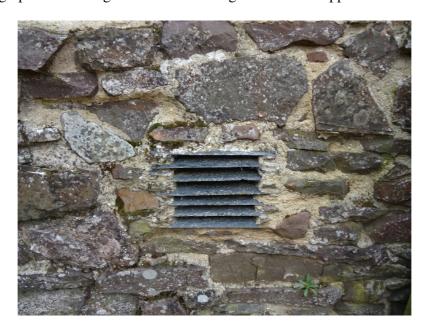
Photograph 8 - Slate vents inserted to aid airflow to undercroft
