Conservation of the Bathhouse Stevenage

December 2008

Bathhouse Conservation Project Stevenage

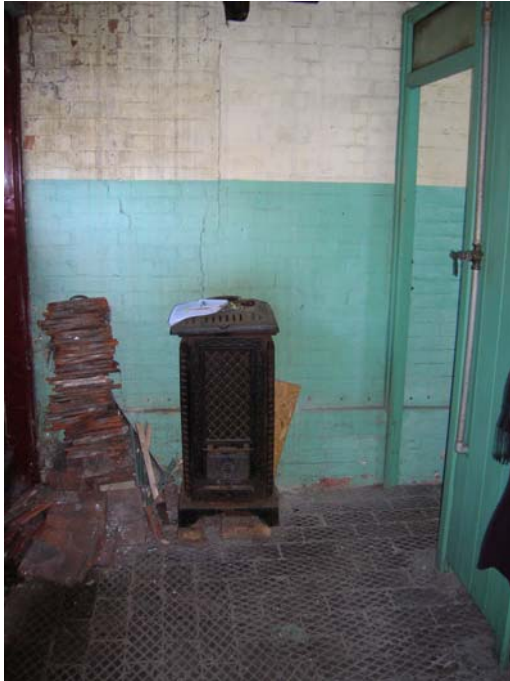
The cast iron stove had surface rust and its flue pipe had rusted almost completely away.

Photograph 1 – Before Conservation
View of north wall and rusting stove with missing fluepipe

8. **Rusted iron surfaces** were cleaned/stabilised using dilutions of **Orthophosphoric acid**, which dissolves and removes rust, whilst reacting with iron to form an insoluble, stable and corrosion resistant surface layer of iron phosphate. The main areas were the iron bath sides, the boiler and the stove.

9. Most of these metal surfaces were then painted (for protection and integration) with appropriately tinted paraloid B72 methacrylate resin (i.e. generally silver - mixture of pearlite mica and raw umber - for the pipes, boiler, boiler flue and angle iron water tank and boiler frames, black for the stove, with added fine sand to simulate corrosion textures, for the plastic replacement stove flue).

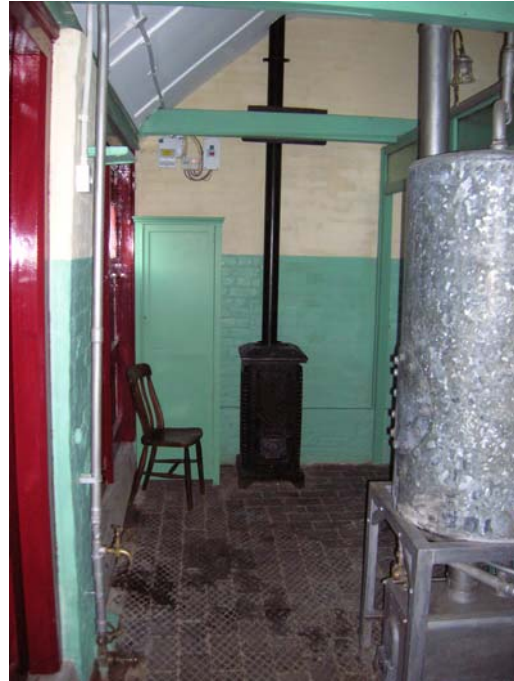
Photograph 2 – After conservation
North wall with stove, cupboard, attendant's chair and boiler

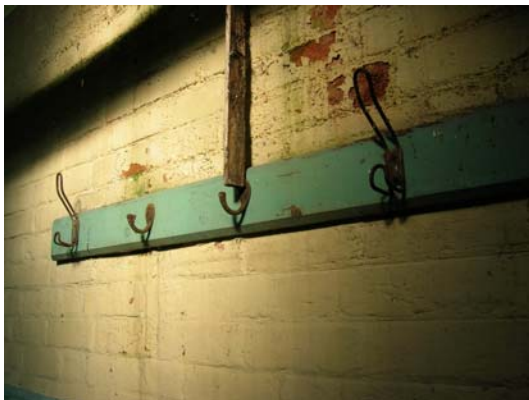
All the metal hooks were rusty with most of their black paint disrupted.

Photograph 3 – Before conservation
Coat hooks on south wall of cubicle 4

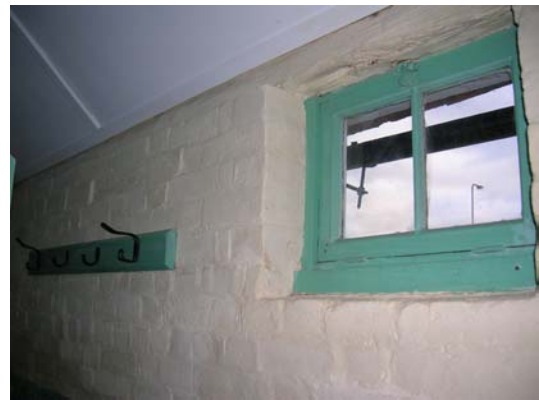
Photograph 4 – After conservation
South wall in cubicle 4

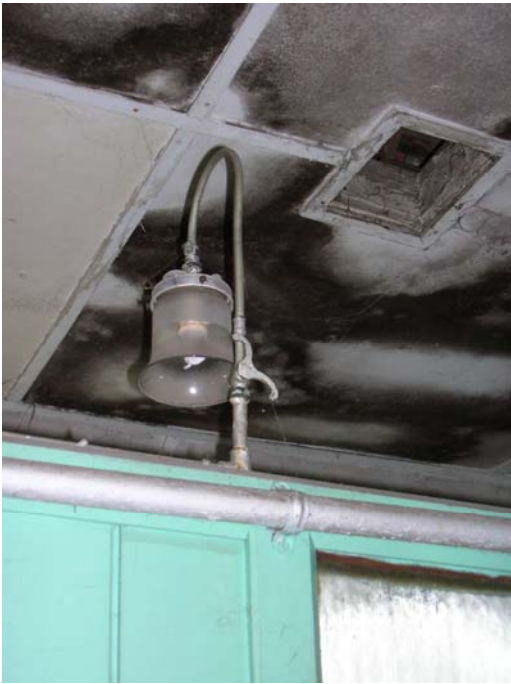
Photograph 5 – Before conservation
Gas lamp above cubicle 2

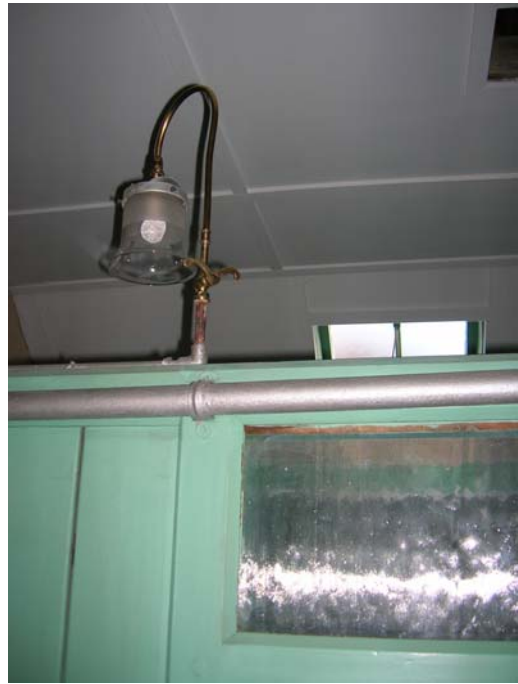
Photograph 6 – After conservation
Gas lamp seen from outside cubicle 2

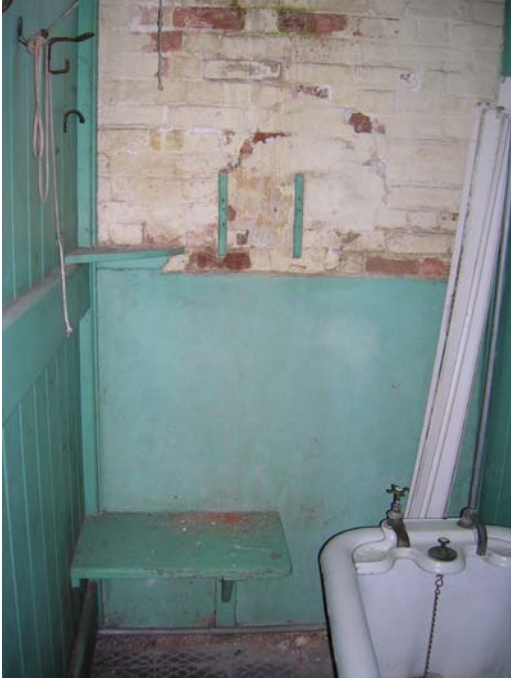
The brick walls, mostly up to 1.5m height, but also at near ceiling height, exhibited decay/flaking/powdering of paint and brick surfaces (up to several centimetres deep on some bricks) as a consequence of moisture and soluble salt migrations.

Photograph 7 – Before conservation
Cubicle 2, note decaying bricks on wall
and missing mirror

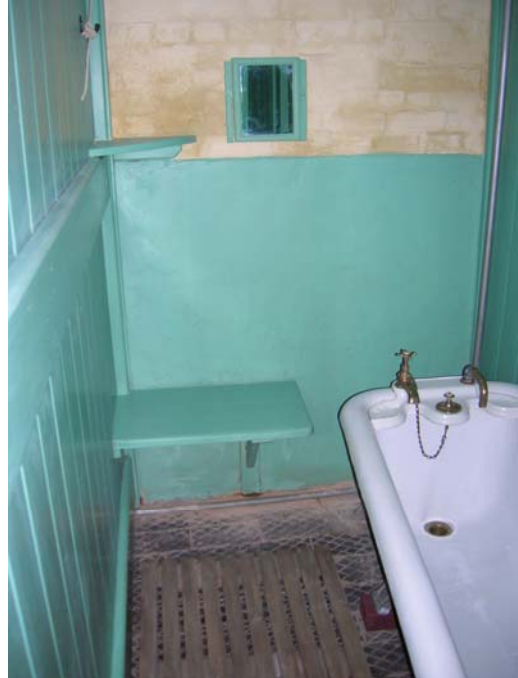
Photograph 8 – After conservation
Cubicle 2 showing new mirror

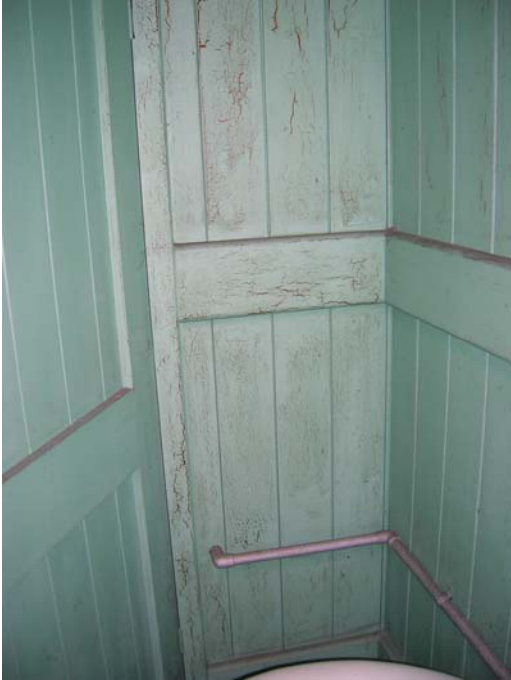
In several significant areas (0.5 -1m²) of the partitions and doors, the green paint exhibited severe shrinkage cracking (rather than age cracking) and wrinkling, where it overlies a glossy clear varnish/resin (possibly shellac) which was applied as a knotting and water sealant, but which was probably still drying during application of the green paint. This was particularly noticeable in cubicle 3 and on the outside of the door for cubicle 4.

Photograph 9 – Before Conservation
Cracking and wrinkling paint on wooden portions of cubicle 3

15. **Replicated wood** elements were repainted in **acrylic paint** and **metal** elements in pigmented Paraloid B72, to match and integrate visually with the cleaned surrounding original paints, distressing them as necessary. In order to restore the colour balance and harmony of the Bathhouse, presenting it in an aesthetically pleasing way, by retaining as much of the 'aged' fabric as possible but without total repainting, integration of damaged surfaces was necessary: **Large areas** of mould stained, severely cracked, lost and damaged paint surfaces were **sensitively 'in-painted'** and distressed as necessary, using **acrylic paints** to visually match, the surrounding aged extant paint, feathering their edges with sponges into the original to integrate gradually. **Small isolated cracks** etc. were carefully **retouched with acrylics or tinted Paraloid B72.**

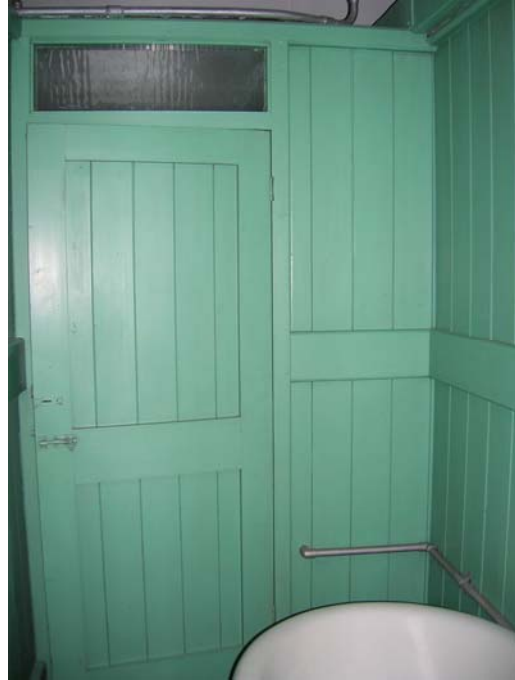
Photograph 10 – After Conservation
Cubicle 3 re-touched door and walls

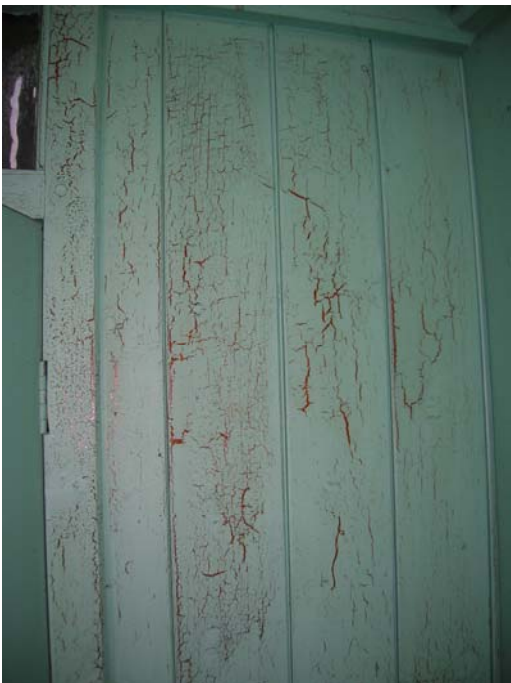
Photograph 11 – Before Conservation
Cracking and wrinkling paint on wooden portions of cubicle 3

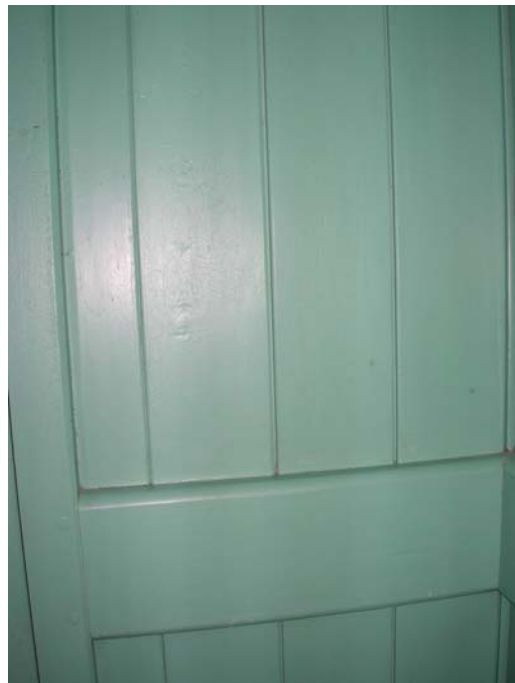
Photograph 12 – After Conservation
partition wall, cubicle 3 after cracks and wrinkling had been re-touched.

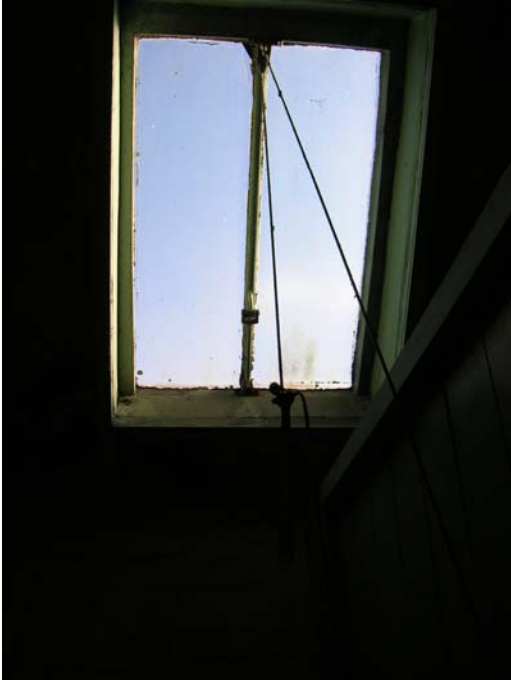
The window opening mechanism (cord, pulleys, levers) on each of the two sloping windows was broken, rusting and not functioning. The painted cast iron lever on the right hand window was broken away but retained.

Photograph 13 – Before Conservation
Broken window lever in cubicle 3

11. The **broken cast iron widow lever** was secured back into position using chemical metal resin, and the **cord/pulley mechanisms reassembled**.

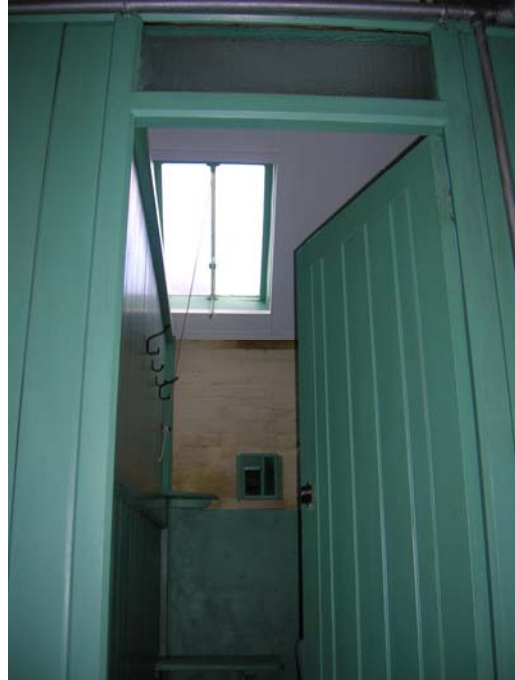
Photograph 14 – After Conservation
Cubicle 2 showing window

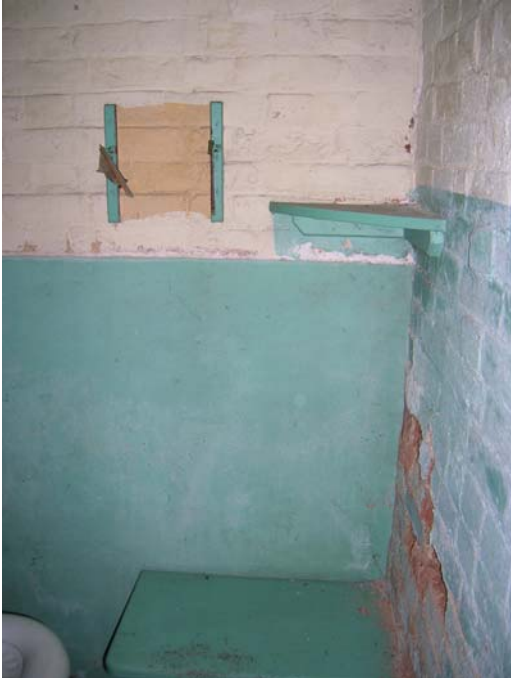
Photograph 15 – Before Conservation
Decaying brick walls and missing mirror
in cubicle 4

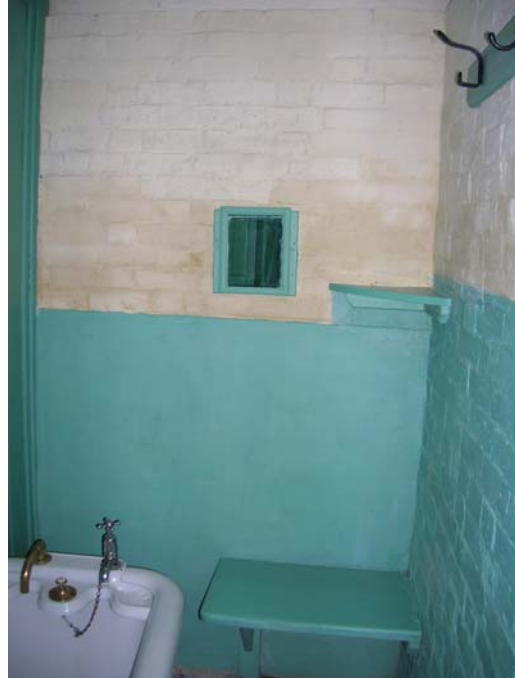
Photograph 16 – After Conservation
Inside cubicle 4 showing new mirror

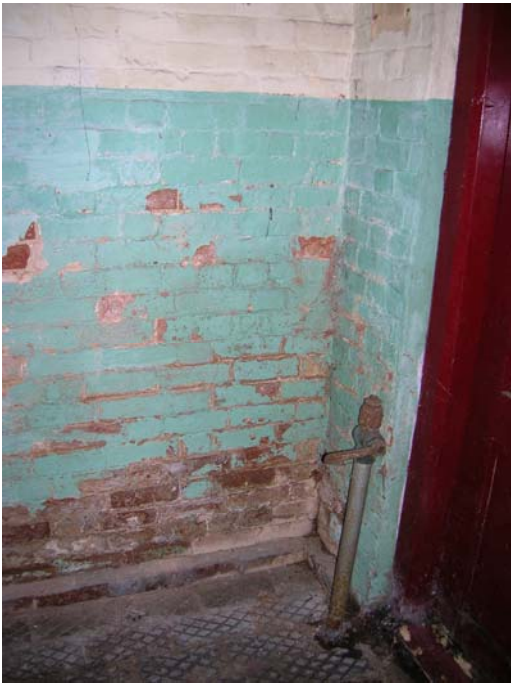
A section of gas and water pipe was missing, as was a gas meter from the wall and associated pipes, which have been replaced, the gas meter with an appropriate 1938 model which now stands on a new wooden shelf.

Photograph 17 – Before Conservation
Decaying brick in south wall, note missing
gas pipes and gas meter

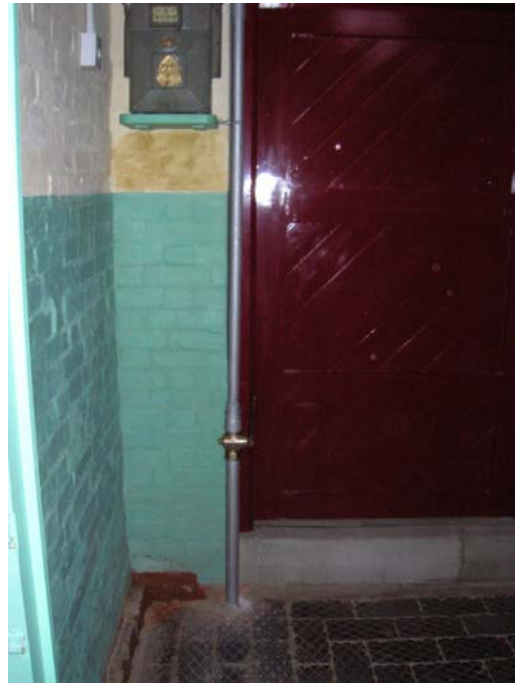
Photograph 18 – After conservation
Gas meter with pipes and shelf

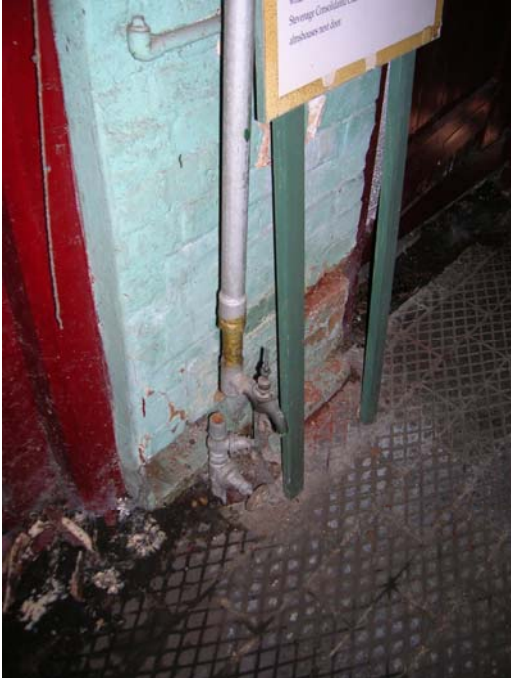
Photograph 19 – Before Conservation
Missing water pipe against west wall,
by door

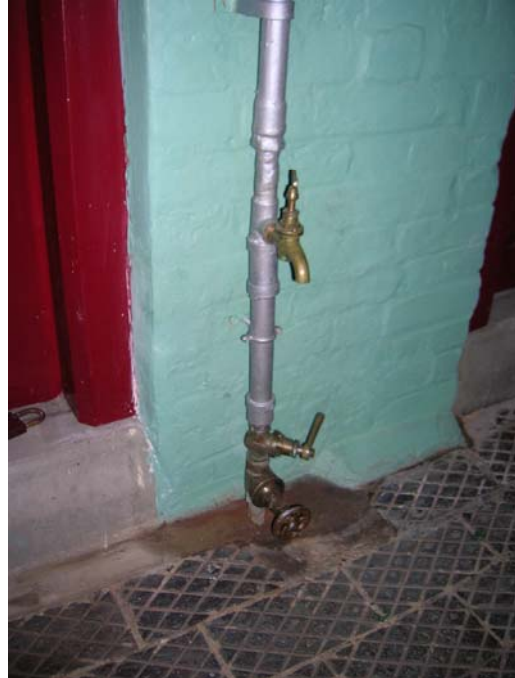
Photograph 20 – After conservation
Renewed water pipe

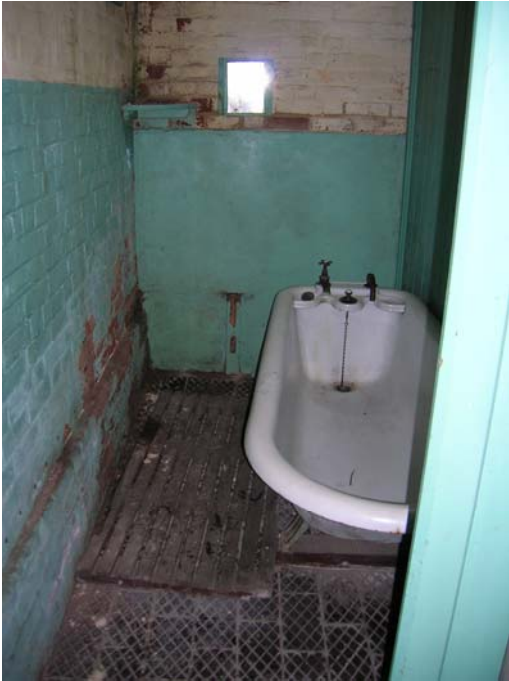
Photograph 21 – Before Conservation
General view of cubicle 1

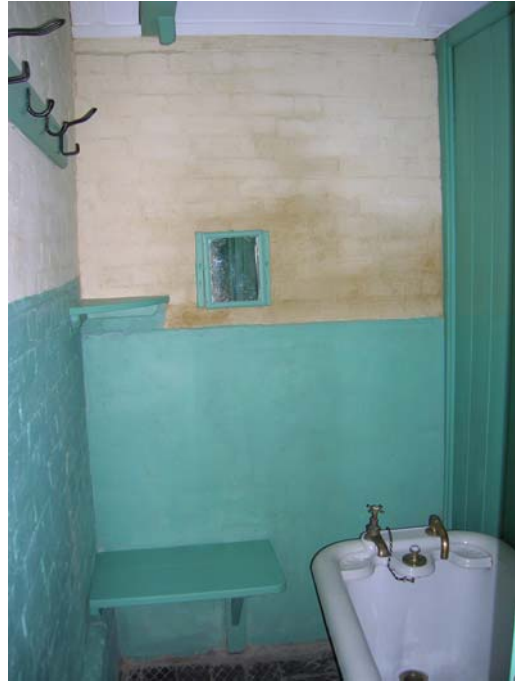
Photograph 22 – After Conservation
Cubicle 1

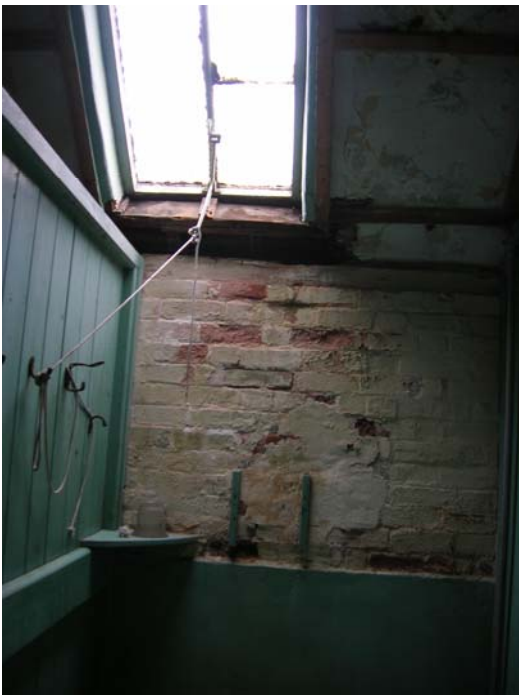
Photograph 23 – Before Conservation
General view of cubicle 2 window

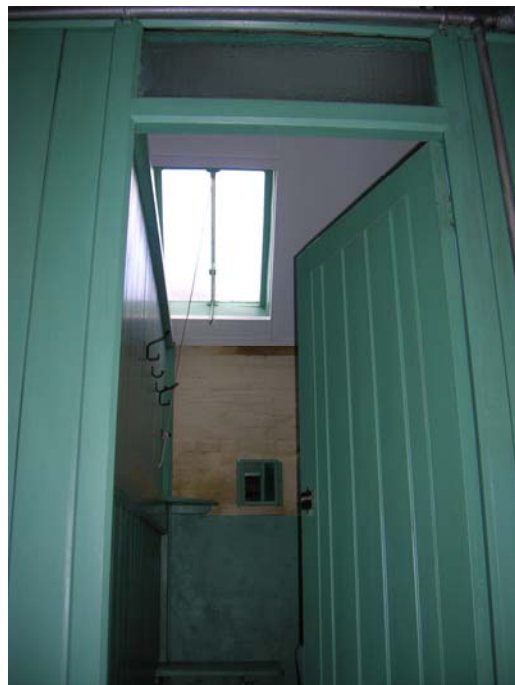
Photograph 24 – After Conservation
Cubicle 2 showing

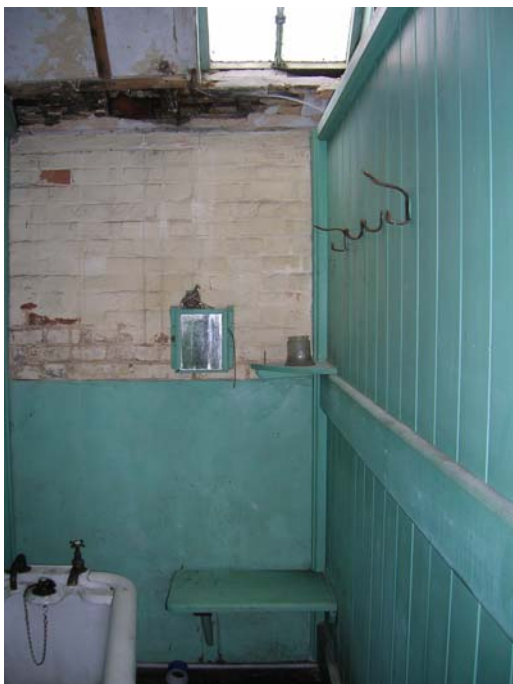
Photograph 25 – Before Conservation
General view of cubicle 3 showing broken
window lever

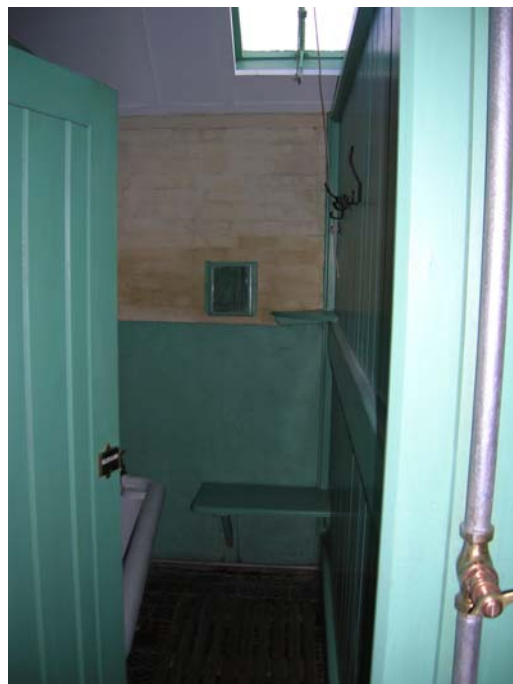
Photograph 26 – After Conservation
Cubicle 3

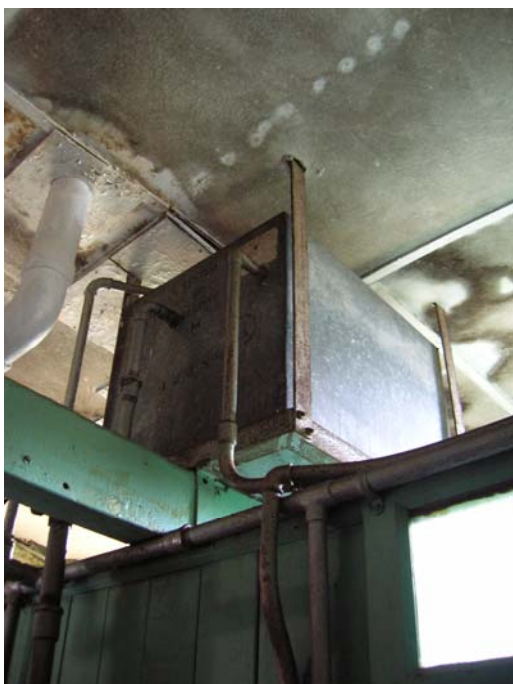
The angle-iron stands and framework for the 1950s boiler and water tank had much surface rusting and pitting, as did the boiler. In addition the large asbestos flue pipe to the boiler had to be replaced.

Photograph 27 – Before Conservation
Rust water tank supports

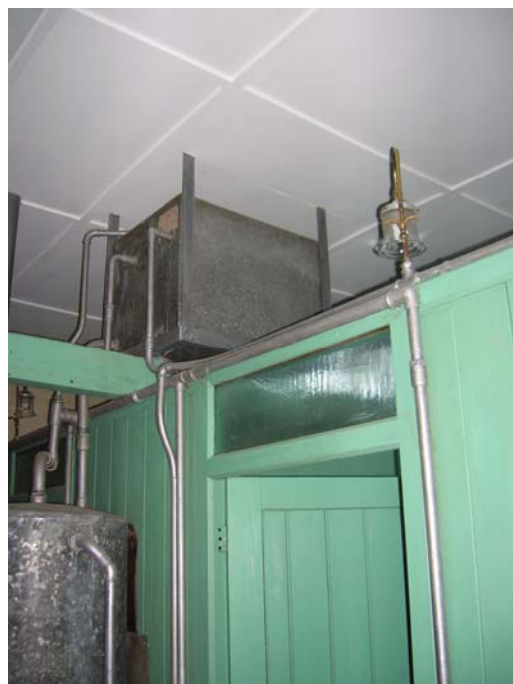
Photograph 28 – After Conservation
Water tank

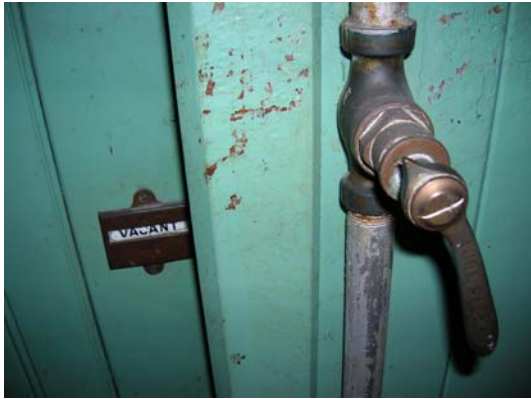
The bronze gas lamp pipes/fittings, bath taps and chains, door latches and engaged signs, stop valve levers etc had tarnished significantly.

Photograph 29 – Before Conservation
Tarnished brass hot water valve and engaged
sign on door of cubicle 3

10. **All Brass/copper metal surfaces** (taps, plugholes, pipes, gas lamp fittings, valves, engaged signs etc.) were cleaned using a fine alkaline paste – siliceous/diatomaceous earth with ammonium hydroxide – **Autosol**), applied with cotton wool, to carefully remove discoloured corrosion products (copper oxides and sulphides). A clear, **protective laquer – Incralac** (Paraloid B44) was applied to the cleaned brass surfaces, to inhibit further corrosion.

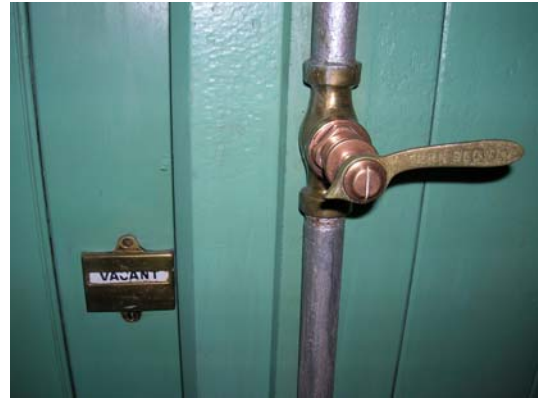
Photograph 30 – After Conservation
Water stop valve and engaged sign

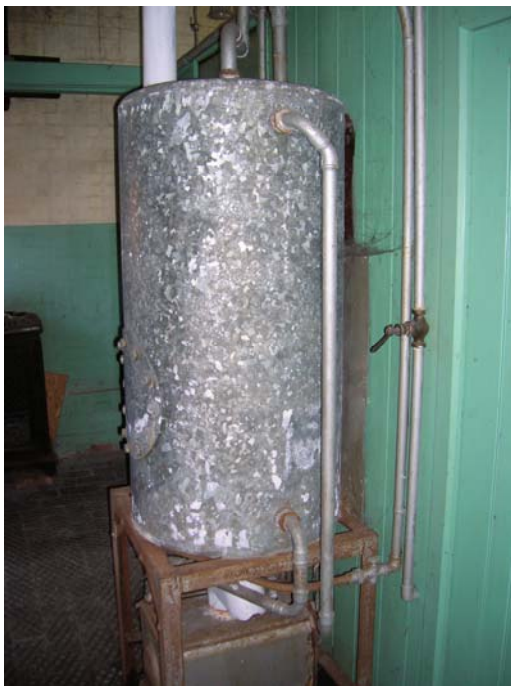
Photograph 31 – Before Conservation
Rusting boiler

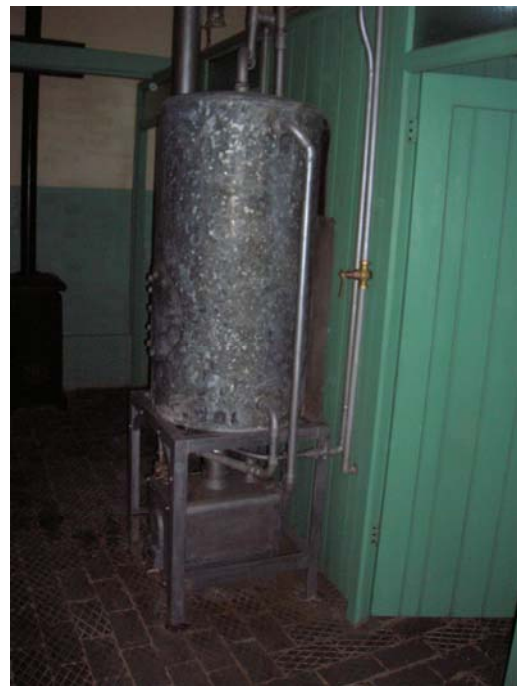
Photograph 32 – After Conservation
Boiler and pipes

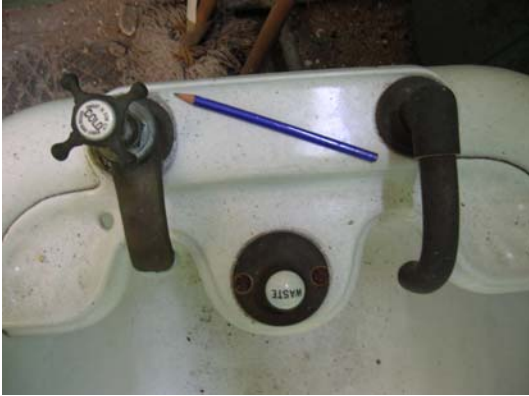
Photograph 33 – Before Conservation
Tarnished brass taps

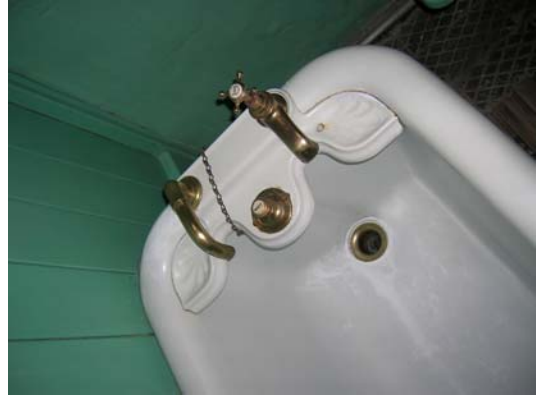
Photograph 34 – After Conservation
Bath and taps in cubicle 3

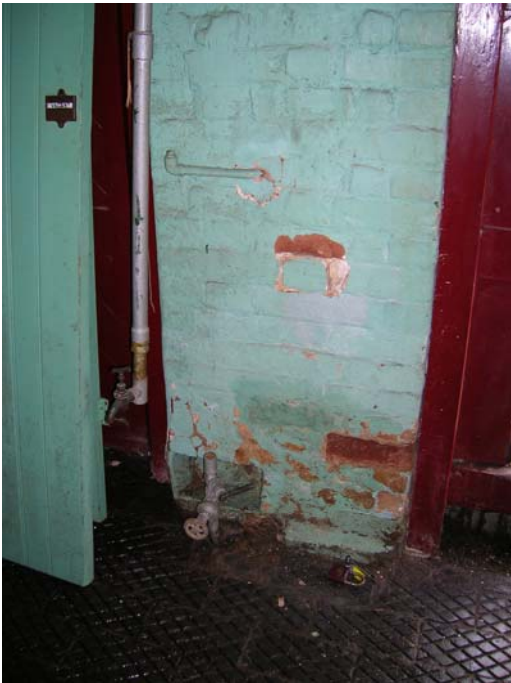
Photograph 35 – Before Conservation
Displaced and missing water pipe
Against west wall

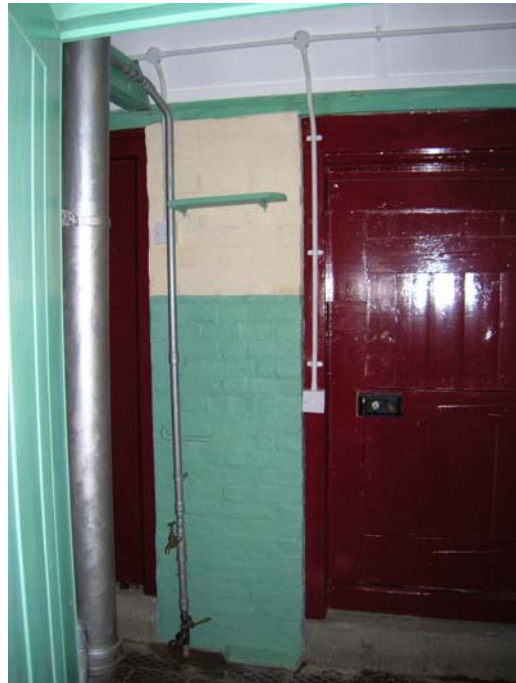
Photograph 36 – After Conservation
replaced water pipes

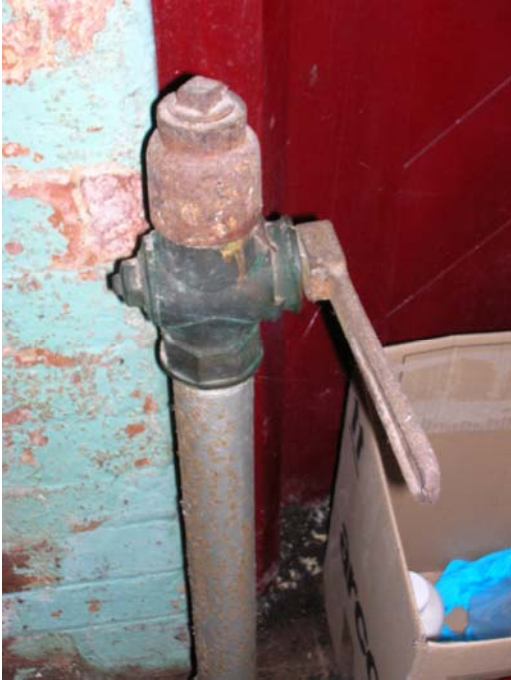
Photograph 37 – Before Conservation
Rusting and missing gas pipes

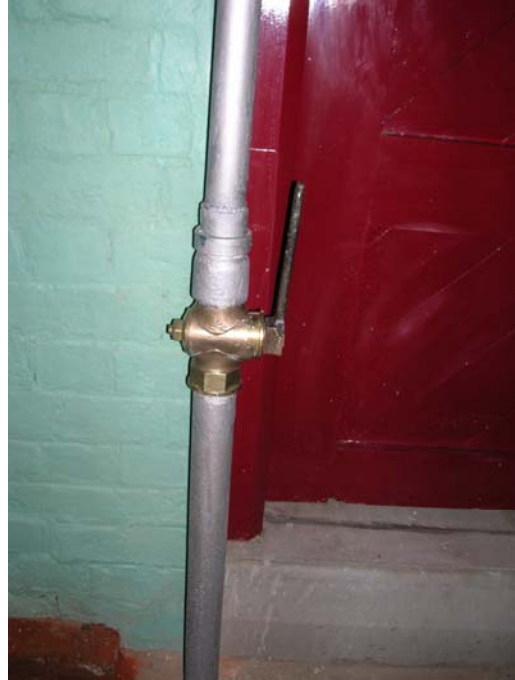
Photograph 38 – After Conservation
Replacement gas pipe

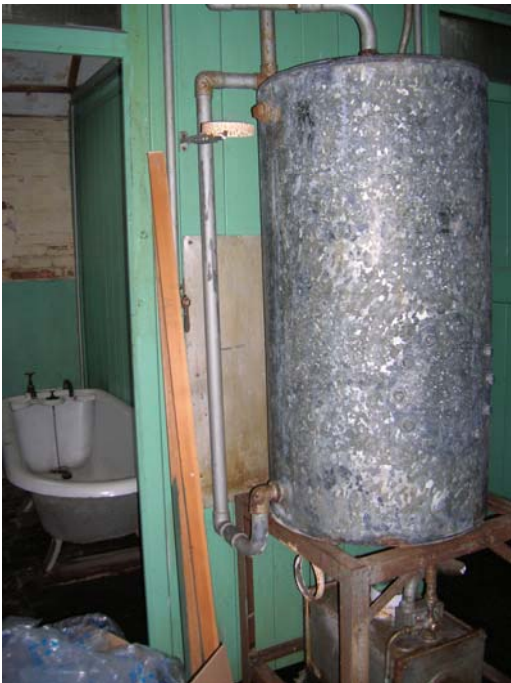
Photograph 39 – Before Conservation
Rusty boiler and missing flue pipe outside
cubicle 2

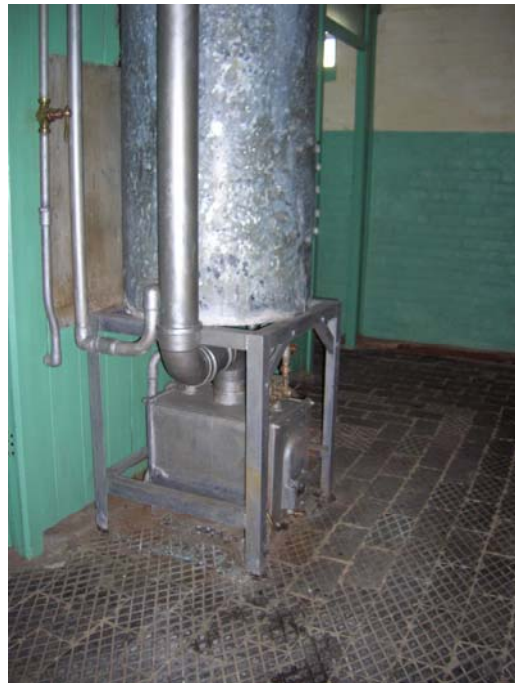
Photograph 40 – After Conservation
Boiler and flue pipe

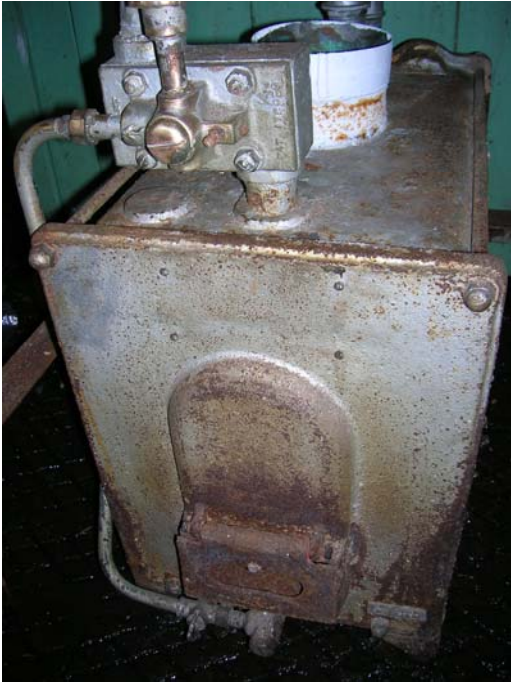
Photograph 41 – Before Conservation
Rusty boiler

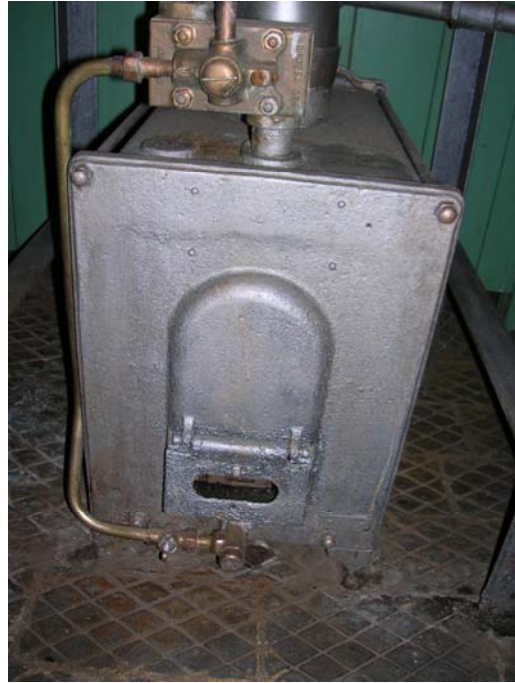
Photograph 42 – After Conservation
Restored/stabilised boiler

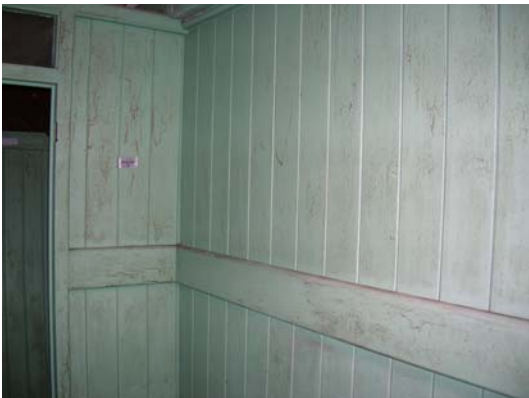
Photograph 43 – Before Conservation
Dirt and cracked paint on partition walls
of cubicle 3

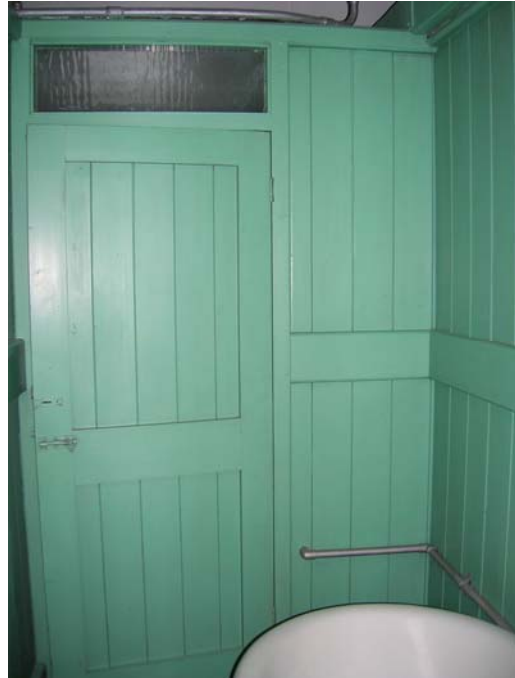
Photograph 44 – After Conservation
Retouched door and walls, cubicle 3

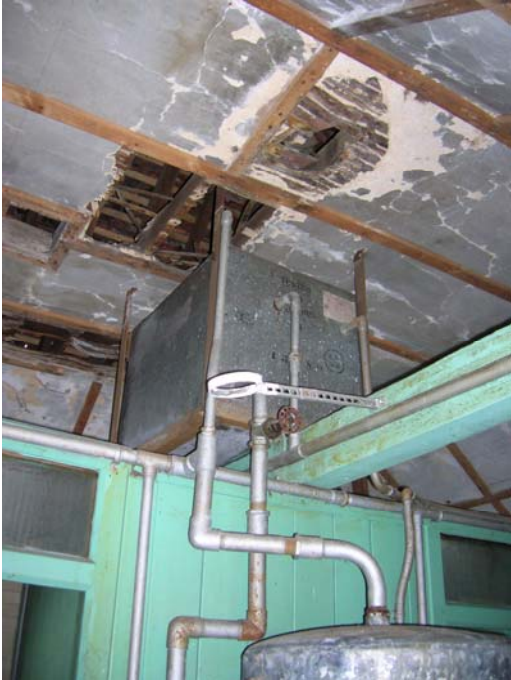
Photograph 45 – Before Conservation
Rusting supports to water tank

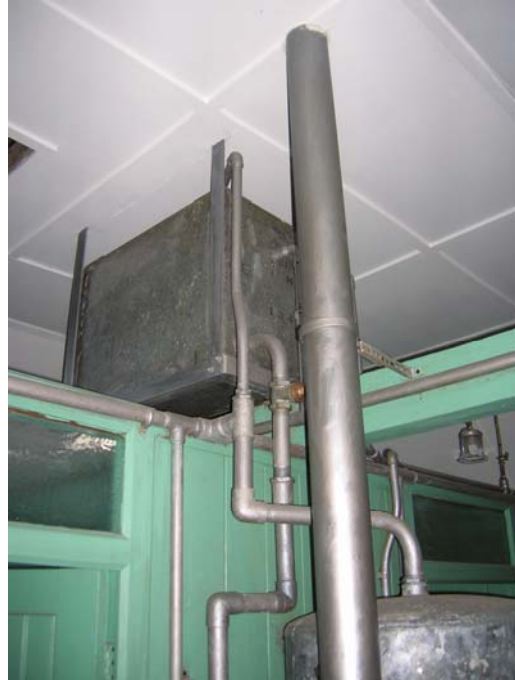
Photograph 46 – After Conservation
Boiler flue pipe replacement

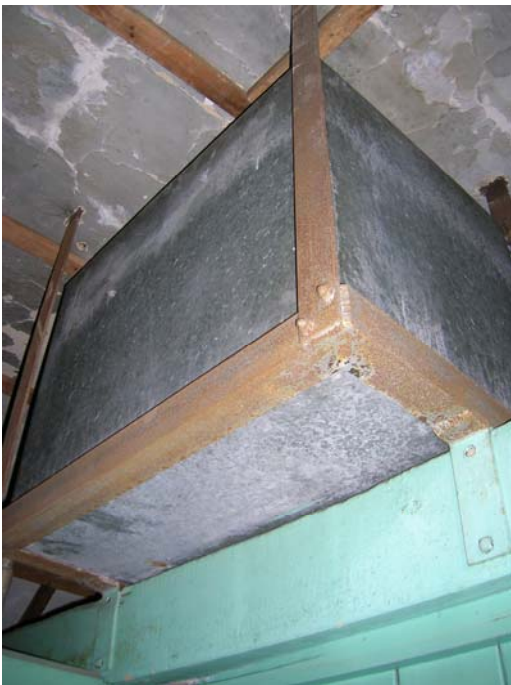
Photograph 47 – Before Conservation
Rusting supports to water tank

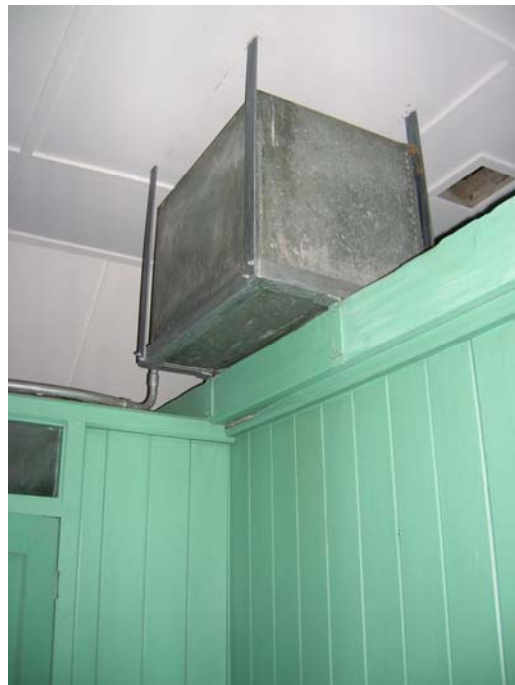
Photograph 48 – After Conservation
Water tank seen from inside cubicle 2

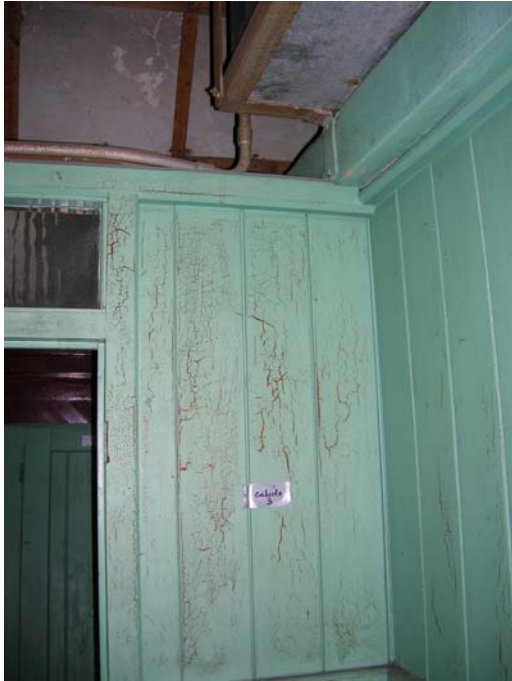
Photograph 49 – Before Conservation
General views of cracked paint on partition
wall of cubicle 3

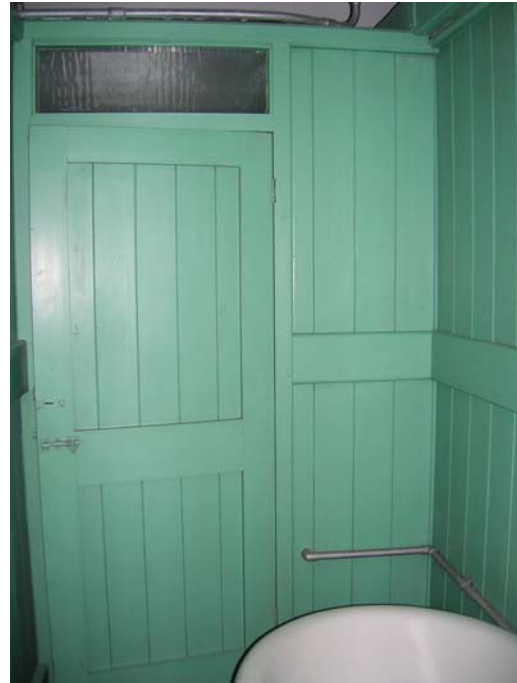
Photograph 50 – After Conservation
Cubicle 3, retouched door and walls

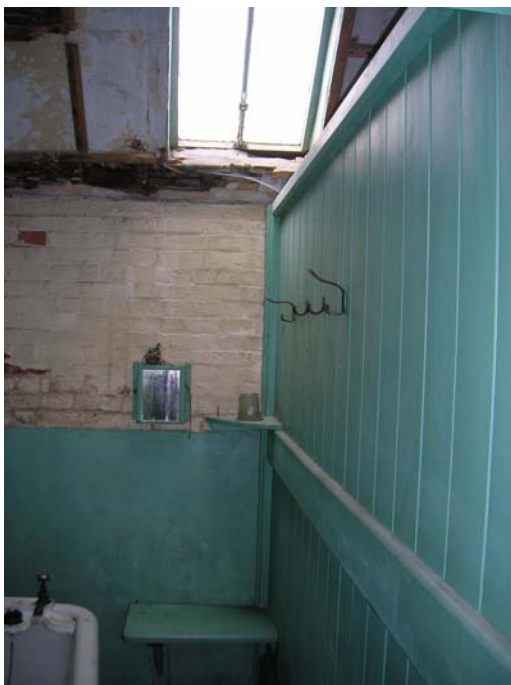
Photograph 51 – Before Conservation
Cubicle 3, showing broken window lever etc

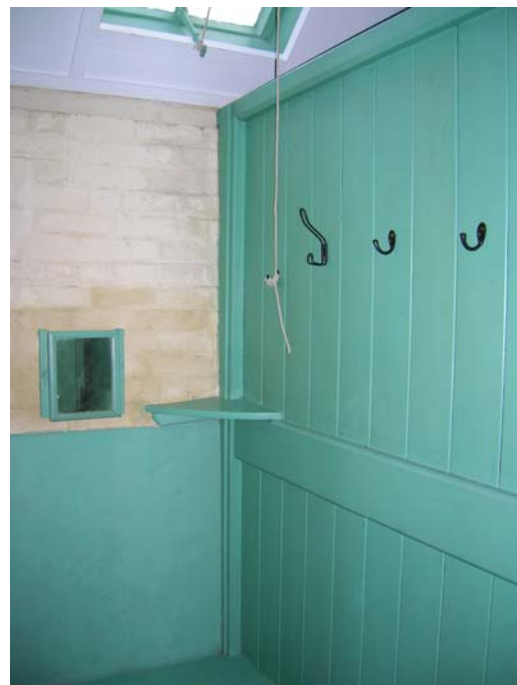
Photograph 52– After Conservation
Cubicle 3
