Treatment Report
Conservation Programme to Monuments
St Mary Magdalen, Fifehead, Dorset

1315

July 2018

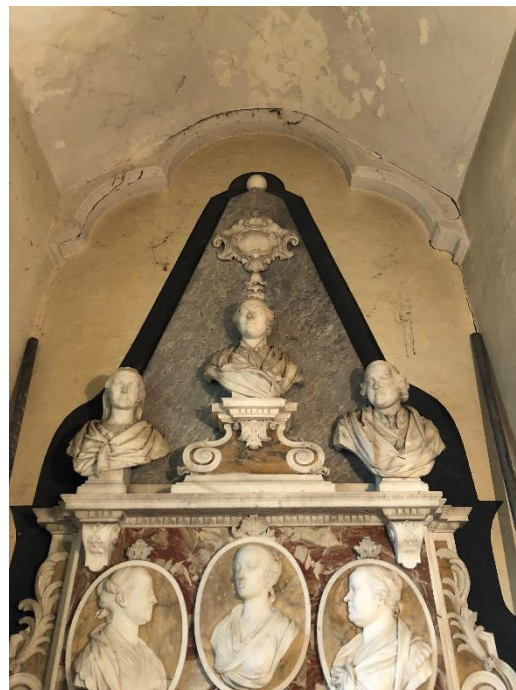
Figure 2: Detail of the north elevation with the cracking through the plaster and loss of surface paint clearly visible

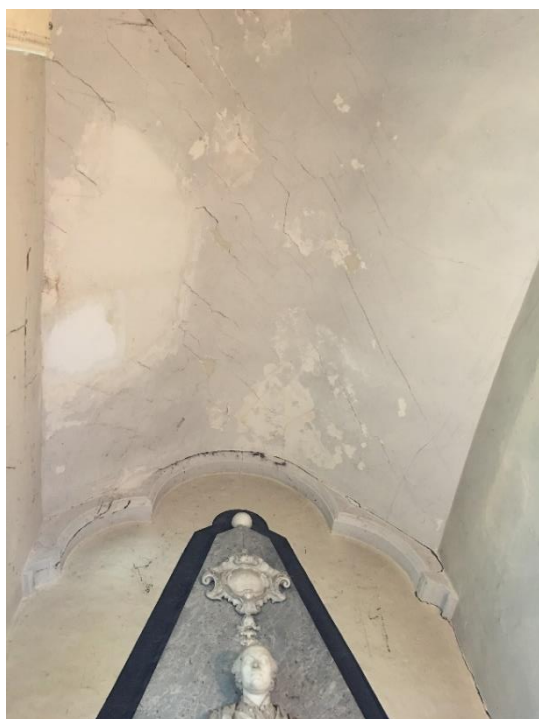
Figure 3: View of the ceiling before the conservation programme showing extensive cracking and previous patch repairs

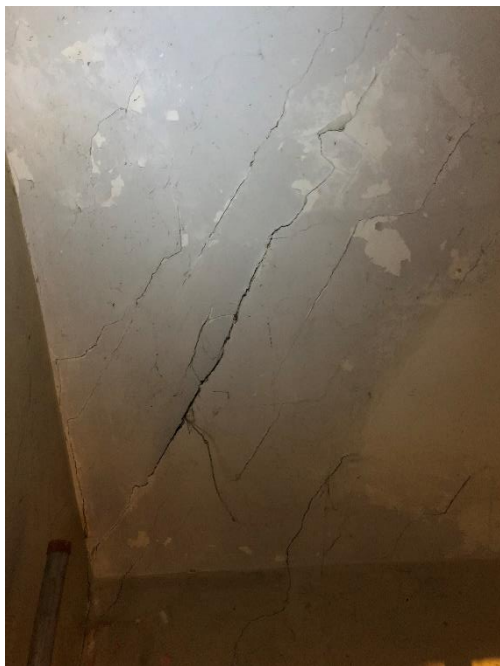
Figure 5: Detail of the extensive cracking to the ceiling

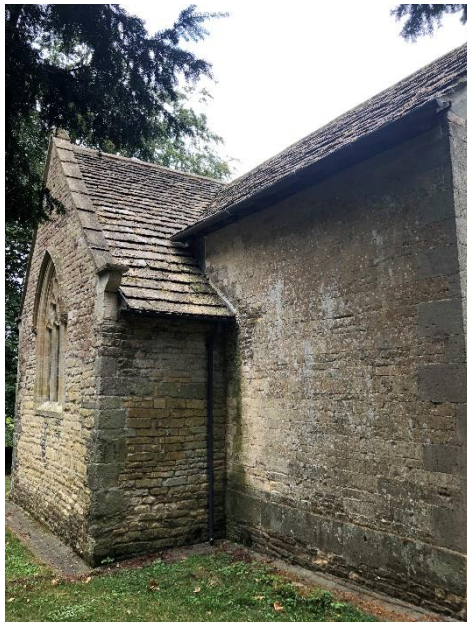
Figure 18: The east elevation of the Newman Chapel showing the faulty rainwater goods at the intersection with the chancel. The area of green biological staining can be seen adjacent to the downpipe where the rainwater is spilling over the wall

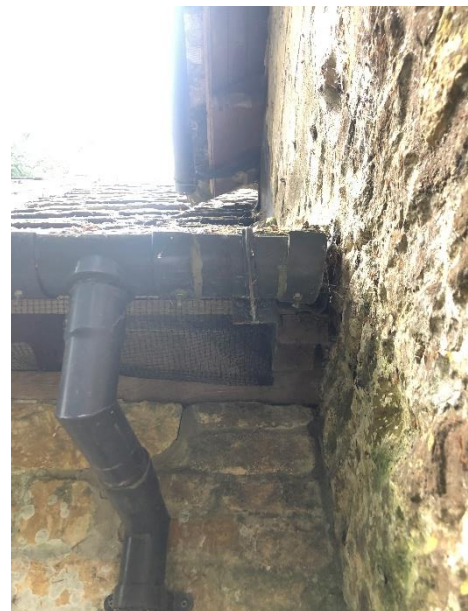
Figure 19: Detail of the guttering shown in Figure 18 with the opportunity for rainwater to spill over the wall

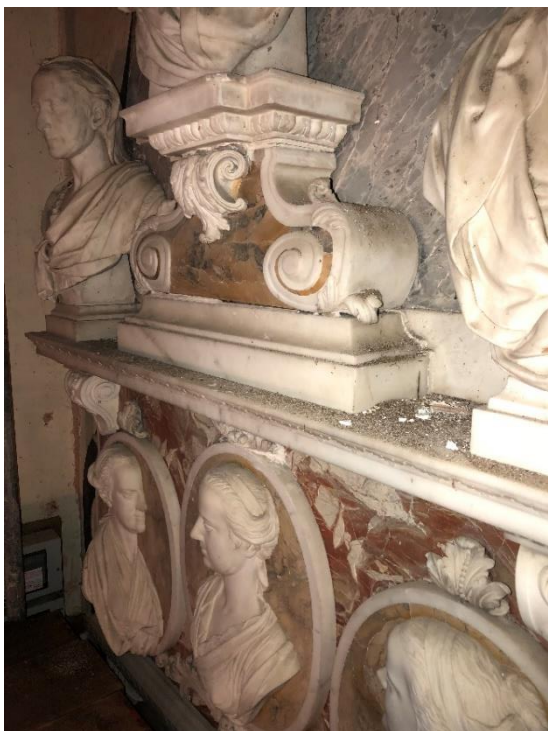
Figure 24: Illustration of the high levels of surface soiling and dust and debris over the monument

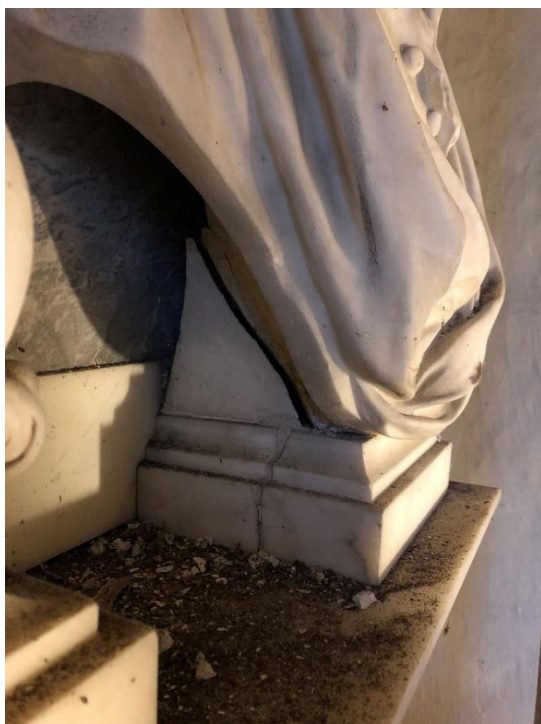
Figure 26: Significant crack through the plinth to the bust of Samwell Newman due to the corrosion of the iron fixing. The bust was completely mobile and removed during the initial inspections

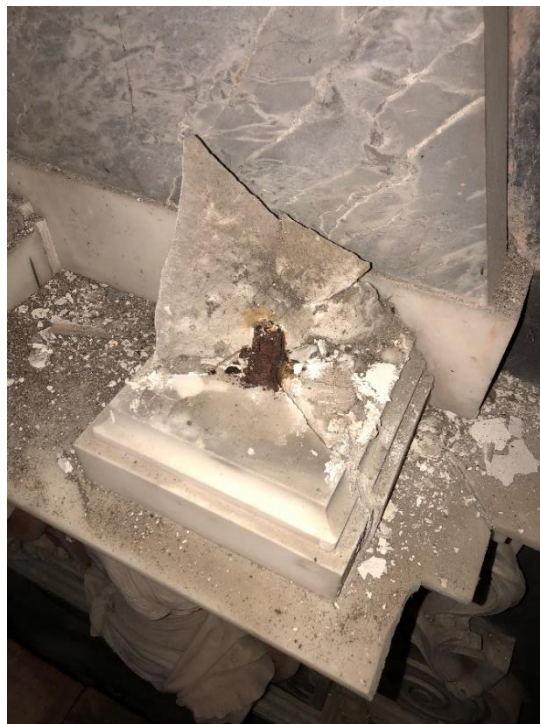
Figure 27: The bust to Samwell Newman removed revealing where the severely corroded iron fixing had exerted pressure on the marble causing multiple fractures through the marble

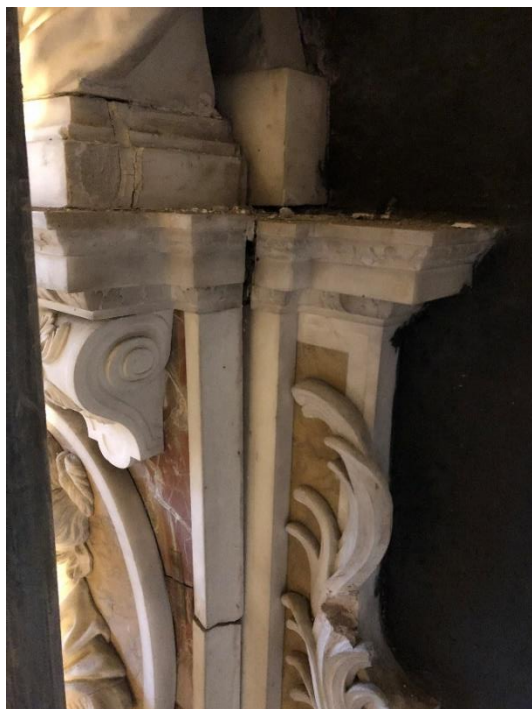
Figure 28: The sinister top corner of the backing panel to the medallion carvings showing the movement through the vertical joint of up to 25mm due to corroded iron fixings. Associated horizontal cracking can be seen through the marble frame and veneer

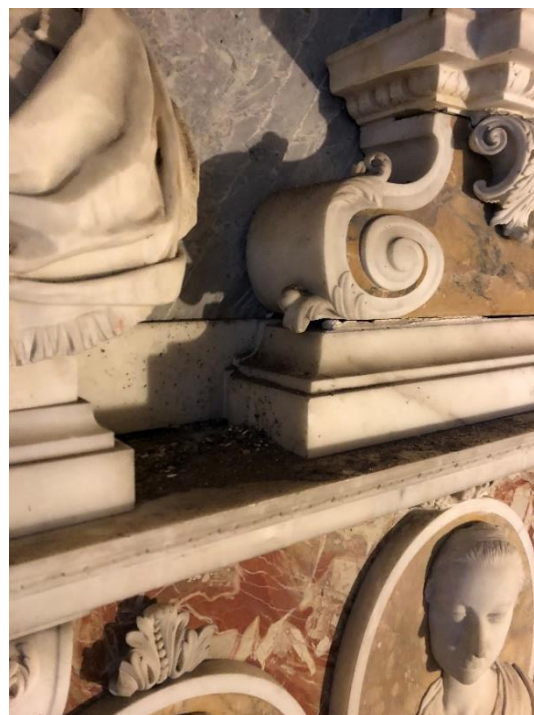
Figure 29: Detail of movement through the plinth to the central bust of Sir Richard Newman

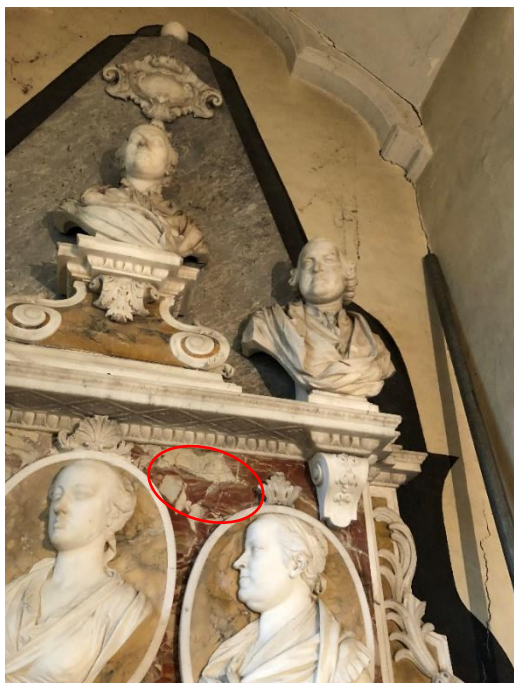
Figure 30: Overall view of the busts to Sir Richard and Samwell Newman illustrating the point that is hard to see how unstable these portrait carvings are without a close inspection. The cracking through the veneer has been highlighted

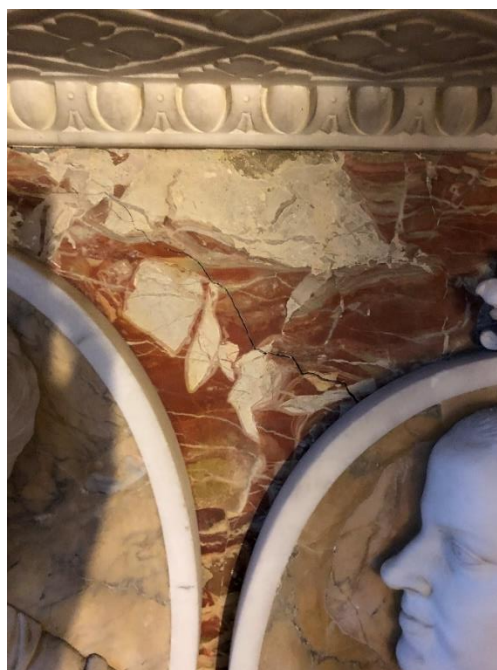
Figure 31: Detail of the cracking through the veneer to the dexter of the sinister medallion carving

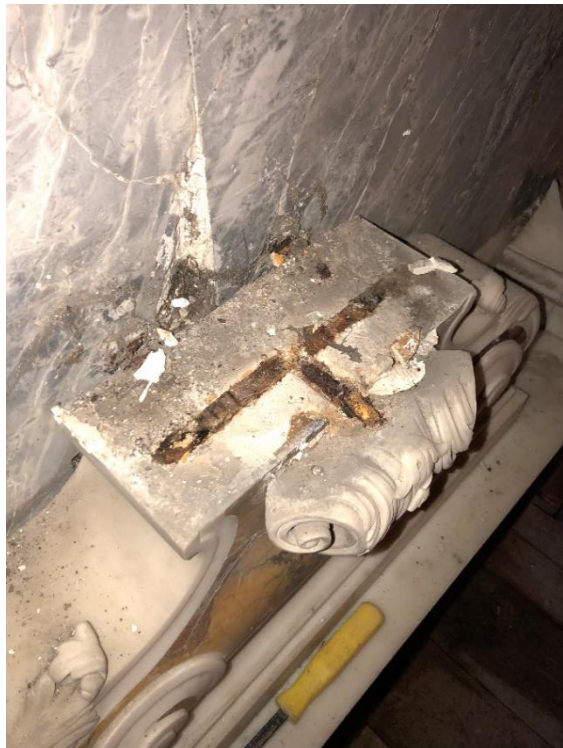
Figure 32: Corroded iron embedded into the central plinth which has caused the movement through joint resulting in the portrait bust of Sir Richard beginning to become mobile

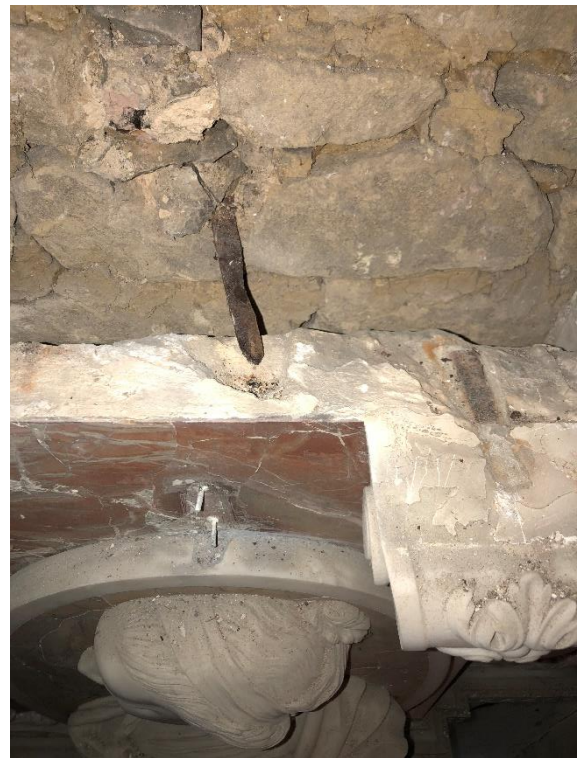
Figure 38: More corroded iron revealed during dismantling

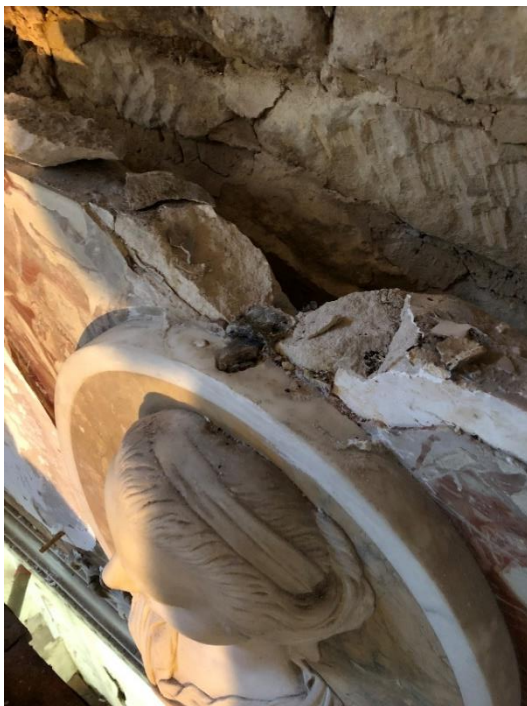
Figure 39: Corroded iron fixing at the top of the central medallion

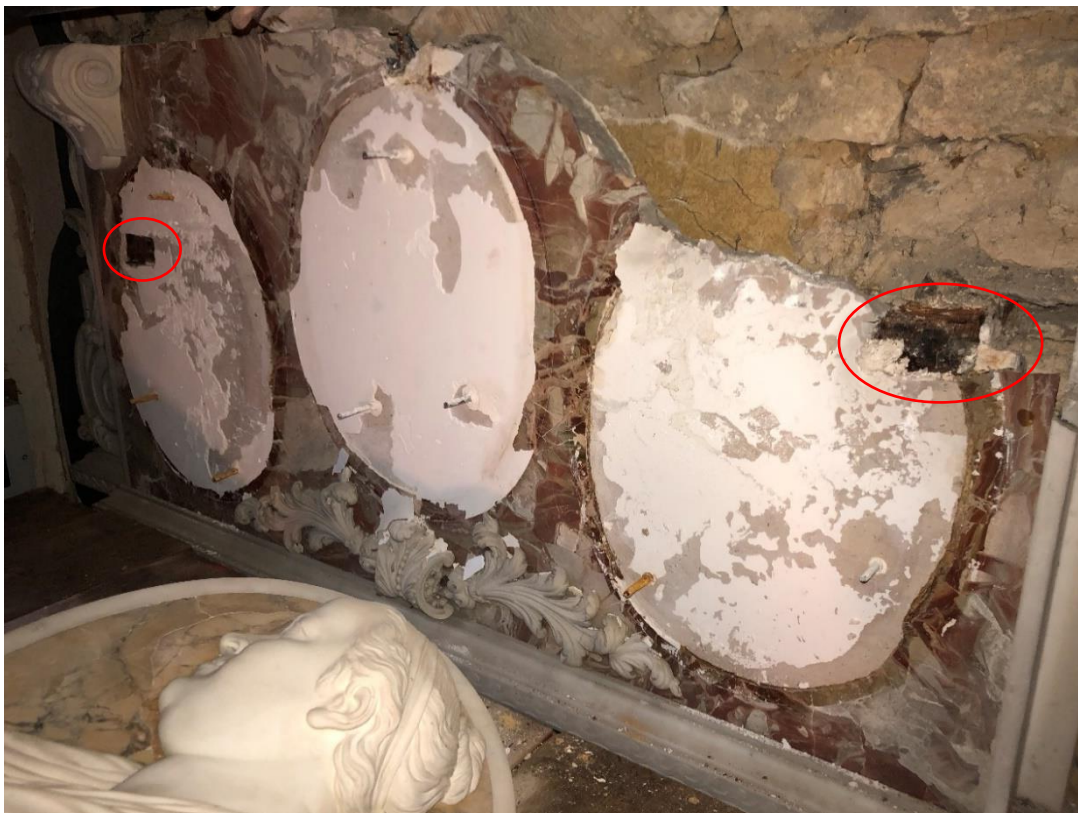
Figure 41: All three medallion carvings and damaged veneer removed to clearly show huge hanger iron section with a second one revealed behind the dexter medallion carving

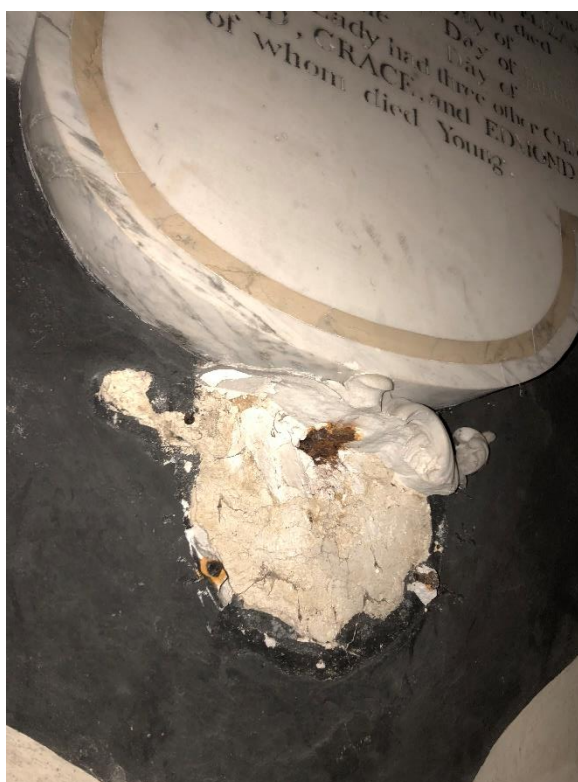
Figure 46: The corroded iron fixing which had split the central decorative corbel in two

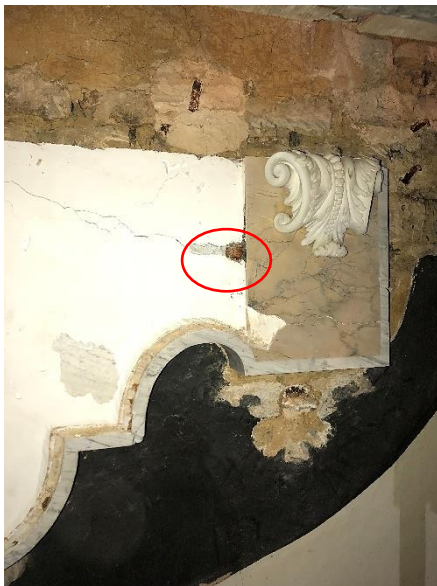
Figure 47: The sinister gudgeon and pintle iron fixing revealing itself after the removal of the inscription panel. The significant fractures through the panel can also be seen

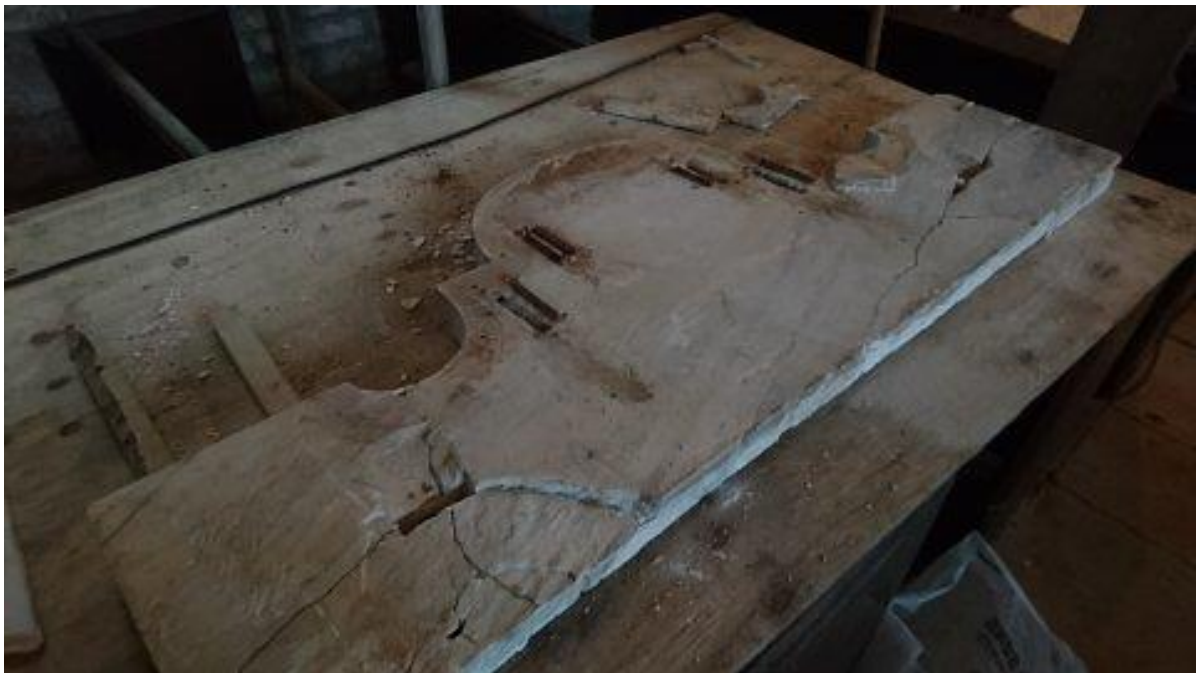
Figure 49: The back of the lower panel showing the extensive damage caused by the corroded surface mounted iron cramps

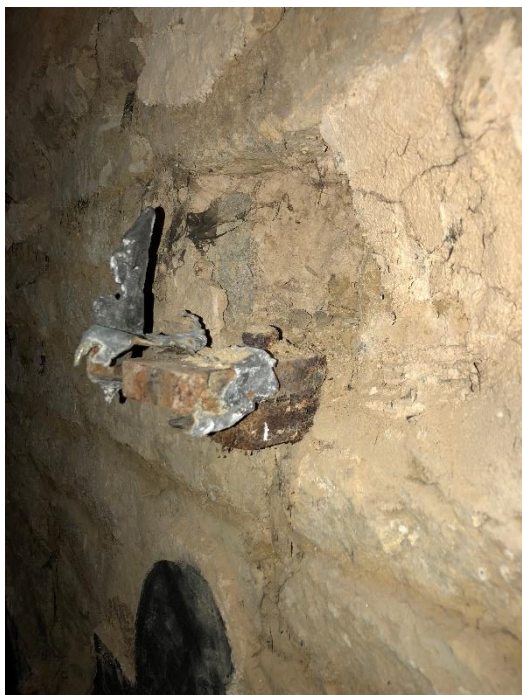
Figure 50: Detail of the corroded gudgeon and pintle fixing after the removal of the lower section showing the failed lead

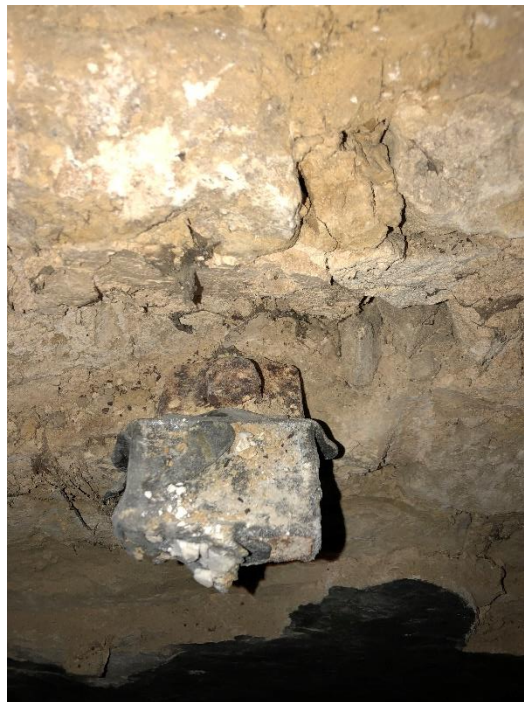
Figure 51: Detail of the corroded sinister gudgeon and pintle fixing with the failed lead

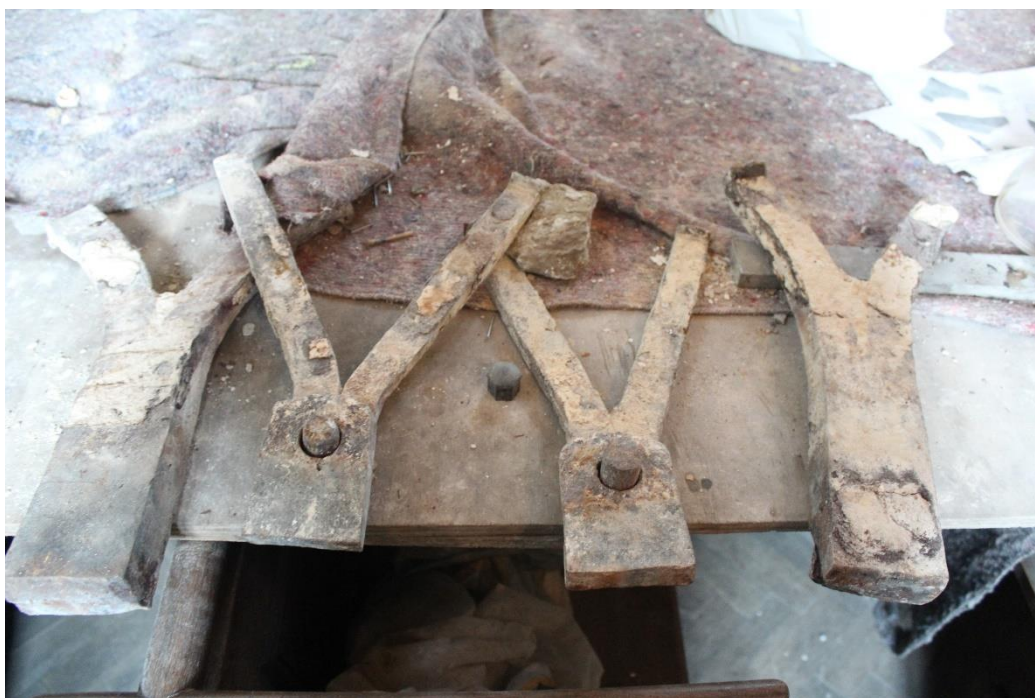
Figure 53: The four large iron fixings in all their glory which caused so much damage to the Newman monument

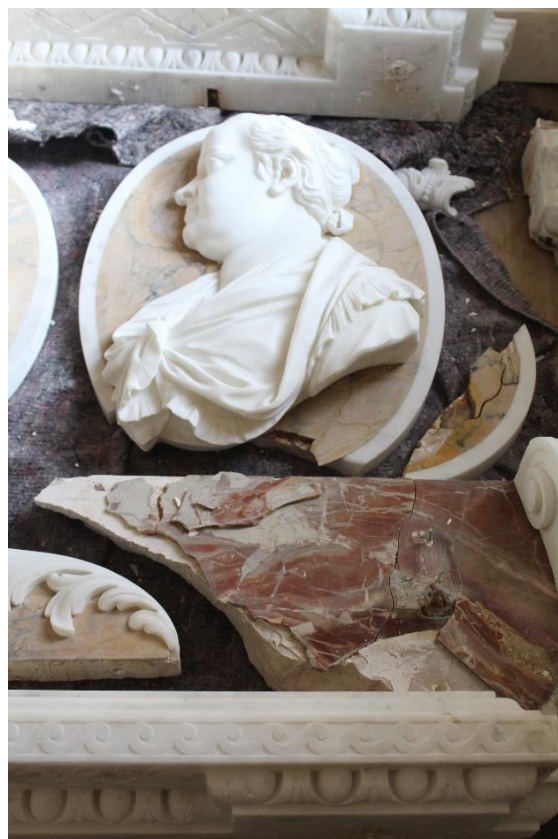
Figure 70: Sinister medallion portrait after cleaning programme. The numerous fractures to the veneer and fracture to the backplate to the medallion can be seen

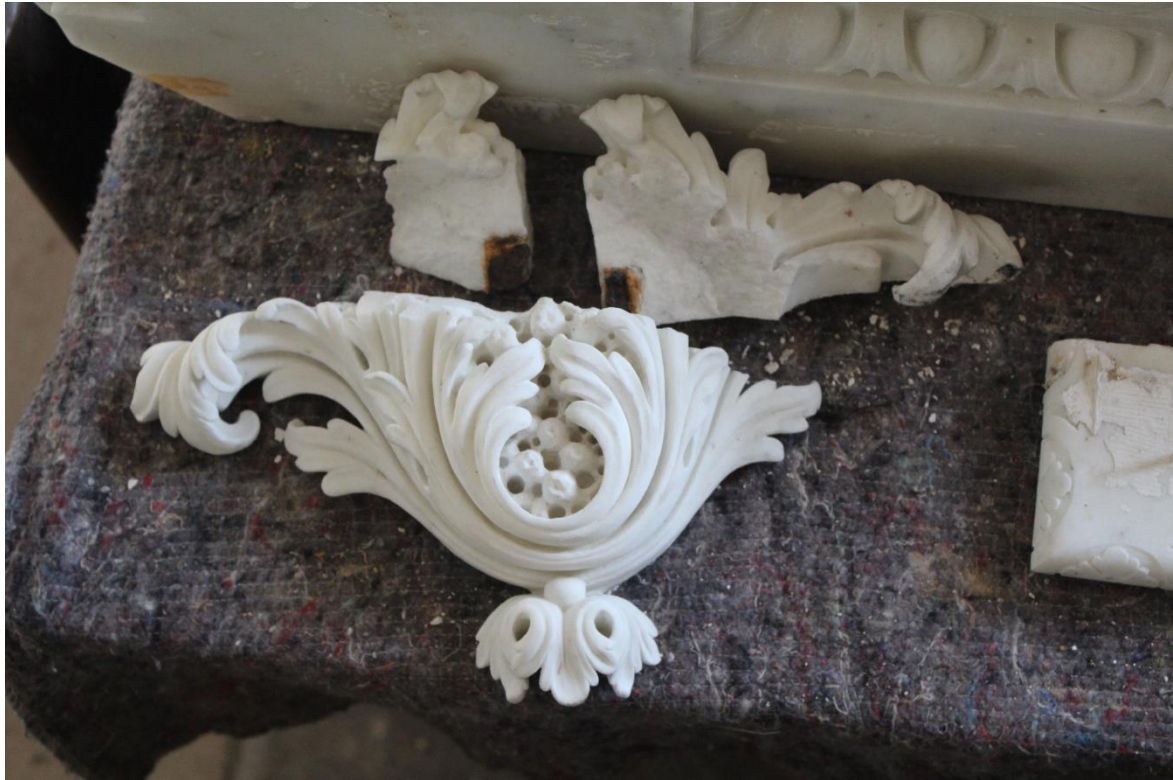
Figure 74: Decorative lower corbel after cleaning showing the attention to detail of the carving. The damage caused by the corroded iron fixing can also be seen

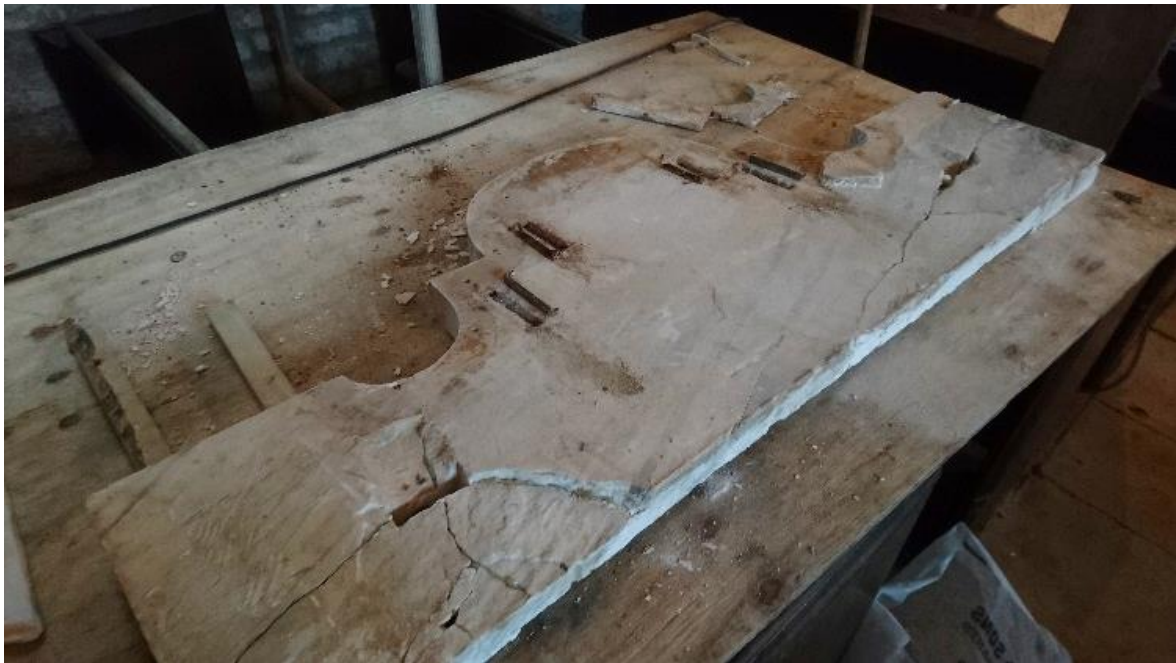
Figure 75: The back of the inscription panel showing the numerous corroded iron fixings and associated severe cracking

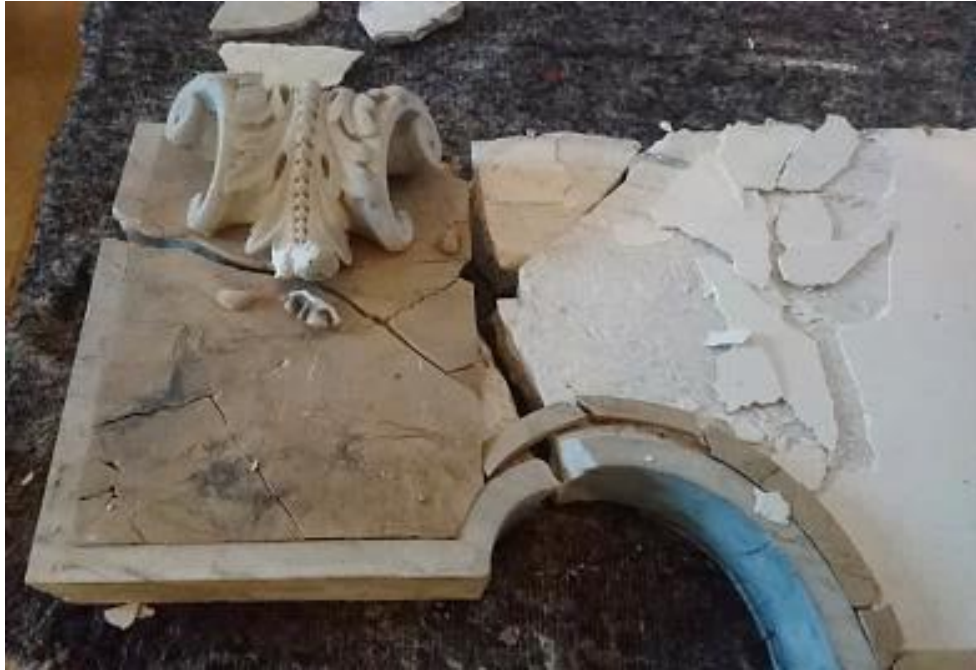
Figure 76: damage to the veneer and backing stone due to the corroded iron fixings

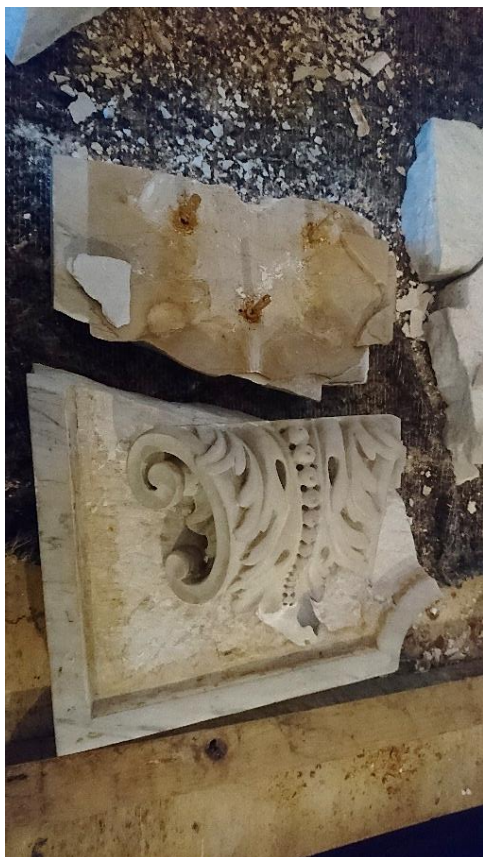
Figure 77: Surface mounted corbel with fracturing the backing stone and corroded pins running through the veneer

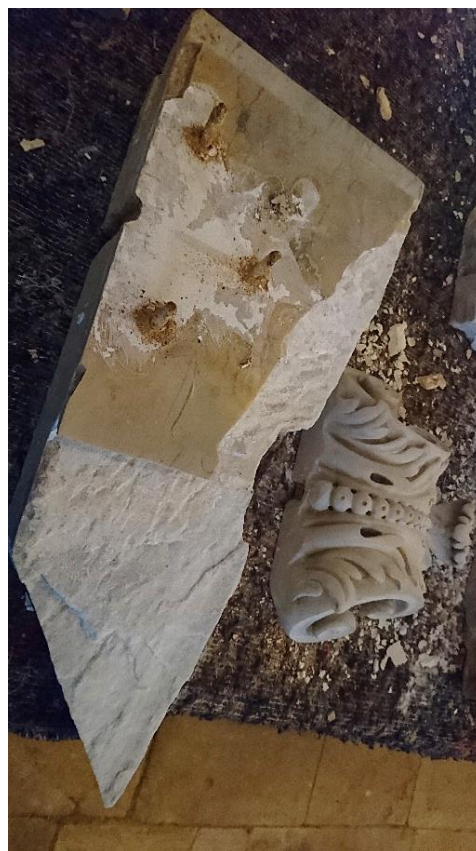
Figure 78: Further example of corroded pins running through the veneer and the fractured backing stone

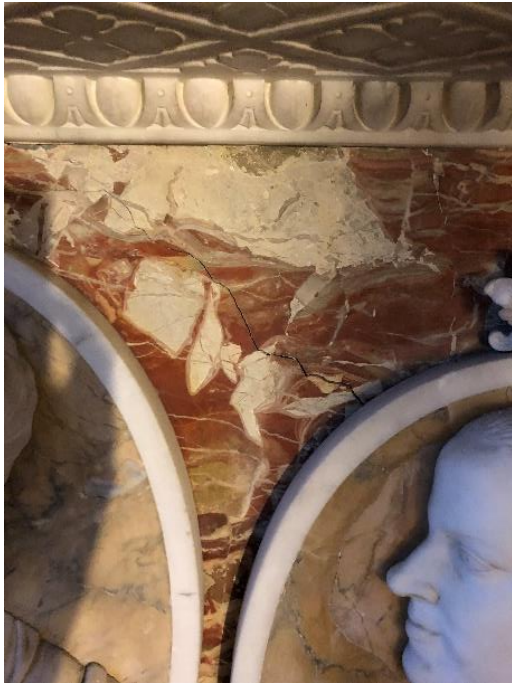
Figure 87: Cracking seen through the red veneer before the conservation programme

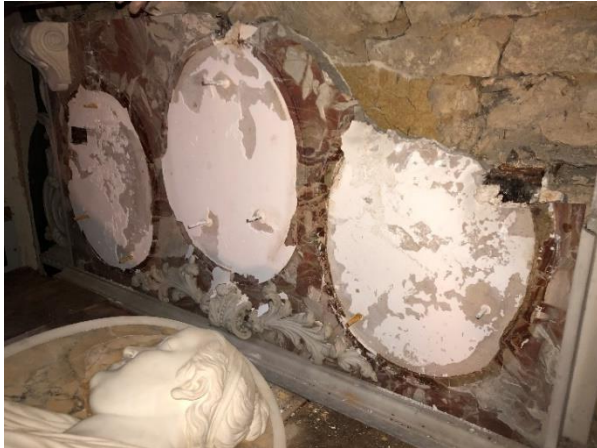
Figure 91: The middle panel during dismantling showing the location of the two fishtail iron fixings and resulting damage

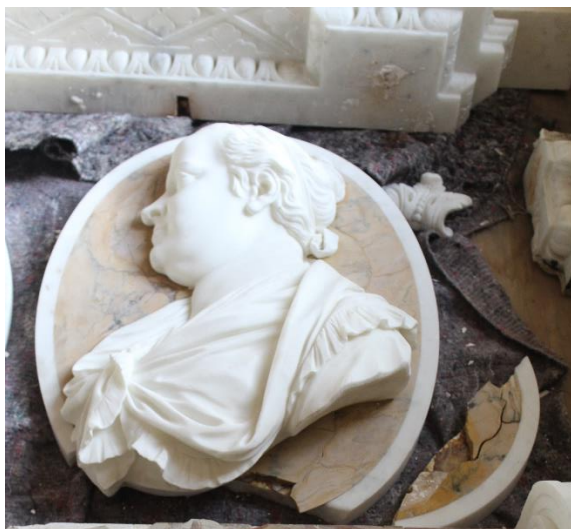
Figure 93: The sinister medallion carving showing the detached section and damaged veneer

The sinister portrait needed the portrait resetting on a bed of plaster and the lower section of the oval, which had become detached, re-fixed. The latter was achieved using stainless steel fixings, resin and plaster of Paris.

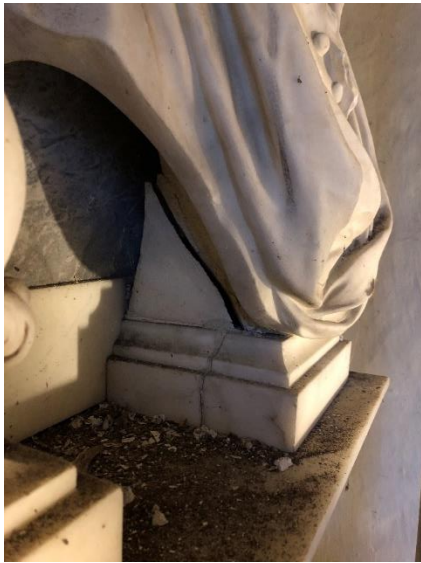
Figure 97: Image of the cracking through the plinth and bust

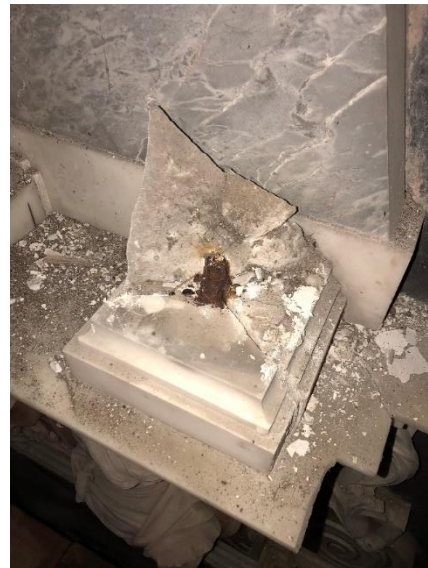
Figure 98: Image of the corroded iron fixing causing fracturing through the plinth

Figure 99: The plinth repaired with plaster and secured with a stainless-steel pin

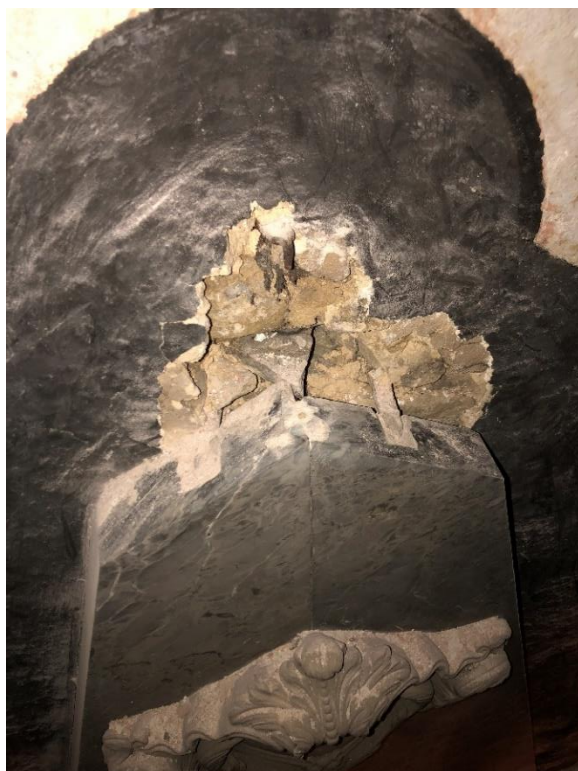
Figure 112: The corroded iron retaining cramps in place before removal

Figure 113: The retaining cramps replaced with stainless steel and the surmounting marble ball reinstated. The coat of arms can be seen after cleaning

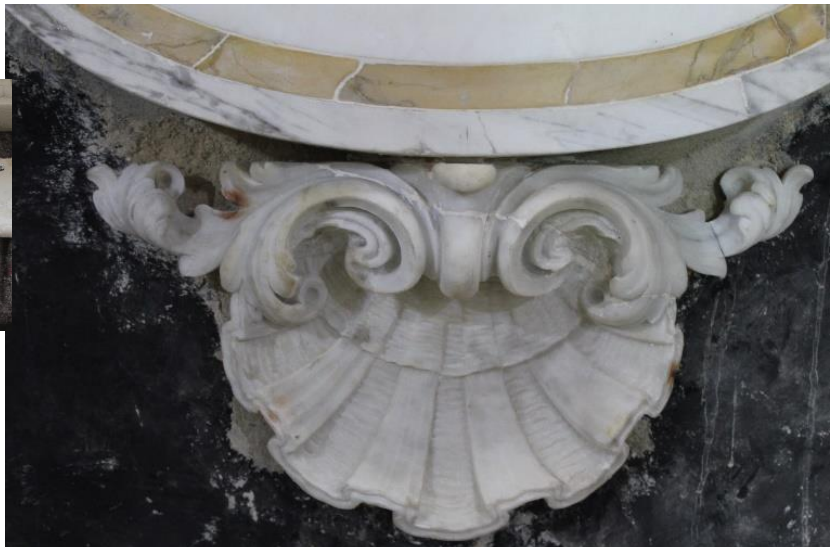
Figure 118: Central corbel below inscription panel which was cracked through the upper section repaired and reinstated
