East Worlington Parish Hall Newsletter

Parish Hall Conservation and Improvement Project

Edition 12 - Week Ending 08 January 2016

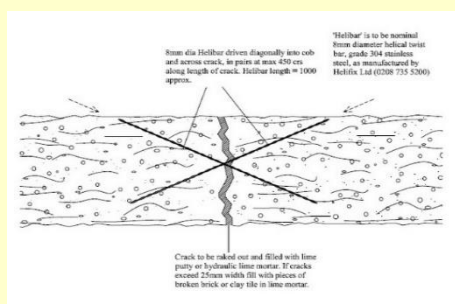
Visitors to the Hall may have seen cracks in the corners of the walls between the south end wall and the east wall and west wall. This has been monitored over a period of time and while it has not shown to be getting worse it is clearly an issue that requires resolution. The walls will be pinned and the cracks filled.

Diagram showing how the wall will be pinned
