INTRODUCTION

THE EXCAVATION OF STALBRIDGE HOUSE 2018

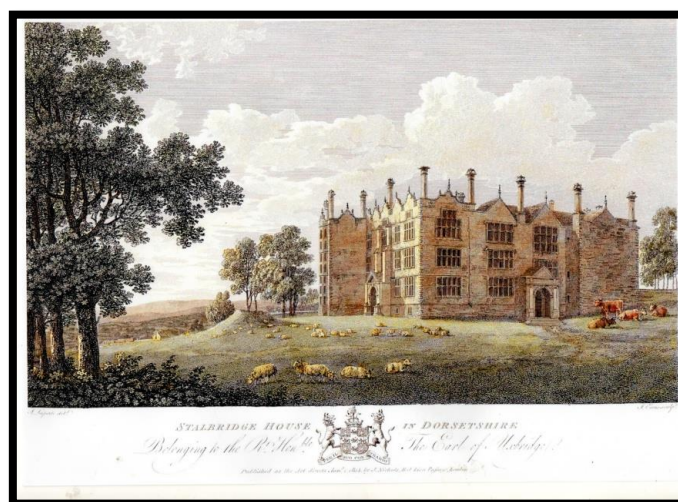
Fig.1 Stalbridge House, north-west facing elevation.

One of the things that archaeologists do not do is go into an excavation blind. Yes, we did have the location of the house on old maps and we did have one painting and one drawing (Figs. 1 & 2), but like most old drawings and maps they can be inaccurate, so the first thing we did was to undertake a geophysics survey to see what remained under the green grass, cropped by cows, horses and Doris the Donkey. The results were quite dramatic.

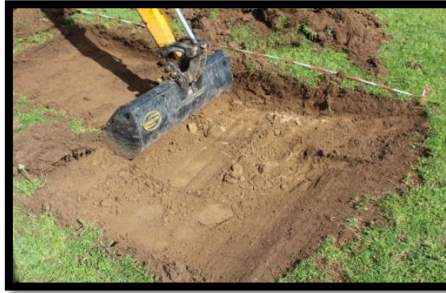
Fig. 4 The first cut, but hopefully not the deepest!

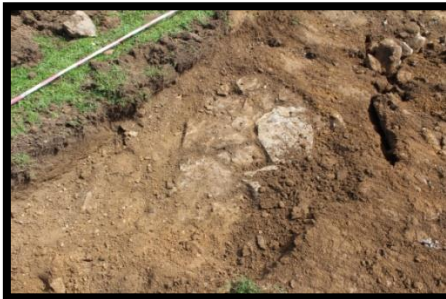
In this case the archaeology started to come up quickly and clearly in trench G1, with the hard noise of steel scraping cold grey stone. The house was still there! It had been assumed from the records that most of the material had been systematically dismantled and used in the villages in the immediate area for building, so the chance of anything remaining could be slim.

Fig. 5 Our first look at Stalbridge House in 200 years.

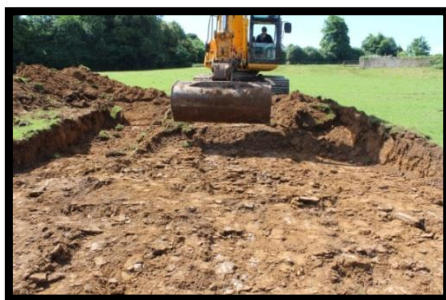
As the machine continued to take off the subsoil in the north corner of the trench it was hoped that more of the surviving foundations would be unearthed, but with a sinking feeling it was becoming apparent with each sweep of the bucket further south that the stone was disappearing and the rest of the trench was unearthing a backfill of soil and rubble. When the machine hit natural clay we knew that the chances of finding any more foundations were at an end for this trench.

Fig. 6 Disappointment followed.

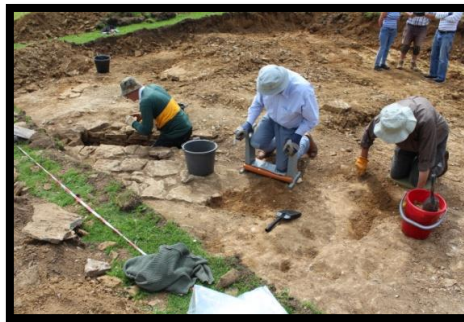
Fig. 7 The hard work begins.

Luckily the corner of the house was still there, but unluckily it ran under the baulk (to the left in Fig. 7), so we had to manually extend the trench slightly. The stones of the foundation were large and well laid and would have borne quite a large wall, but it was the extra remains of a very large drain that surprised us all. It was *inside* the house wall and obviously contemporary with it, the capping stones having fallen in and the whole space filled with dirt.

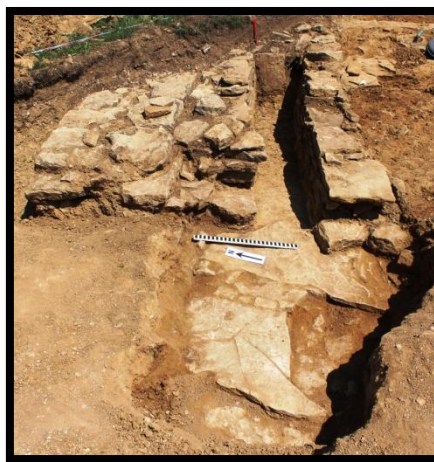
Fig. 8 The Great Drain, with the house wall to the left.

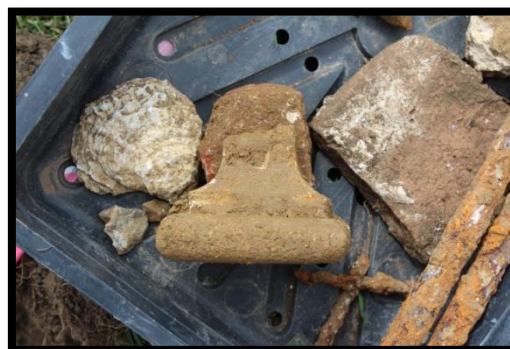
From the soil in the drain we had our first finds and they turned out to be of all different materials, including oyster shell, iron and tile one of the best being this nice piece of worked stone.

Fig. 9 Finds.

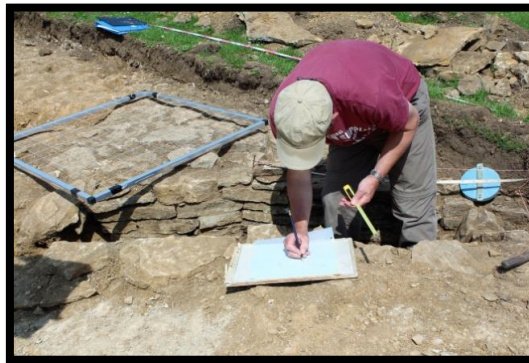
An important part, if not the most important part, of archaeology is recording, because excavation is destruction, but in an organized way. When a 'feature', be it a wall, pit, posthole or grave, has been excavated it needs to be cleaned and photographed using a scale, photo board (number of the feature, date and site code) and north arrow. The feature is then drawn from above, the plan, and this is done at 1:20 scale. If the feature is a pit which has had half its dirt, the 'fill', dug out the archaeologist can then draw the section, the 'profile', of the pit at 1:10 scale. These drawings are tied into the site grid (5m or 10m squares) or one can use a GPS (Global Positioning System) that locates the site and all the features into the landscape. We then use a dumpy level to record the height above sea level of all the features. As one can imagine this takes time, but is vital for the archive where all of the information is deposited.

Fig. 10 Drawing the wall and great drain at 1:20 using a planning frame and permatrace paper.

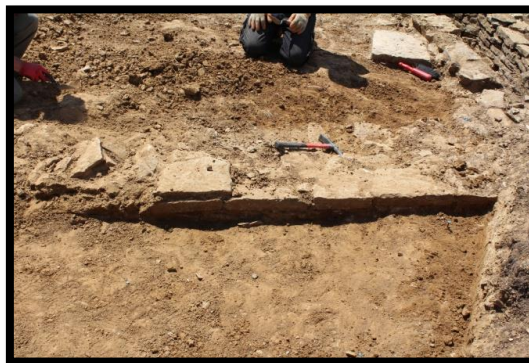
We continued to excavate the walls to see how deep the courses of stone went into the ground. One puzzle was the absence of any 'bedding' trench, where the wall has been inserted into a trench to give it stability. In fact we found that the walls had been built on a rough foundation and that was straight onto the silty-clay natural. No wonder the house needed constant repairs.

Fig. 11 The wall sitting on rough stones and natural.

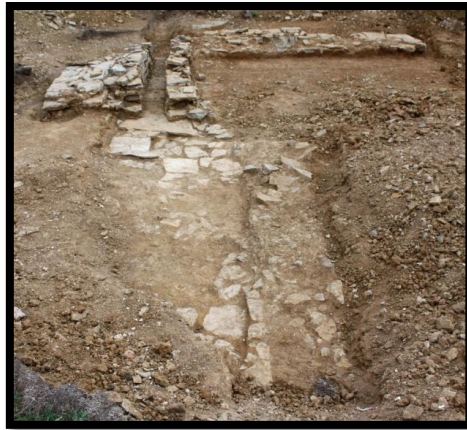
One of the main questions we wanted answering was directed to the text records that indicated that the structure of the house was altered in its two hundred year life. Much of this work was due to changing fashions in architecture, but also due to structural problems, which are confirmed by the shallow foundations used in its build. Toward to the end of digging in G1 one of our volunteers came across this smaller wall inside the larger one, which means that this wall must have been earlier. The larger wall was a rebuild, to take the weight of the bay windows that we see in the painting and drawing.

Fig. 12 The main wall and drain (top left) with the narrower wall (foreground).

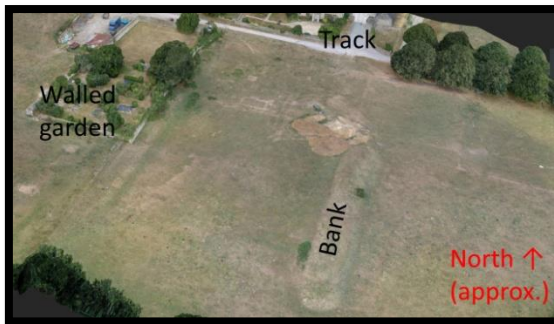
As the summer rolled on we entered a period of very dry and hot weather which carried on for some weeks. This created a situation where the grass became very stunted and all over the country fields dried out and marks began to appear that could be picked out from the sky by drones. On our field we also had these ‘parch-marks’ appearing.

Fig. 13 The drone recording where the parch marks are clearly visible – the N arrow is wrong.

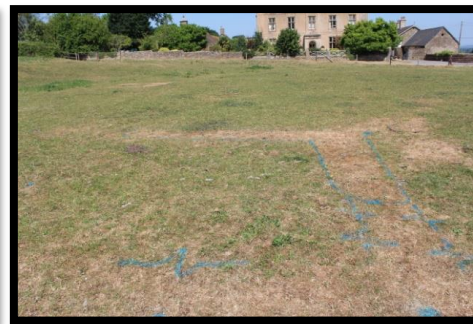
Fig. 14 The parch mark of the ‘porch’.

This was the area where our geophysics indicated a doorway into this part of the house and the parch-marks appeared in the shape of a rectangle. This was an opportunity to excavate this part of the structure and record the dimensions of this entrance porch and to see if any fabric remained, so we opened trench C3. Things didn’t quite work out as expected.

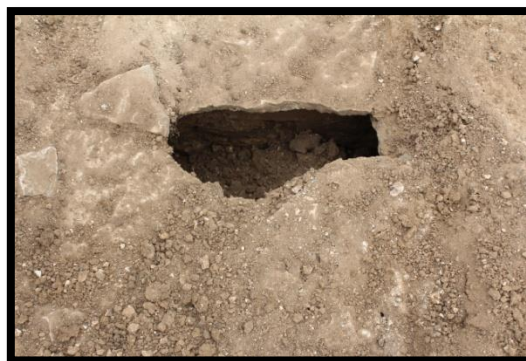
Fig. 15 An unexpected void!

After we had literally put our foot in it we realised that this was the large drain structure we had uncovered in trench G1. So we carried on excavating and found that the drain was configured as a rectangle.

It was seen to form the shape that had been the parch-mark at this point, so it was not the porch that had created it. In fact the drain followed the shape of the porch exactly, once again as in trench G1 it was inside the main structure of the house. This was confirmed by our extensions to this trench, where we found the remains of the porch foundations.

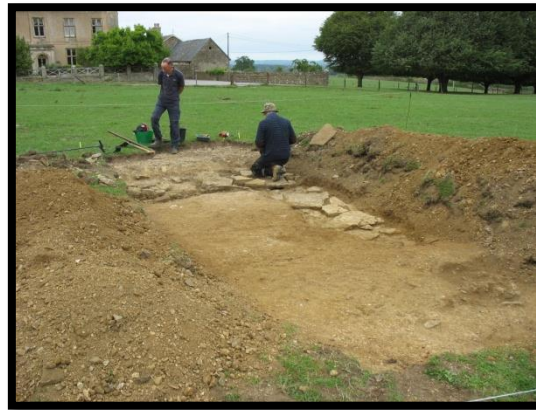
Fig. 16 The Great Drain turns south-east.

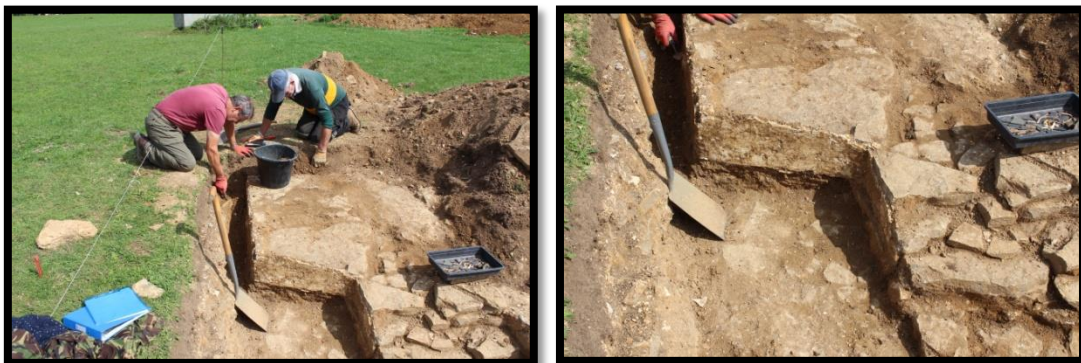
Fig. 16 & Fig. 17 The porch foundation with plaster facing. The wall runs to bottom right.

The column fragments that we found would probably have sat on these bases, with the steps shown on the painting running up and over the wall seen here. The drain is inside these structures. The main wall running away south-east from this base was nicely preserved and led to the remains of an internal floor surface, none of which survived in trench G1. We think that once through the entrance on this side of the house one would have been in the entrance hall with a stone floor, a door would have been on ones left and led to a large room facing the church to the north-east. It is highly likely that this room had a wooden floor, probably oak, and even oak-lined panelling on the walls. It was lit by the bay windows, as seen on the painting.

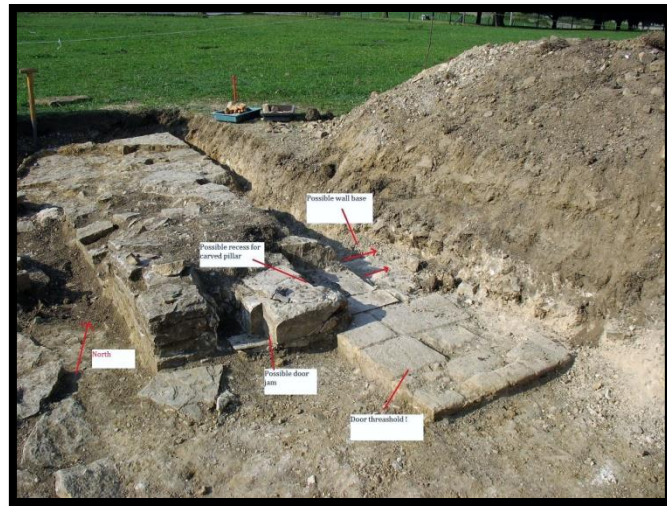
Fig. 18 The wall and floor surface.

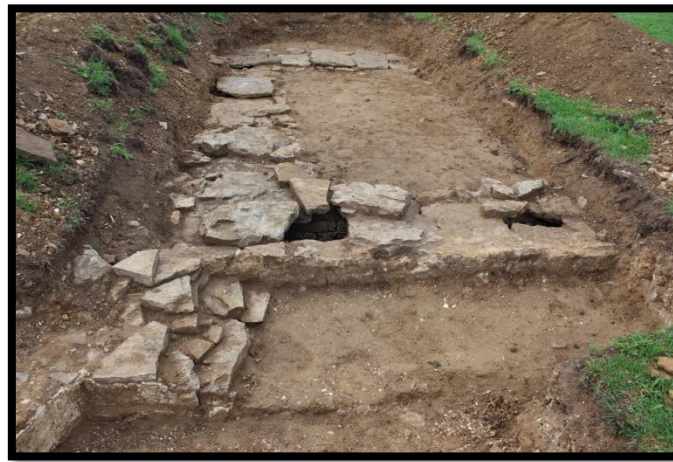
Fig 19 Trench C3. Looking south-east.

As can be seen here the drain follows the shape of the porch and is inside it, and the top of the picture shows the drain coming in from the right with the porch drain heading to meet it. The drain at the top carries on heading north-east until it emerges in trench G1.

Trench C3 was smaller than the 10m x 10m G1, but it showed us a great deal about how the entrance to this side of the house had been constructed, and once again surprised us with how the drain first unearthed in G1 was constructed in relation to the main structure of the house.

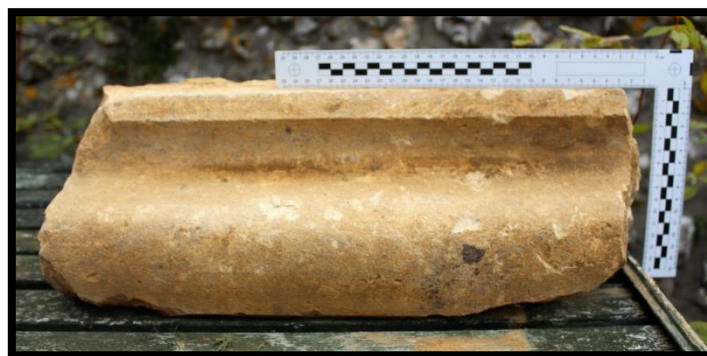
Fig. 20 Part of the stone facade of the house, found in C3.

The remains of the walls showed that they were made of large stone slabs and in-filled with stone rubble. The Great Drain was made of small brick-shaped stone.
