Follow up Access Audit, Salford Museum and Art and Gallery
Conducted on 27th September, 2013

An access audit was carried out by the A2AA group in May 2013. Since this visit some work has been completed at the Museum and Art Gallery following recommendations made by the group.

A2AA were asked to return to Salford Museum and Art Gallery to comment on the works carried out already, prioritise the outstanding works and identify any new issues.

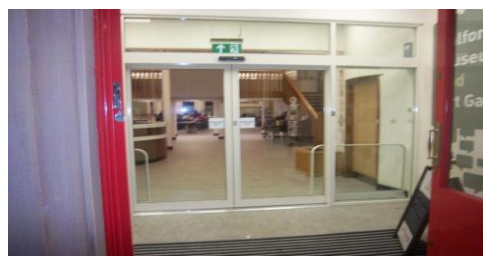
- Close to bus stop and security guard helpful and friendly at barrier
- Uncovered parking. Pay and display parking
- The steps did not have yellow markings so difficult to differentiate between steps making it a hazard. When leaving the building the top step in particular is hard for a partially sighted person to distinguish between where the top step is and the next one down.
- Circular ramp at left hand side would be difficult to access by a wheelchair user on their own and coming back down is very fast and you hit the railings.
- No intercom system at the bottom of the stairs in case of difficulty accessing the building

The entrance steps now have rails but it is important to have yellow markings or highlighted strips put onto the steps to enable partially sighted people to be able to establish where the step edges are.

An intercom system at the bottom of the steps or ramp would ensure that staff were aware that someone needed assistance.
