# A Conservation Management Plan for Eaton Camp, Ruckhall, Herefordshire

Scheduled Ancient Monument, Herefordshire 10

Final version February 2013

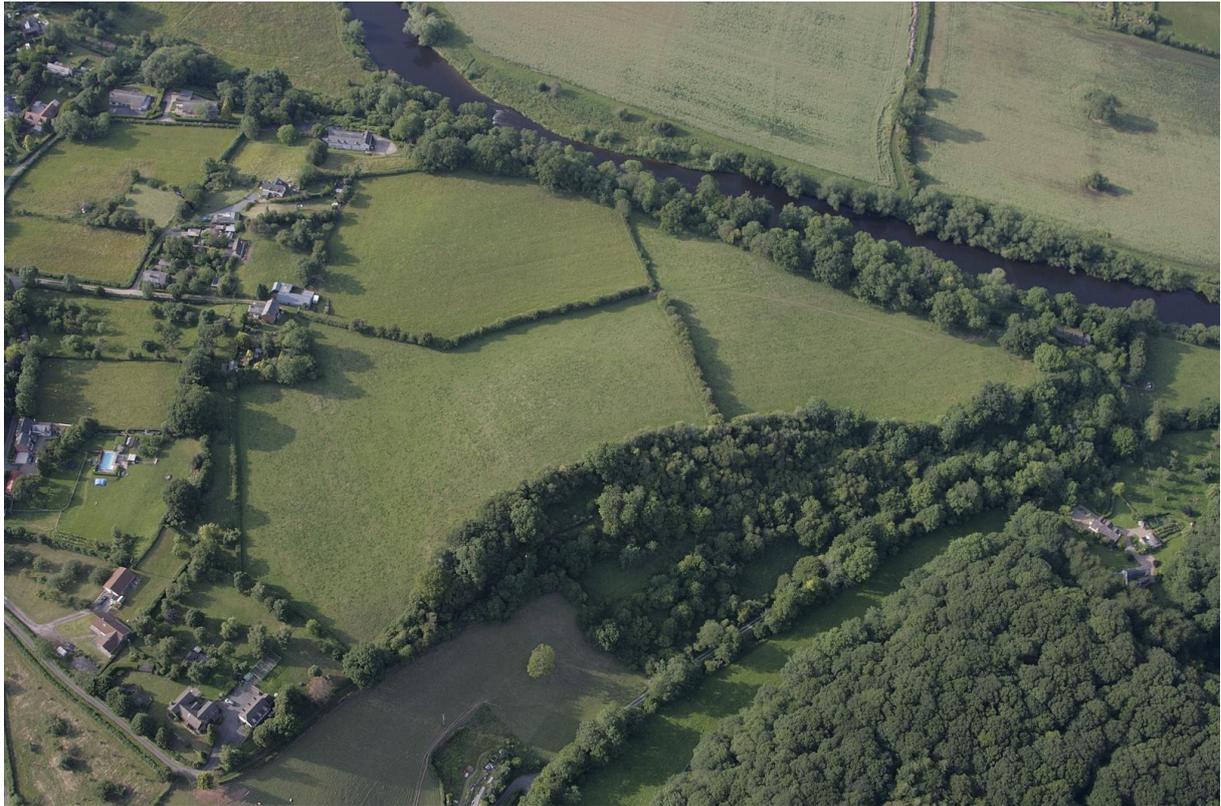
*Figure 4: Eaton Camp from the south showing the interior of the fort and the development along the line of the rampart*

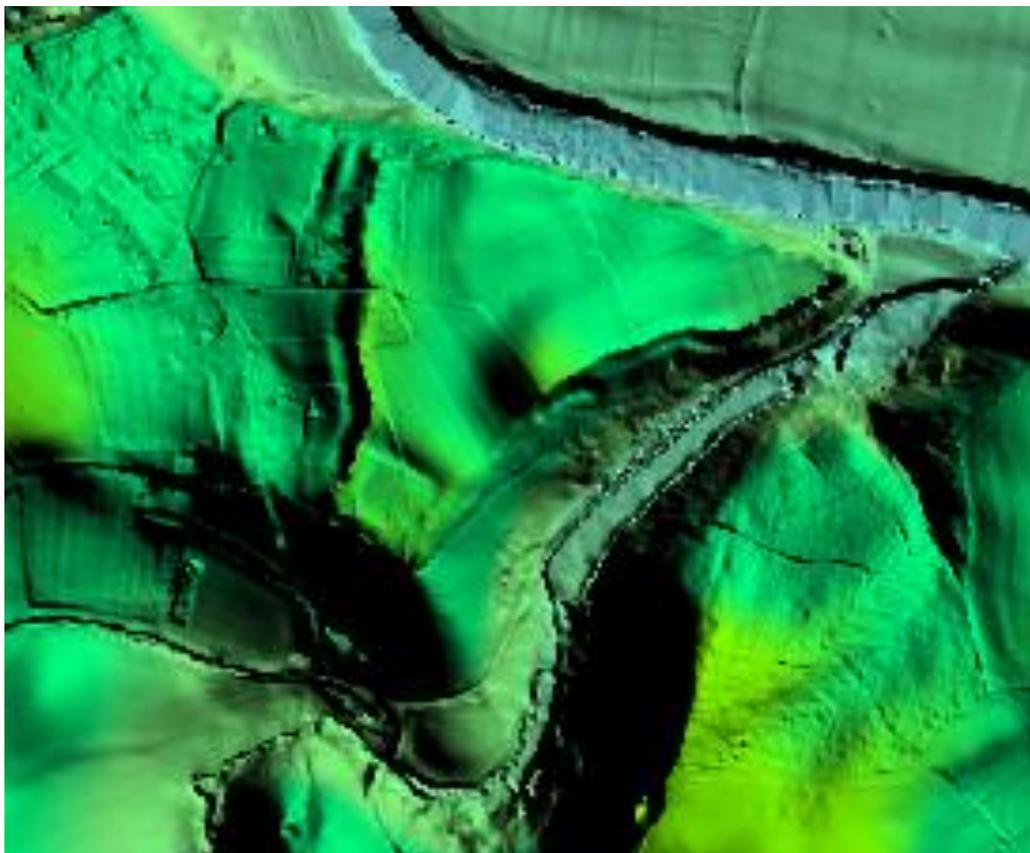
*Figure 5: Lidar data for the site showing the steep scarp slopes, the ramparts and the broad low bank to the west*

During the survey element of the current conservation project Lidar data for the site and surrounding area was examined. A broad earthwork bank was identified approximately 60m to the west of the surviving ramparts and seemingly running parallel to them. Although some of this feature has been destroyed by landscaping and cultivation enough survives to show that in running from close to the top of the north facing scarp of the promontory towards the top of the south facing scarp it appears to isolate the promontory in the same way as the ramparts and it has been suggested that it may represent an artificial earthwork defining an annexe area or perhaps the area of an earlier larger enclosure.

Given the size and form of the feature on the ground, it is about 40m in width and approximately 1.5m high, an alternative interpretation, and one on balance favoured by the writer (PD), is that this earthwork may be a natural, perhaps glacial feature. Such definition of a denuded and ploughed out rampart is thought to be unlikely and suggests that the feature started life as a very broad low bank of natural origin. Furthermore its location on low ground at the base of the natural hill-slope, utilised by the hillfort rampart to maximum effect, suggests that this is unlikely to have ever served a defensive or boundary defining function.

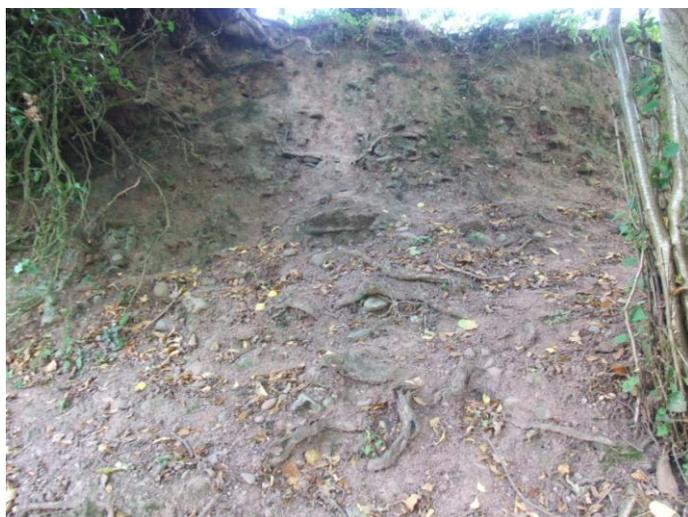
*Figure 10: Scarp edge erosion on the northern side of the hillfort*

The main issues affecting the interior of the site are those of scarp edge erosion and badger activity. A lack of ground vegetation cover on the steep scarp slopes has led to active erosion taking place. In some places this is beginning to undercut the fields in the interior and is probably affecting some in-situ archaeological deposits. The root systems of mature trees along the scarp top are helping to prevent excessive erosion but this issue needs to be addressed before these trees become over-mature.

On the northern scarp this erosion has also seriously affected the route of the footpath (EB21) and will continue to have health and safety implications (see woodland section for management recommendations).

- Protect through woodland management (see Objective 2)
- Specify project to physically repair scarp edge erosion if identified as necessary from monitoring
- Provide gate and repair poaching between the two ownerships in the interior
- Carry out tree surgery on mature trees as deemed necessary

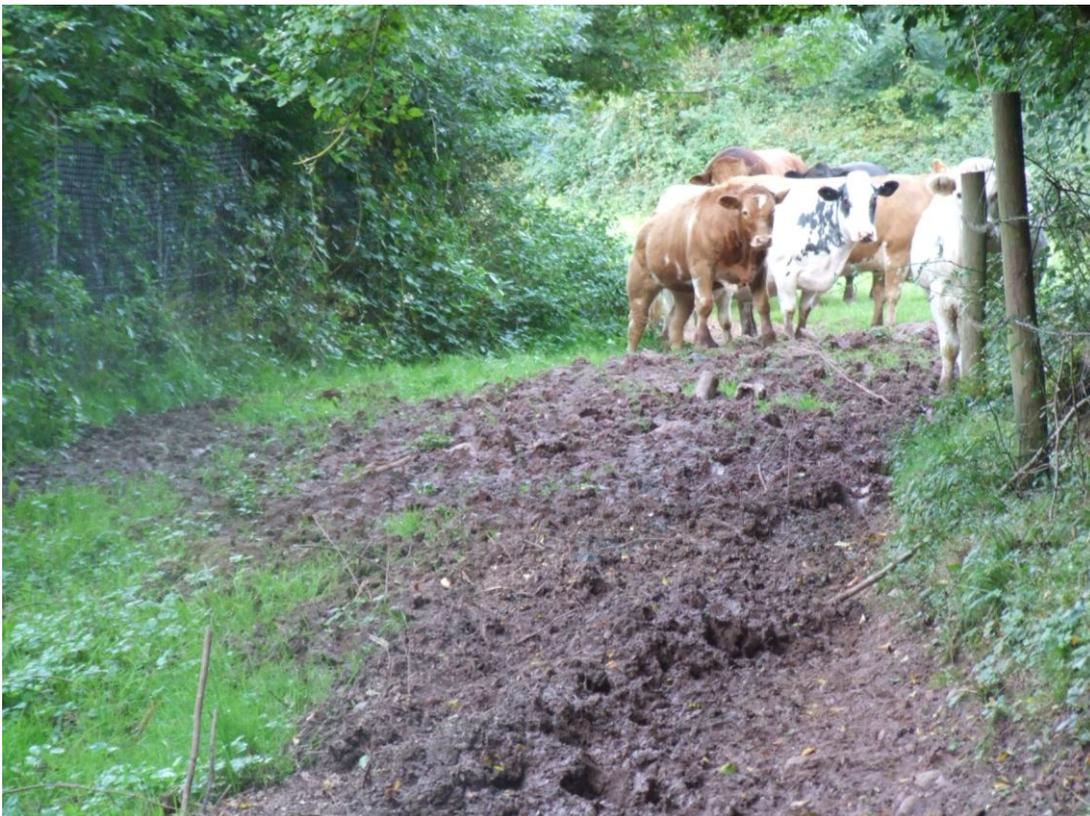
*Figure 11: Poaching of wet ground on footpath EB21*

One of the main problems of poaching of wet ground is occurring on the footpath that provides access to the eastern end of the site and that is part of the proposed circular walk route (EB21, figure 11). It appears to be exacerbated (ironically) by the presence of the now redundant or mothballed eyesore water pumping station that may have interrupted the natural drainage of this area. It is not known if the source of this water is from a spring or an artificial drainage system.

This is seriously affecting access to and therefore appreciation of the monument and the issue needs to be addressed. The situation is further exacerbated by the lack of water for stock within the camp and the area therefore being on the route of stock to and from the water trough located to the east of the pumping station. The latter issue could be addressed by providing water for stock in the camp interior thereby removing the need for stock to use this path so regularly. The location of the water supply would need to be carefully considered so as not to cause further problems of poaching and erosion in a more archaeologically sensitive area. Hard-standing of some sort may be required around a new trough.

- Explore the possibility of providing a water supply for stock on National Trust land within the interior of the camp
- Carry out remedial works to repair the surface of footpath EB21 where it is damaged by ground water and stock passage, including drainage works if necessary

- Investigate the source of ground water
- Install drainage
- Repair the footpath surface
