Toilets

Maintenance of toilet cisterns

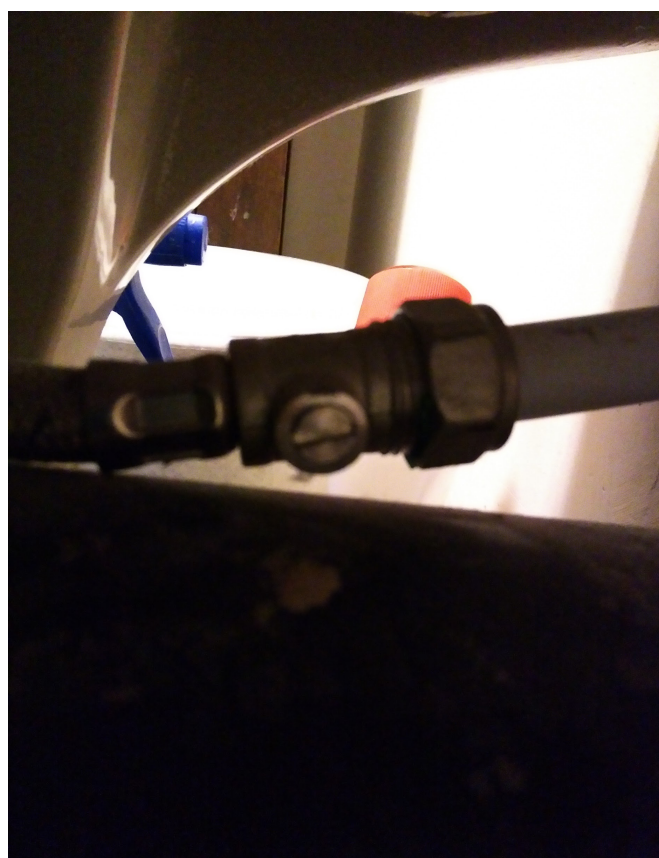
1. Turn off the water supply to the toilet by turning a screw found under the toilet bowl, a half turn to the right

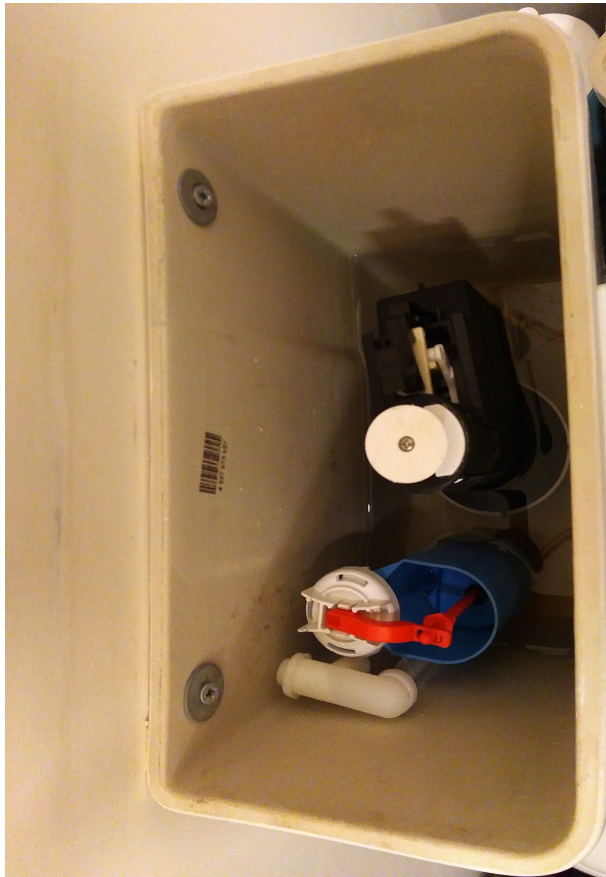
Two parts of the system are visible:

(note: the photo shows the cistern in a vertical profile, rather than the usual horizontal profile)

4. Now remove the lower/left hand part (with the red arm) by using firm but not forceful pressure down (to prevent clips breaking) and turning anticlockwise to release
5. Using any suitable implement, such as a bottle brush, clean off the limescale deposit that, if allowed to build up, will affect the performance of the cistern. You might like to use a spray limescale descaling product, though this isn't absolutely necessary
6. The cistern outlet valve (on the right of the cistern/upper side of the photo) also needs to be checked and cleaned regularly to prevent limescale build up adversely affecting the cistern operation. If the toilet is continuously flushing, it means that the procedure is necessary

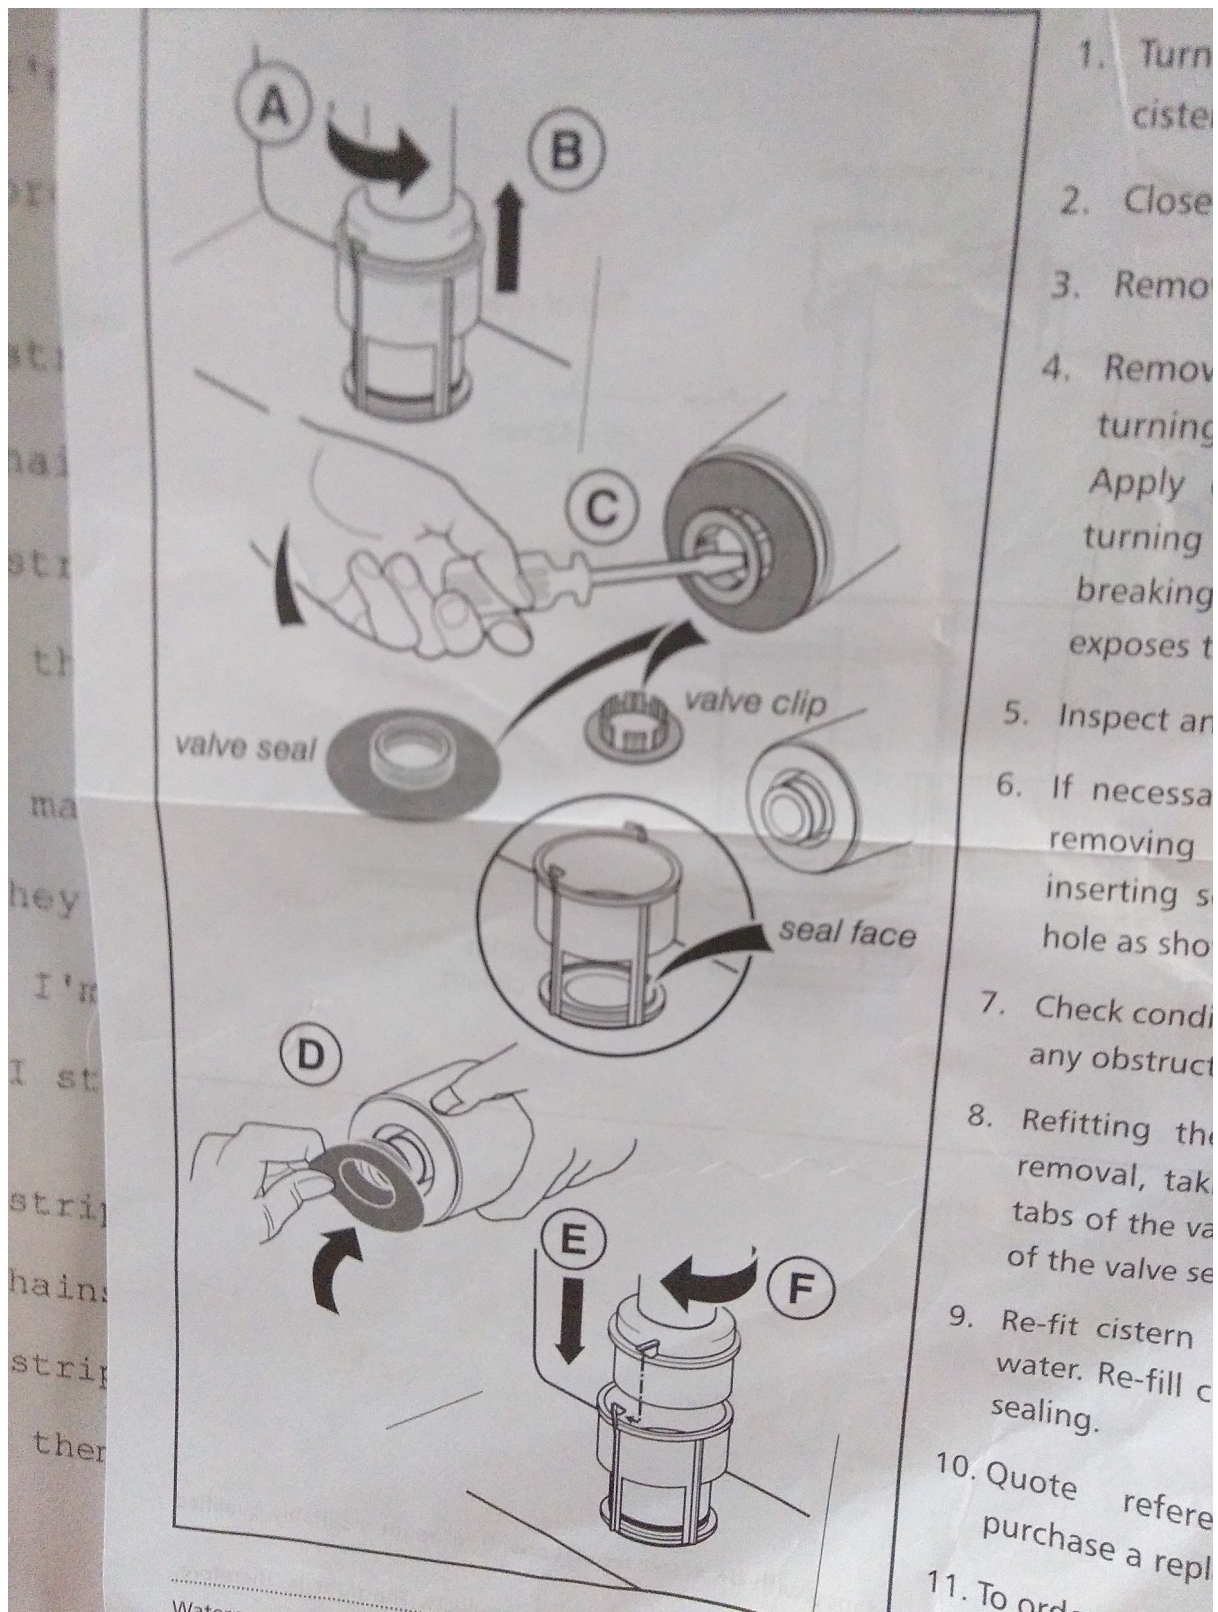
Diagram follows:

7. To remove the valve body, grip and turn it anticlockwise, again using firm but not forceful pressure downwards (to prevent clips breaking)
8. Removing the valve body exposes the valve seal (A & B in diagram below, provided with Ideal Vidima spare part reference SV01967)

9. Inspect and clean the valve seal, using a brush and limescale cleaner
10. After some time, the valve seal will have to be replaced as it will gradually shrink. If you notice the cistern is repeatedly flushing, this is the cause!
11. Remove the valve retaining clip and insert a screwdriver down the centre hole (C & D in diagram) to remove and replace valve seal if it has shrunk
12. Check condition of seal face and remove any obstruction
13. Refitting the valve is the reversal of removal, taking care to locate the tabs of the valve body into the lugs of the valve seat (E & F)
14. Refit cistern lid and turn on water. Re-fill cistern, test flush for usual cistern operation.
