# East Worlington Parish Hall News|etter

**Project Edition 08 - Week Ending 27 July 2018**

## **Parish Hall Conservation Project**

### **Continuation of External Conservation Work**

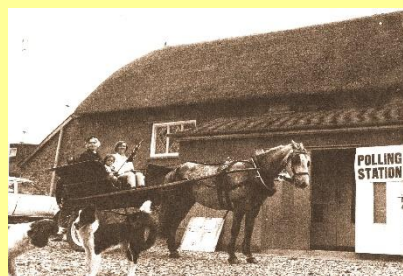
This photograph shows the original stone wall in 1975.

The photograph is of local residents arriving to vote on the referendum to remain in Economic European Union

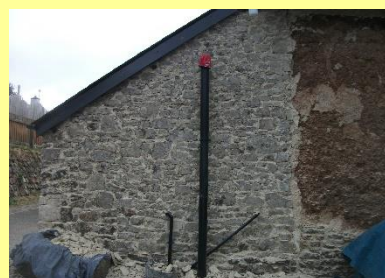
The external wall on the west elevation had a rendered finish. The preparation work necessary was firstly to remove the old render. On removing the render the original external wall was exposed. This was of stone construction and showed how this had been added to the original barn as a extension lean-to, probably for storage. When the barn was converted to a Hall this lean-to was also converted as a kitchen area. The ambition of the Parish Hall Trustees is to conserve the Hall true to its origins and therefore they consider the conservation and continued exposure of the stone work important.

This photograph shows the original stone wall in 2018 when the render applied after 1975 has been removed. It clearly shows the original stonework and the construction of the lean-to against the barn wall.
