Chewton Mendip Precinct Field Excavation

PHASE TWO

Interim Report No. 2

Community Archaeology on the Mendip Plateau

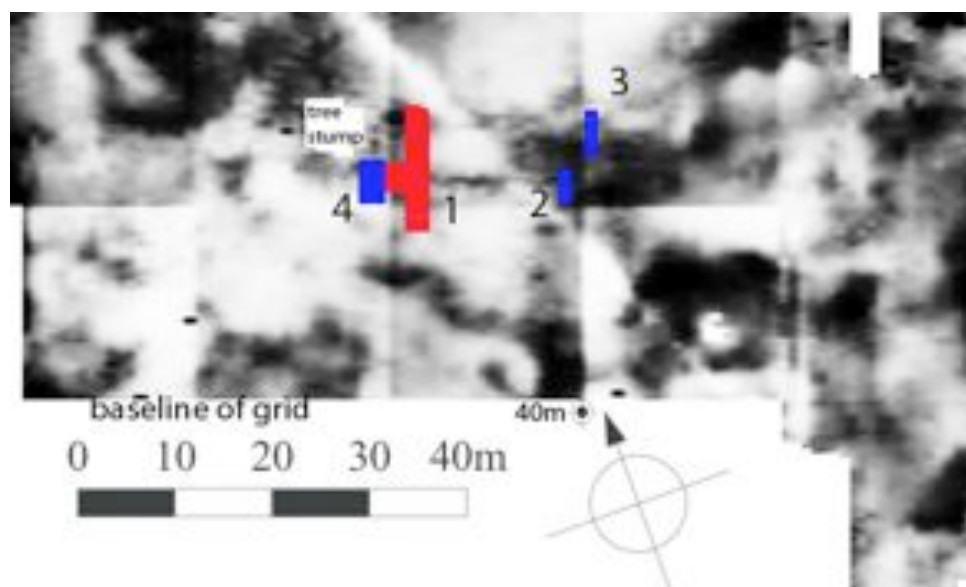
Figure 2 showing siting of the three trenches in Phase 2, part 1

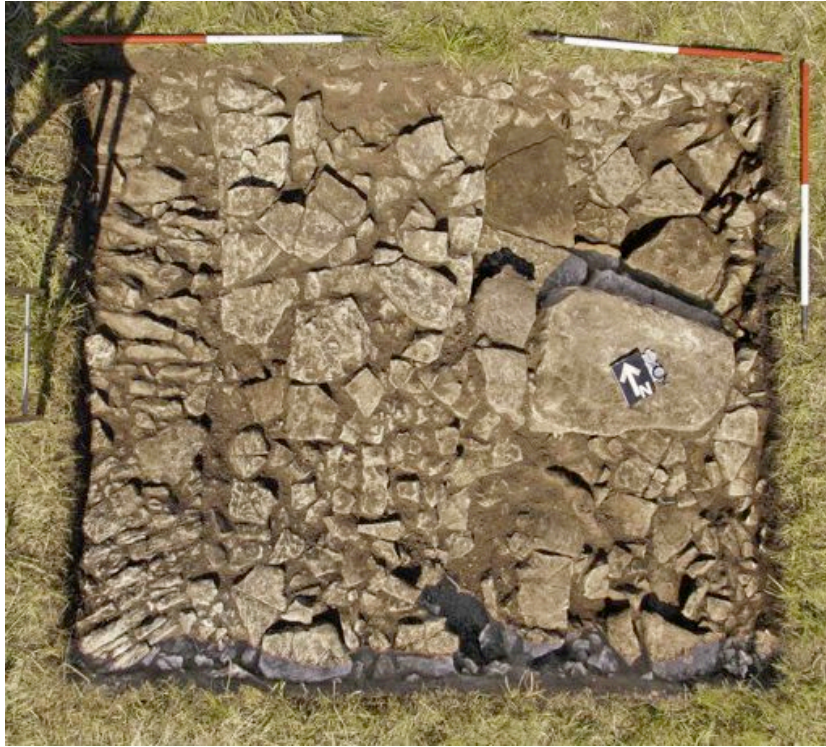
Figure 4 Aerial photo of Trench 4 (photo John Croxford)

The purpose of this extension was to ascertain whether this was the site of the SW corner of the rectilinear building. A complicated picture emerged. Whereas there was evidence of a west wall heading north, there was a 1.5m. absence of south wall foundations linking this wall with the known south wall in Trench 1. Instead, a large stone lay offset across the proposed line of the foundations at 149.74mOD. Its purpose is not clear. Outside this area there is evidence of limestone slabs having being laid abutting the line of the south wall. On the west side of this corner an area of cobble at 149.80mOD is laid at an angle butting up to the west wall. However, one cobblestone was clearly already in place when the wall foundations were laid over it, suggesting an earlier date for the cobble. Again, this is an area to be investigated further.

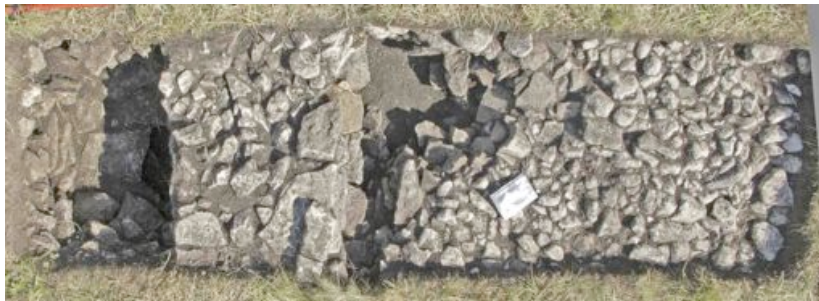
Fig. 6 Aerial photo of Trench 2

A small 3 x 1 metre trench was placed at right angles across the projected south wall line at a point just east of where it was visible on the resistivity. As the archaeology is known to be close to the surface the turf and topsoil, and just enough of the tumble, was removed in order to locate the wall foundations. In the event, the south edge of the wall was well defined and reached at 149.55mOD. The north edge had suffered some considerable disturbance and in order to ascertain that this was indeed a wall it was necessary to remove some of the disturbed rubble. Having done this it was then decided to take the opportunity to see how many courses the wall had at this point and to find the floor level. This could then be compared with the level in Trench 1. Broken flags of an internal floor level were located at 148.87mOD.

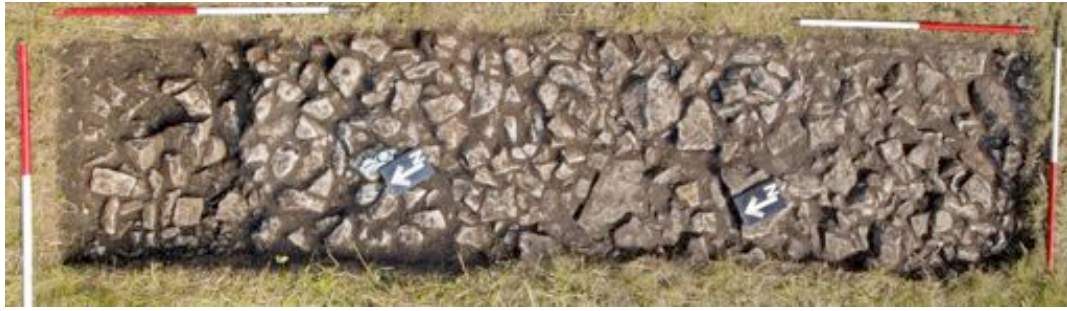
Fig. 8. Aerial photo Trench 3

This 1 x 3.5 metre trench was placed over a dense area of high resistivity in order to gauge whether this was due to rubble deposit or geology. It was also decided to try and locate the north wall. It was immediately apparent that there was much rubble dump in this trench with a suggestion that a further wall may run through the trench, but not on the line of the rectilinear building. It is not clear whether the two are related at this stage. At the north of the trench an area of crushed limestone and rubbish appears to have been dumped in a ditch. Worn cobble edges this ditch. This is an area which needs further investigation. It was therefore decided to backfill this trench with a membrane cover and open again at a later date.
