Chewton Mendip 'Precinct' Field Excavation

PHASE TWO

Interim Report No. 12

Community Archaeology on the Mendip Plateau

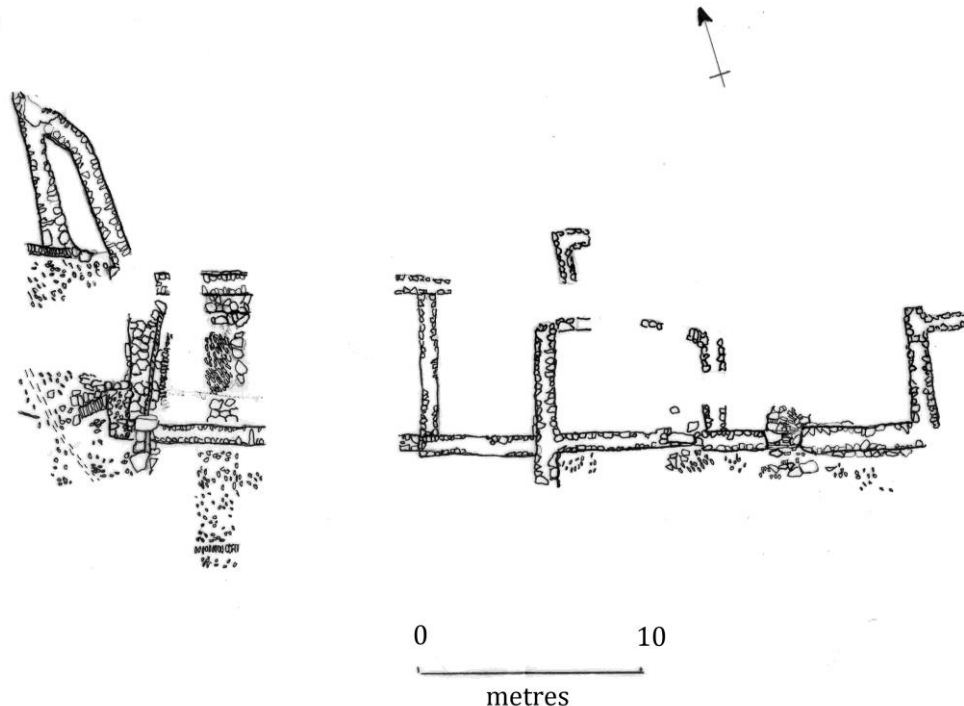
Figure 3 Composite plan of wall features to April 2017. The rectilinear building is to the west with a possible east end wall in the centre of the drawing. The east end of the excavation site is a confusing picture of walls of slightly different orientation, either being reused in later builds or being truncated by them.

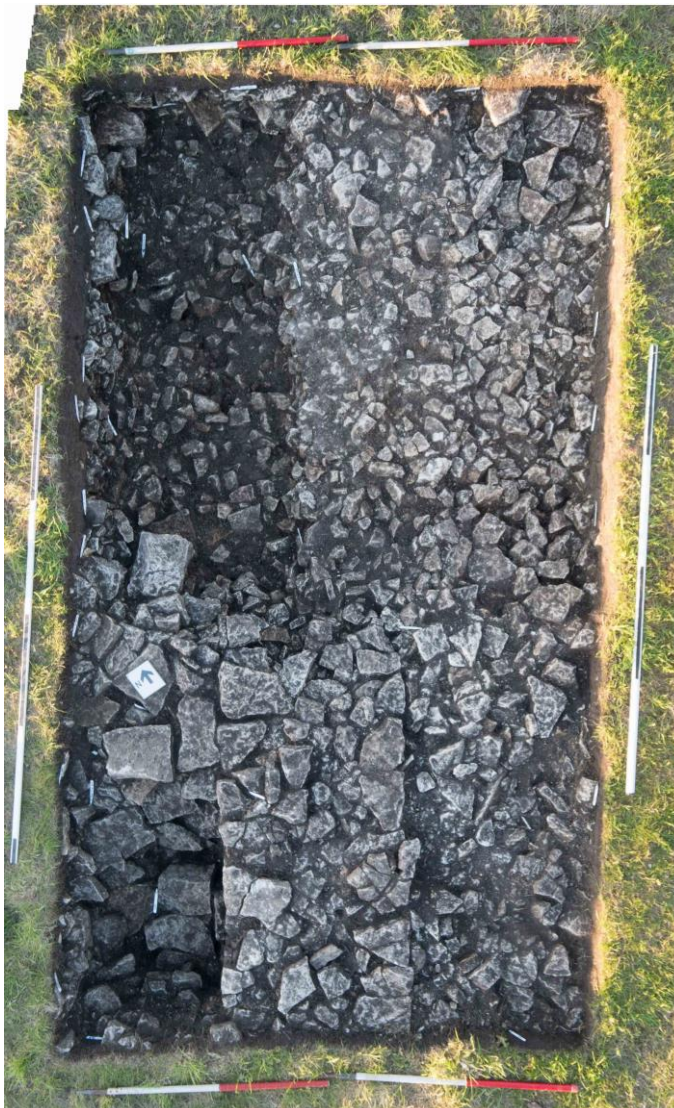
Figure 5 Overhead photo of trench 21 at the finish of the excavation. The trench was not fully excavated. The questions posed in the research objective were answered at this stage. NB The obtuse angle of the feature under the north sign, which is on the same alignment with a similar feature uncovered in trench 3. It may represent a revetment or flooring remains at the robbed out corner of the building.

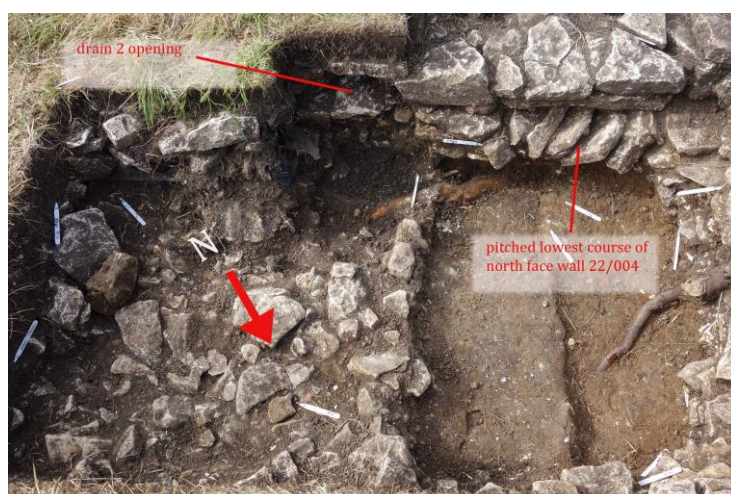
Figure 8
Trench 22 North face
of north wall, showing
pitched coursing at
lowest level and outlet
of drain 2

NNE face. The lowest construction layers consisted of 6 diagonally placed LLS blocks (top to W) on this face only, forming a feature 1 m wide, topped with a horizontal stone lintel and forming a stepped out foundation for the upper courses at this point.

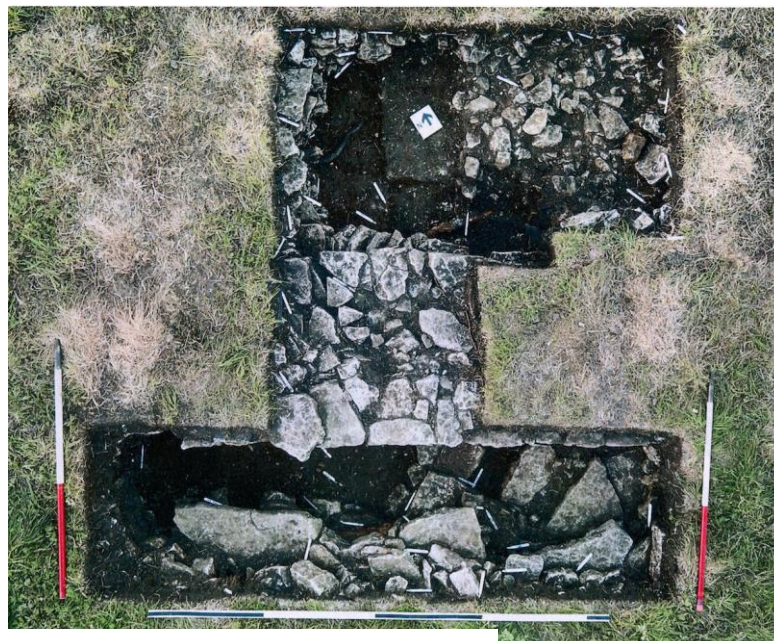
Figure 9 Overhead photo of trench 22 at end of excavation. The drains are at the bottom of the photo with the north wall crossing the centre picture.

forming the lowest course of the wall at this point (drain 1). A possible exit on the N face was not exposed in this dig (see Figure 9).

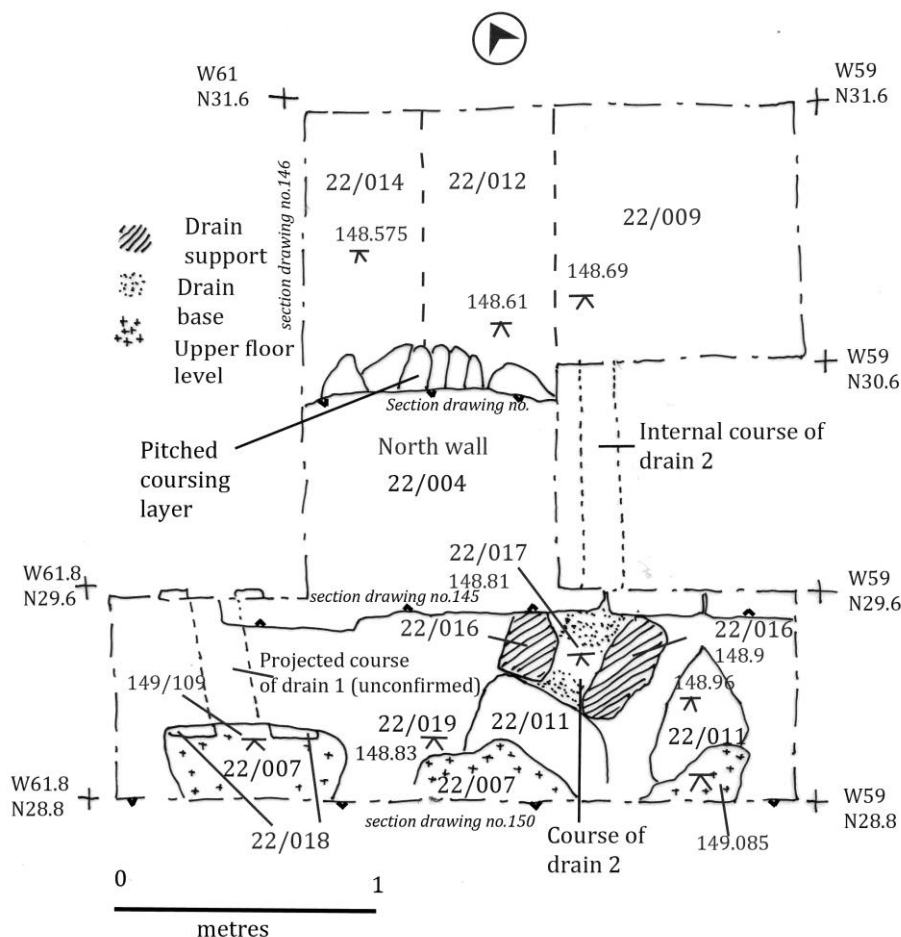
Figure 10 Plan of trench 22 at finish of dig, showing drain detail

A deposit of friable very dark brown (7.5YR 2.5/3) silty loam with LLS cobbles (010) @ 148.99, containing animal bone, formed a bedding layer for a later stone floor (007) of slabs of similar dimensions to 011 and @149.09 on the E tr and 149.13 on the W tr where one of the slabs formed the capping stone for drain 018 (see fig.10)

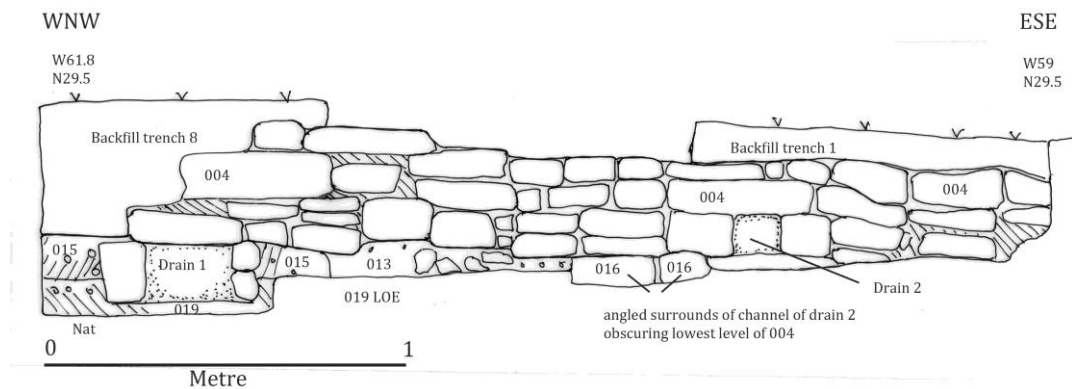
Figure 12 Section drawing 150 of north wall of rectilinear building (21/004), showing drains 1 and 2 channels

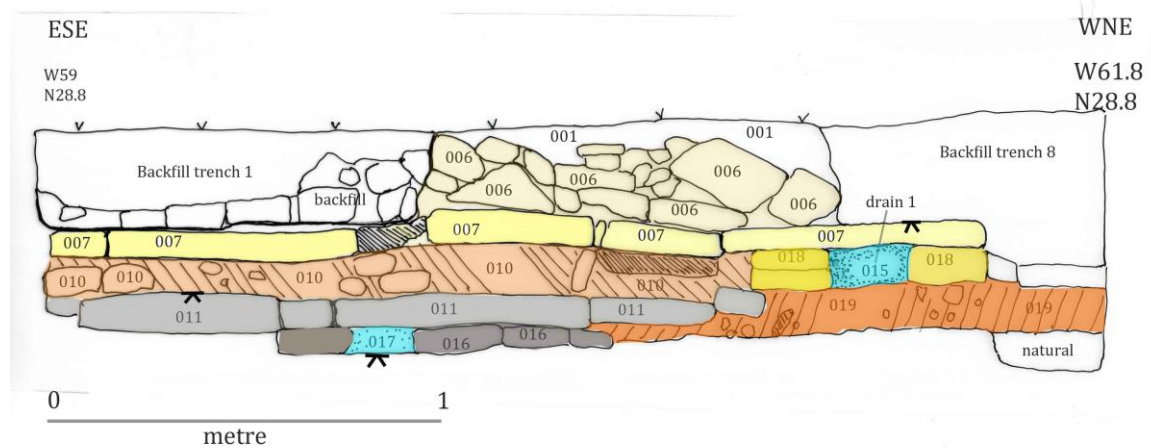
Figure 13 Section drawing 151, the south trench edge with different floor/walkways denoted in yellow and grey. The channels of drains 1 and 2 are shown in blue

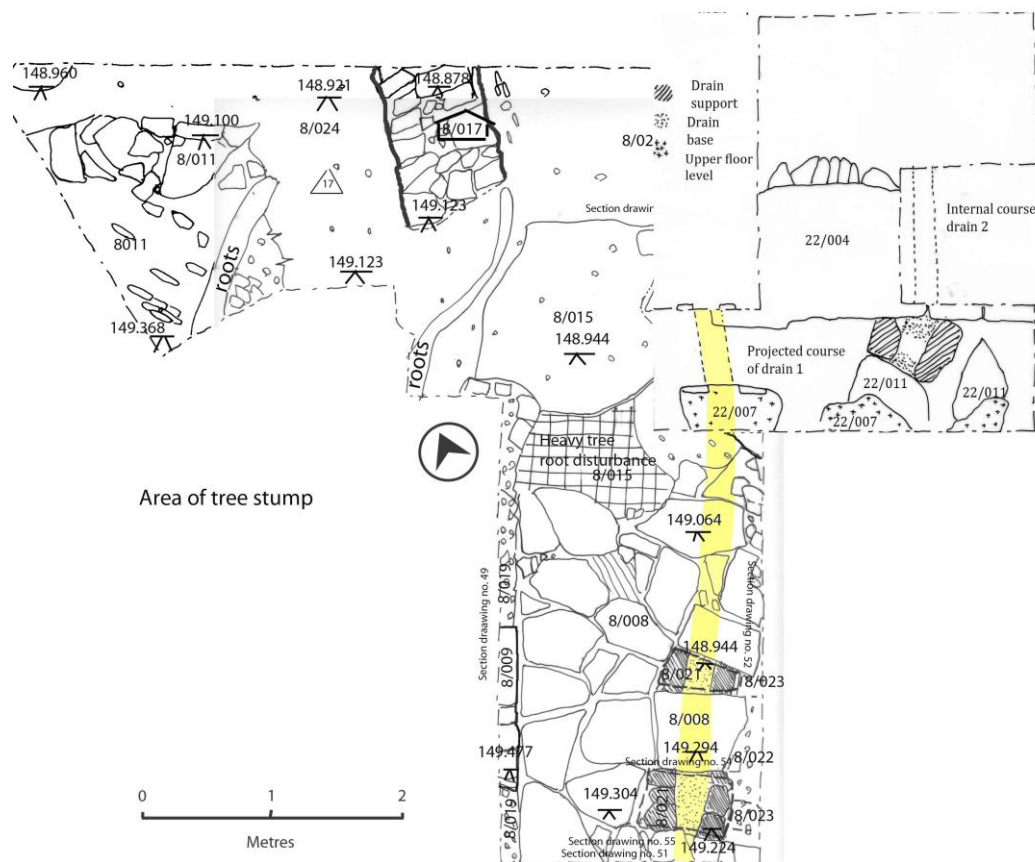
Figure 14 Composite plan of trenches 22 and 8 showing course of drain 1

The course of drain 1 could be extrapolated as being the continuation of that observed running under the slabstones of 8/008 and 4/009 (see Reports 5 & 3). Its truncation 0.1m short of the channel under the N wall could not be explained and therefore it was not proven that the two features were connected. It is possible, and previously considered, that the W end of the rectilinear building had undergone modification at some point. This might have resulted in the removal of the drain surrounds 018 and slab 007 at this point, and the replacement with a cobble and soil infill (015) which had been observed as 8/013 in trench 8 in the above layers.

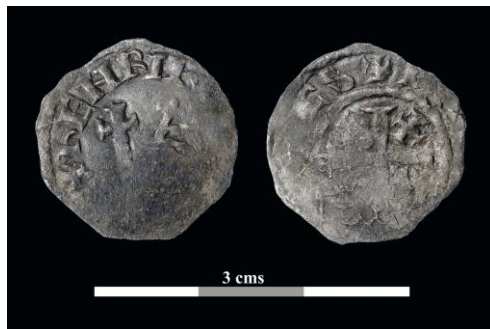
Find 123 in 21/004 (figure 15)

A Henry II silver penny.
Poorly struck on an irregular flan.
Believed to be a 'Tealby' type coin (after the hoard found in Tealby Lincs. This type minted after 1158.
Obverse: +hENRI R
Reverse: E or CS+
Possible mints. If ES, Chester, Gloucester, Lewes, Shrewsbury. If CS, Winchester

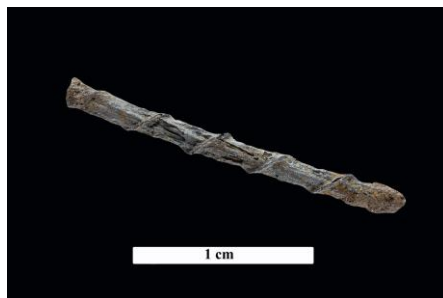
Find 125 in 21/001 (figure 16)

A group of wires with spiral wound outer wire. Function and date unknown.
Length: 19mm
Width: 2mm
Weight: 0.13gr

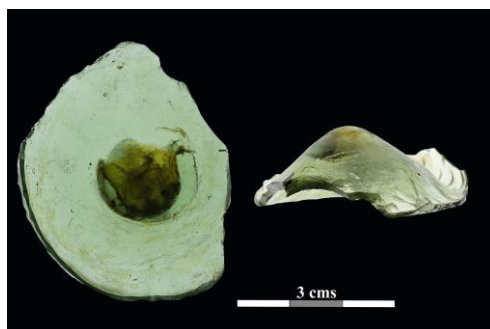
Find 126 in 21/004 (figure 17)

A hand-blown bottle base was found in 21/004. It had a gradual inward taper from the base and rough pontil.
Base diameter: 50mm
Height: 15mm
Thickness: 1mm
Colour: green-tinged
Weight: 11.19gr

Date and function not establish though could be medieval by context
