## Chris's Reordering Blog – Week 18 & 19, 2 to 13 October

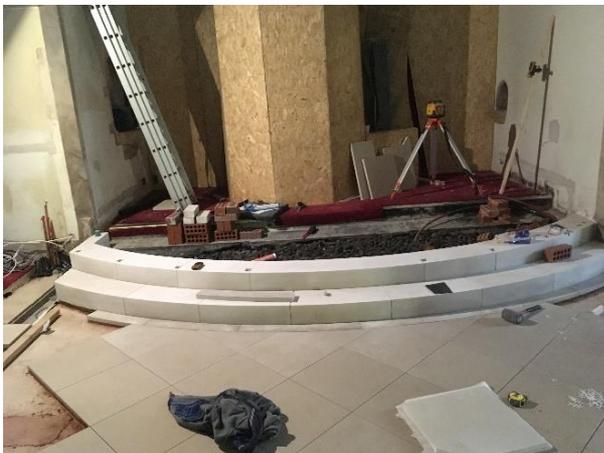
I explained last time the difficulties the contractor was experiencing because the Chancel was not exactly square with the Nave. Well, here we go again, this time not a problem with alignment but with level differences. We knew that the Sanctuary wasn't completely level, but how to deal with this proved not to be straight forward. In fact, there was a 45mm level difference, (nearly 2") between the north and south end of the Victorian Chancel step.

You might expect issues with the construction of the Chancel since it was built in the 13<sup>th</sup> century, but the steps and the tiles on the floor in the Sanctuary are Victorian and once again we are seeing disappointing construction errors in the Victorian workmanship. I'll bet those of you who have knelt at these steps for many years, some of you *very* many years, have never noticed this level difference. That's because the step is dark in colour and the Chancel floor is not level either!

I had hoped we could deal with the level differences and still retain the Victorian tiles in their existing position. To do that, the steps would have to be laid on a slope and that is just not on and I agree with the views of both Wrencon's mason and the architect that the steps must be level. A keen eye would see it was not level and that would never be acceptable.

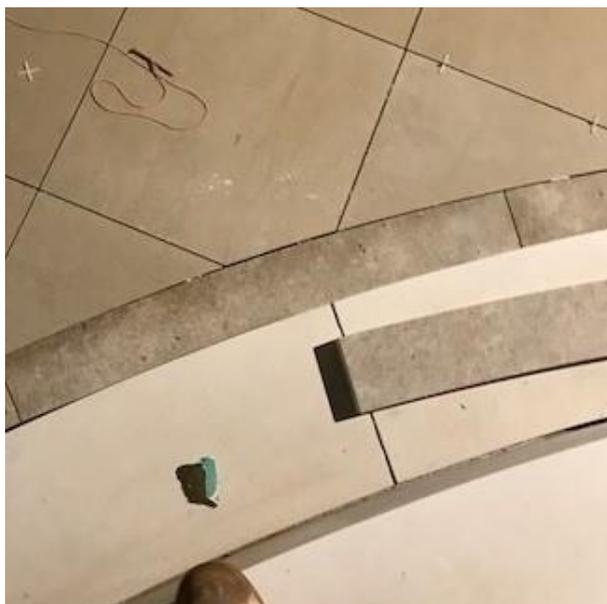
You can also just about make out the level difference in the picture. The steps are at the same height as the top of the tiled floor on the left-hand side

of the picture but certainly not at the right. This means that the Victorian tiles will need to be lifted and re-laid level. Now, we don't yet know if they can be lifted without damaging them, but Wrencon's guys will do their very best to do that. There will of course be an additional cost to do this but it is something that the architect had anticipated and a 'provisional' sum to carry out additional work here has been included in the tender. In addition, our faculty from the Diocese, our permission to carry out the work, does include replacing the tiles with

new ones, of the same colour and pattern if that proves to be necessary. There will be more on this topic in future reports.

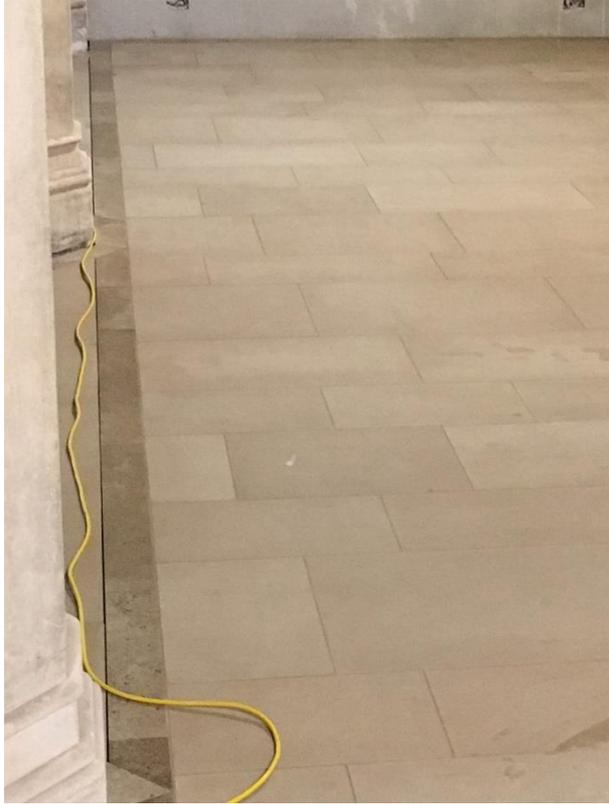
As an aside you can see why laying the floor has taken a long time when you realise the complex curves that have to be accommodated in places, as at the Sanctuary step in the picture on the previous page.

The darker edging stone against the steps were cut at the quarry, but the matching curved edge on the lighter, larger stone tiles have been cut on site.
