Chris's Reordering Blog – Week 4 – 26 to 30 June

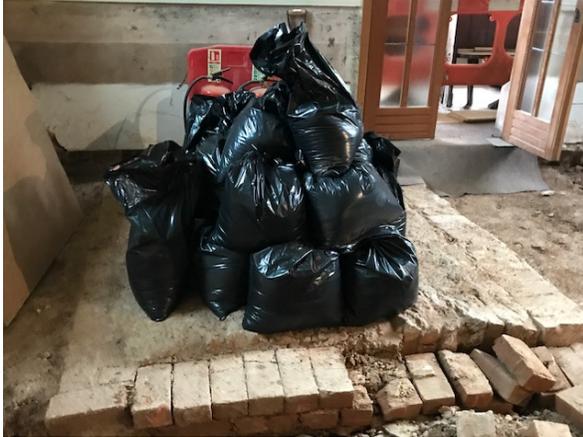
I was hoping the 'Pool vault' issue would be resolved by the end of last week. The structural engineer came and was confident the vault's brick roof would stand the additional weight of the stone floor but that it would probably need a steel mesh set in concrete above the vault to give the arch some additional strength. However, before he could confirm that view he needed to perform a stress test by loading the arch with bags of sand and testing if there was any movement created. The picture

shows this being carried out. The vault roof passed this test so we have a solution with little additional cost. Above part of the vault there will be a cupboard, but the area where there will be an open floor it seems that the depth available above the vault roof will not be sufficient to enable underfloor heating to be installed so there will be a cold spot over this area, which will be compensated for by a radiator against the wall at this point.
