IPC Examination of Heysham M6 Link  
Local Safety Impact  
Presented by John Wilding : Unique Ref.no. HEY  
Member of the Halton Residents' Group Unique Ref. no.

IPC Examination of Heysham M6 Link TR 10008  
Environmental Impact on protected species *Lutra lutra* (Eurasian Otter)  
Presented by John Wilding of the Boat House Halton , Unique reference number  
HEY XXXX, member of the Halton Residents' Group, Unique ref no. XXXX

# *A Confidential Otter Survey of the River Lune between Halton and the Proposed Lune Bridge.*

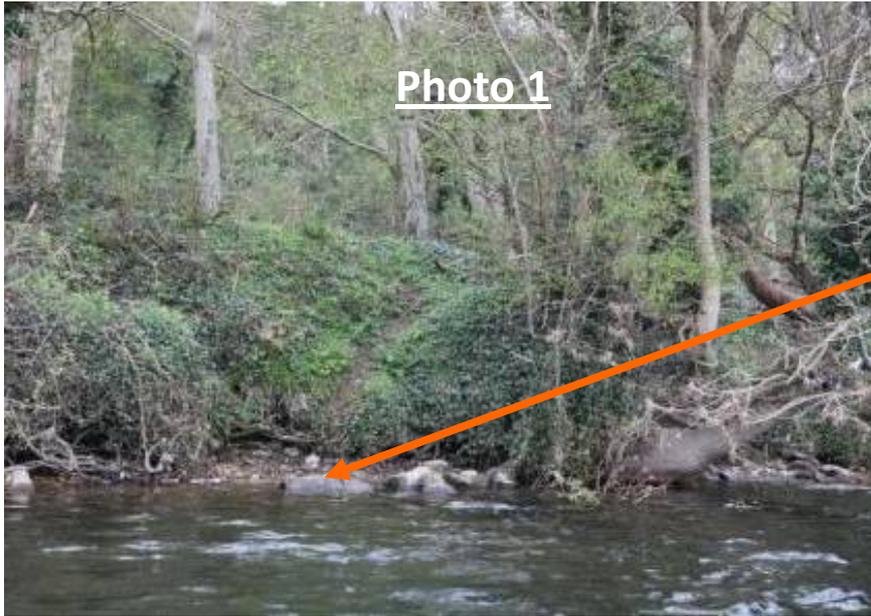
Photo 1

**Photo 1** shows an otter run rising from a gravel /boulder beach up into the woodland close to the sewage plant on the North bank. The boulder below the run is a sprainting site.

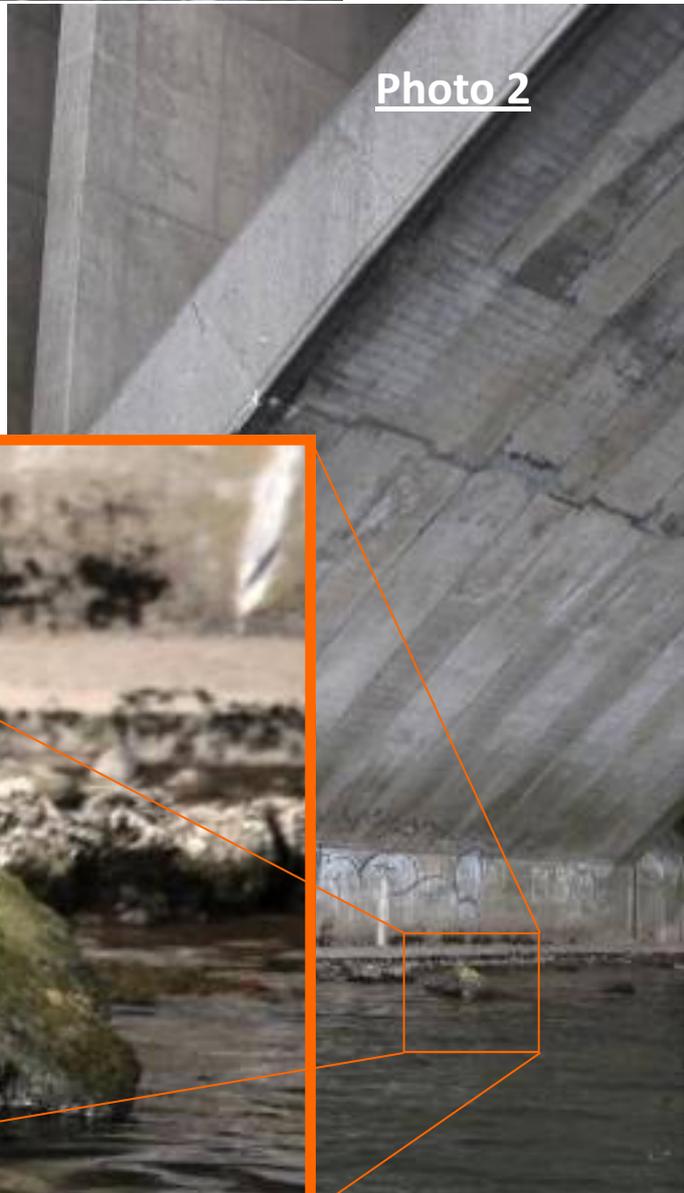
Photo 2

**Photo 2** shows the M6 bridge supports (South side). In the river is a large boulder used as a sprainting site. N.B. the green coloration on the down-stream surface indicates algal growth resulting from nutrients leached out of successive otter spraints. In contrast the adjacent rock is both spraint and algae free.

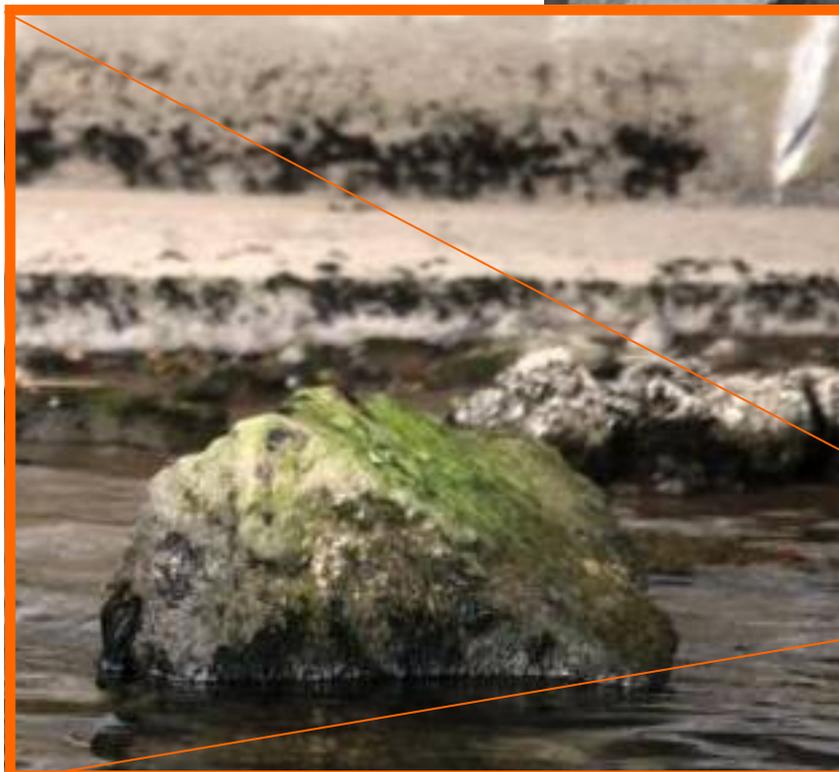
**Photo 3** shows the same boulder from a different angle clearly displaying the frequency of sprainting, revealed as the black, tar-like stream to the left and on the top. Otters often spraint below arches and overhangs, probably because the olfactory messages they contain will last longer. In more exposed locations the rate of spraint loss is linear with time, 50% disappearing in about 2 weeks., and 90% gone in 8 weeks.

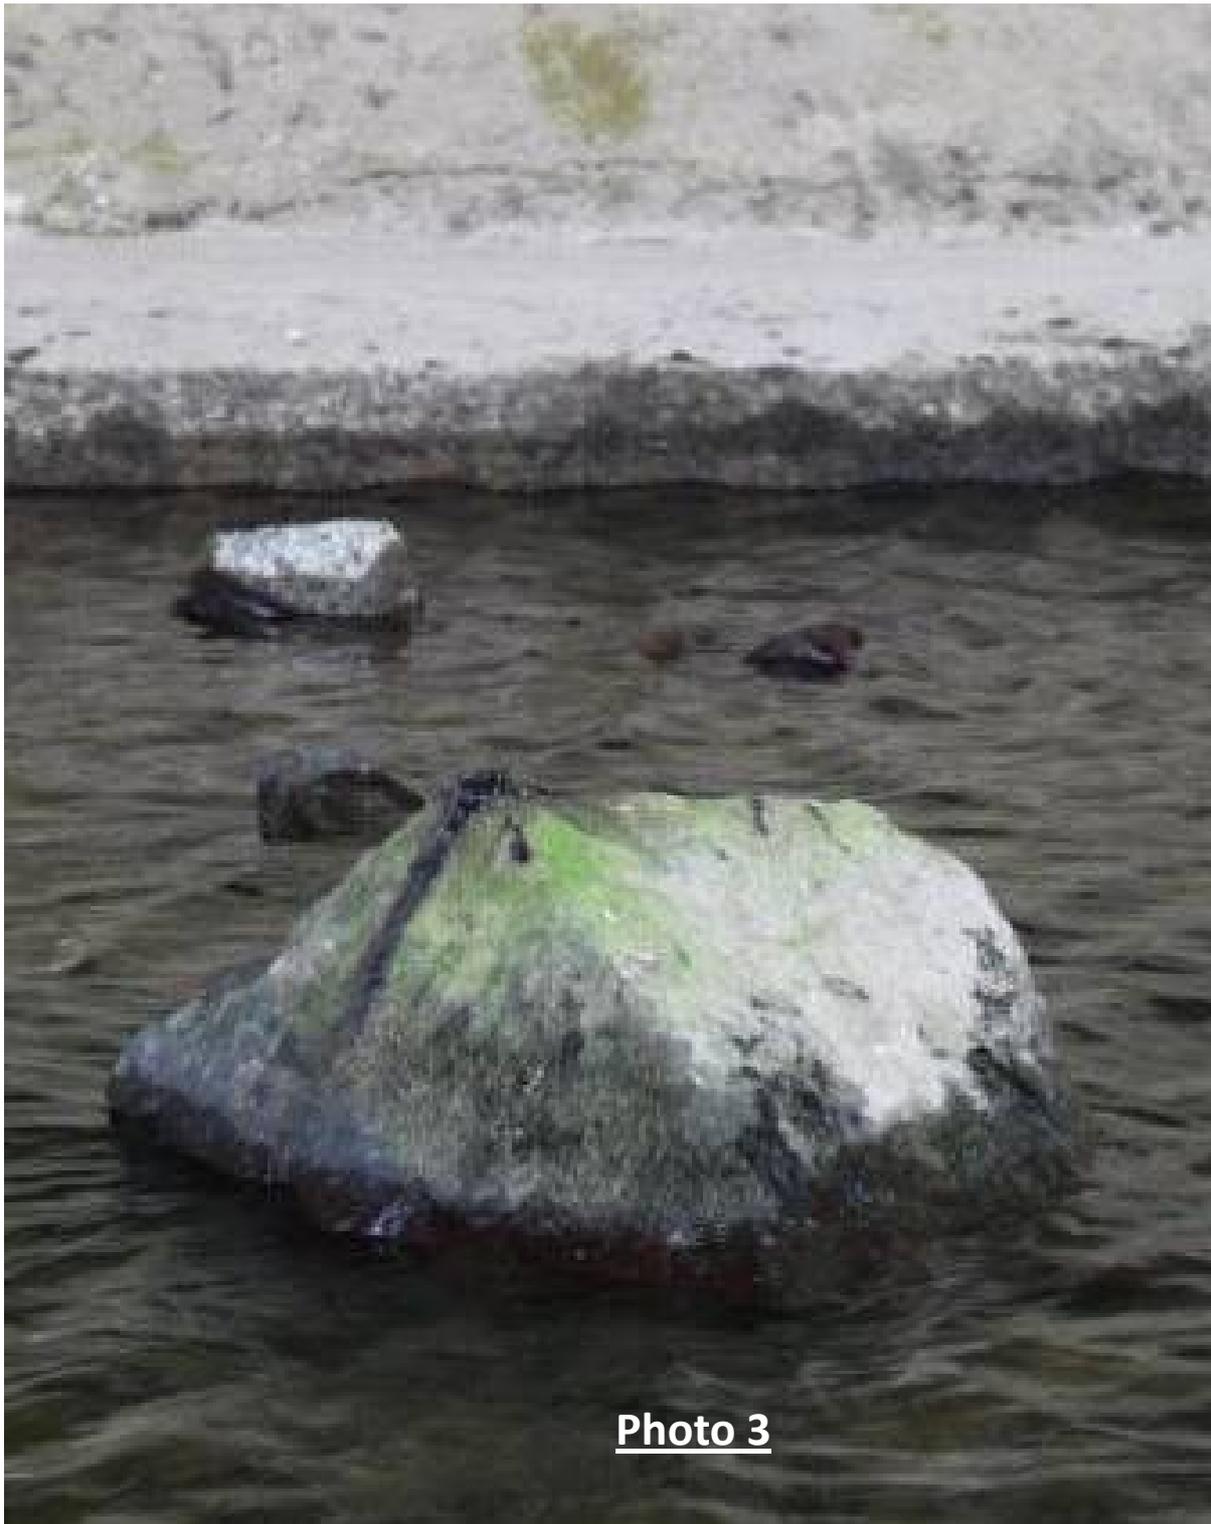
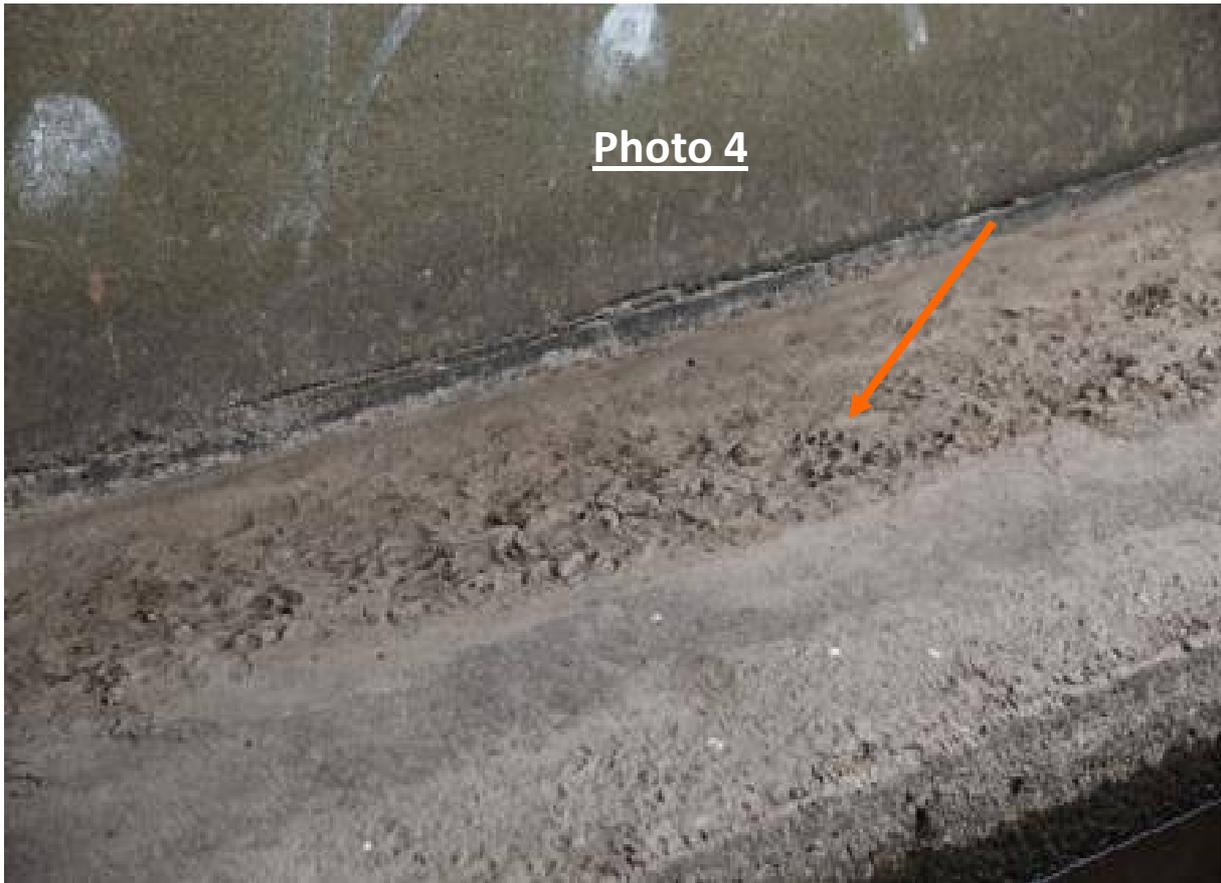
**Photos 4 & 5** show numerous otter prints in both the [wet silt](#) and in the [dried silt](#) on the concrete at the base of the South side of the M6 bridge. The prints indicate a variety of paw size proving visits have been made by more than one individual otter.

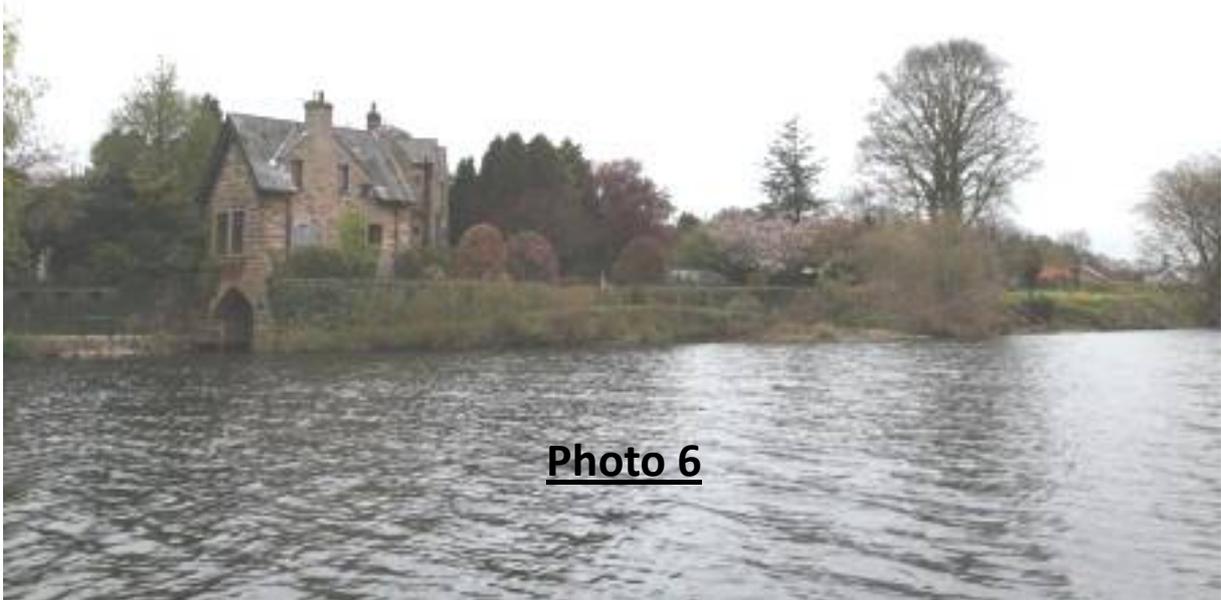
**Photo 6** shows “The Boathouse” at Halton which is the scene of the CCTV otter footage. The owner has allowed the unrestricted growth of river bank vegetation in order to enhance the habitat for otters, unlike the bankside (**Photo 7** below) which has been “manicured” by felling to reveal what would otherwise have been an enclosed layout which would have had more otter appeal.

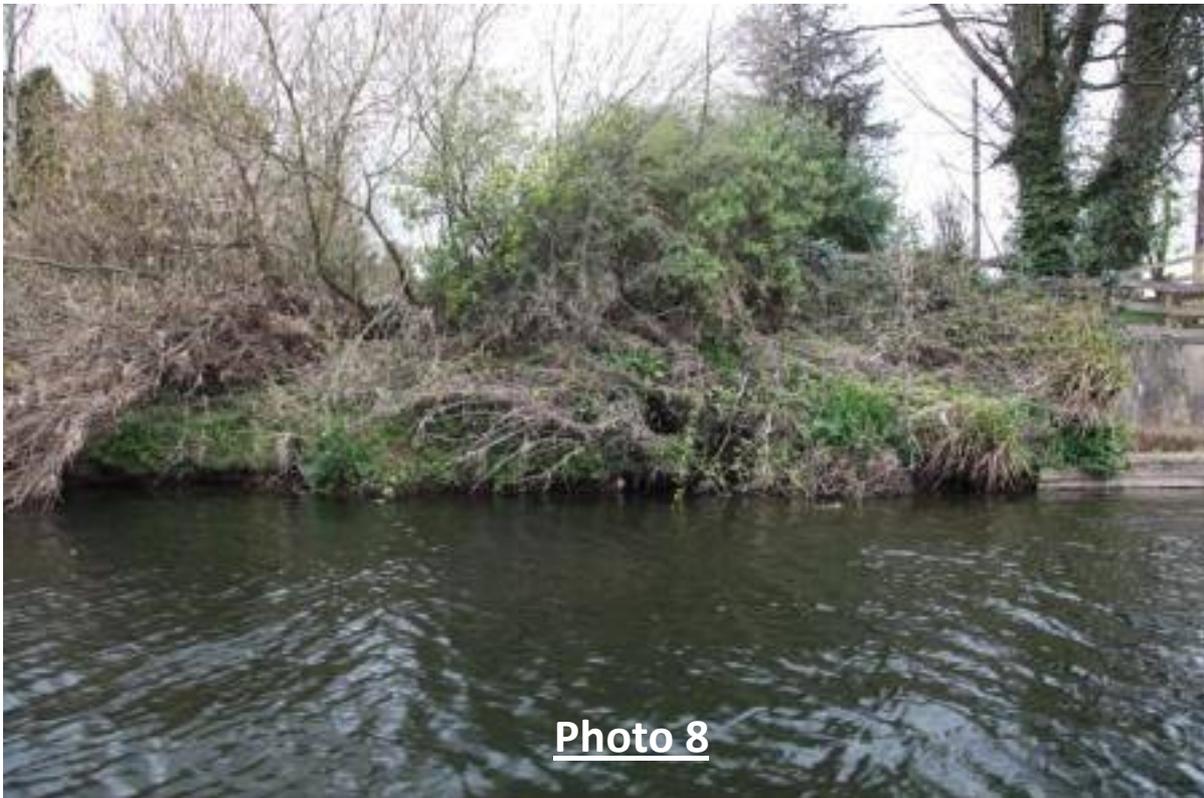
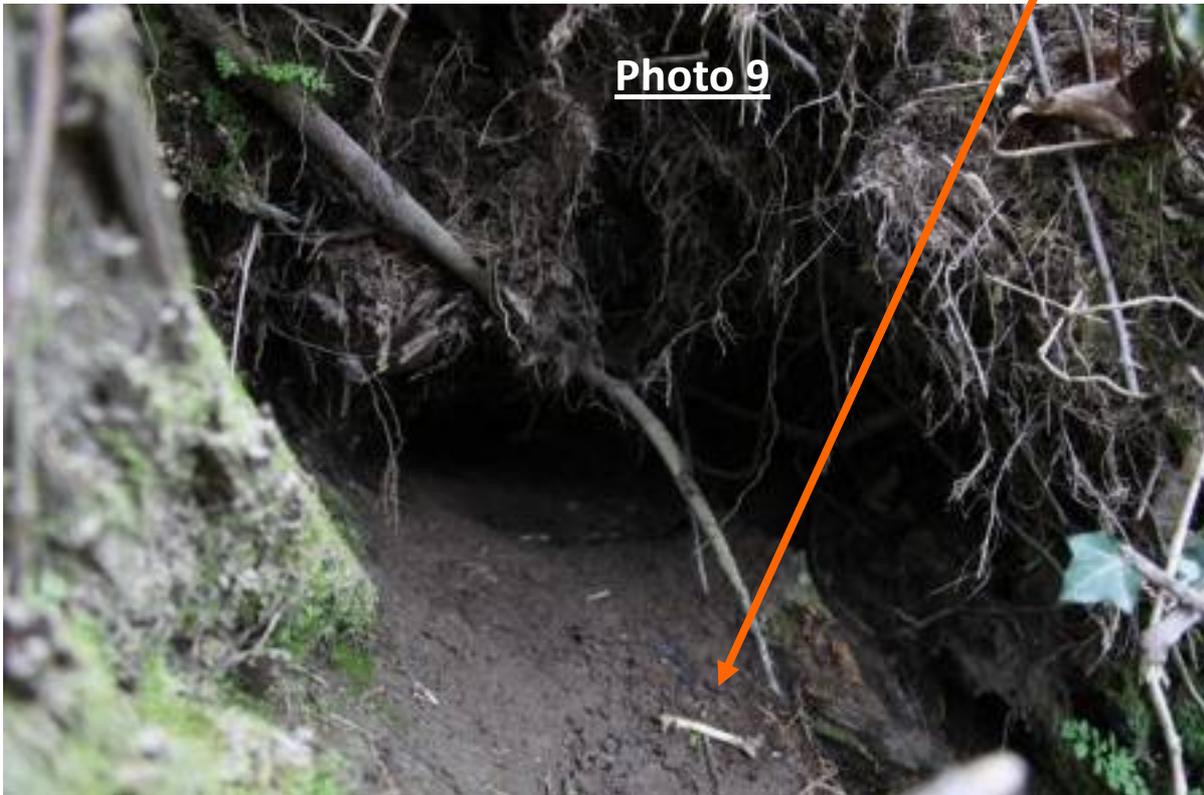
**Photo 8** shows the location of a holt (centre) within a thick tangle of undergrowth. **Photo 9** shows a close-up of the holt entrance revealing compacted earth, paw prints and the bones of a waterfowl.

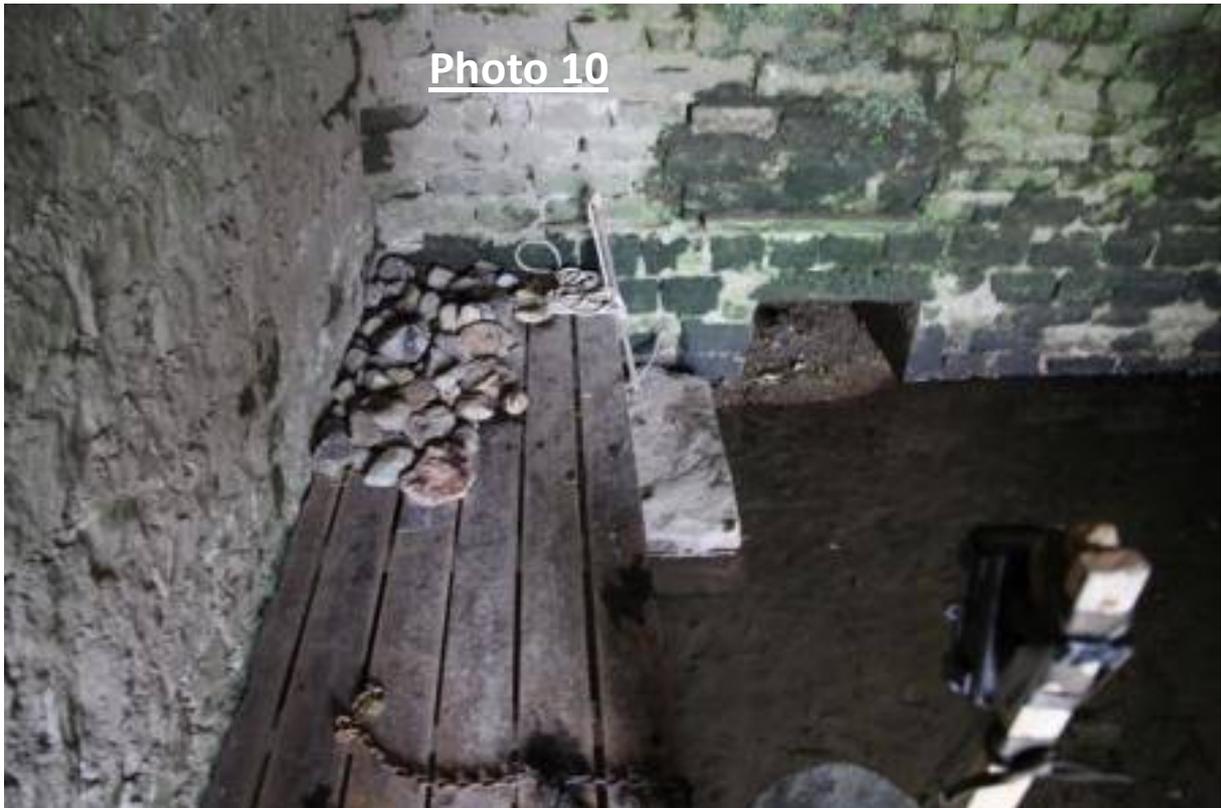
Photo 10 shows the interior of the boathouse at Halton which provides the CCTV and stills footage of otters. The owner placed the rocks on the decking and the adjacent rectangular block in the water in order to provide the elevated features otters prefer to spraint on. These rocks and the ropes are coated with spraints. Photo 11 shows an otter run in a typical “tunnel” format with a spraint rock at the river margin. The undergrowth almost completely covers the run as it ascends the North bank of the river..

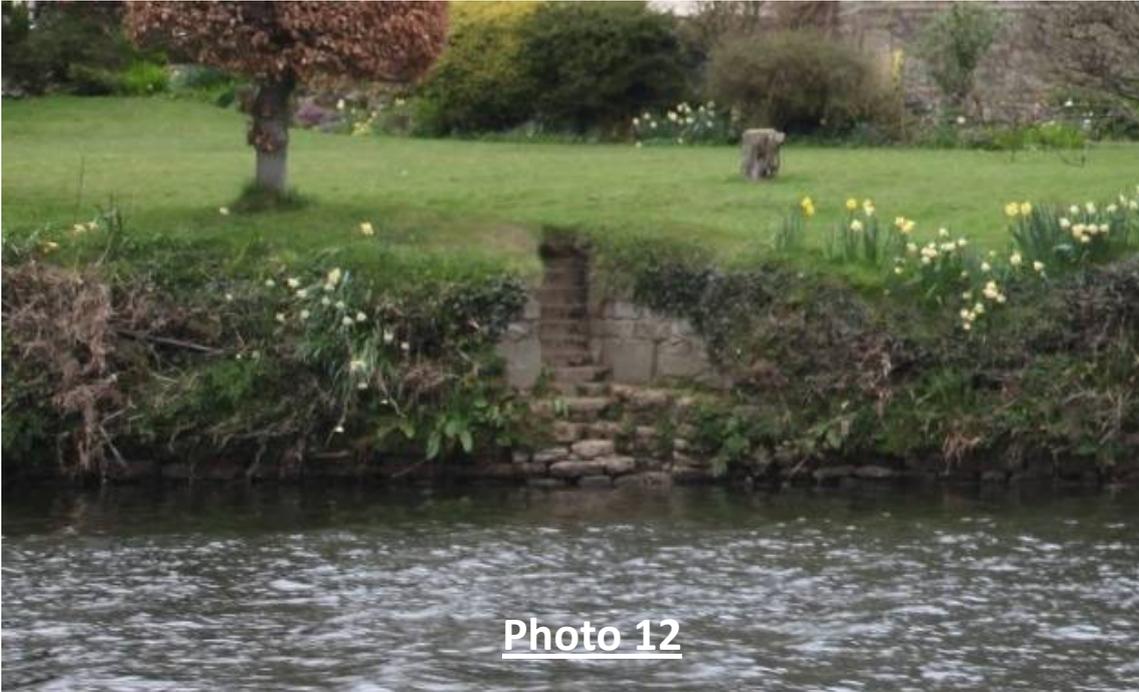
**Photo 12** shows a typical example of the narrow wilderness fringe of a lawned riverside property on the North bank, which if it is frequented by otters is likely only under the cover of darkness.

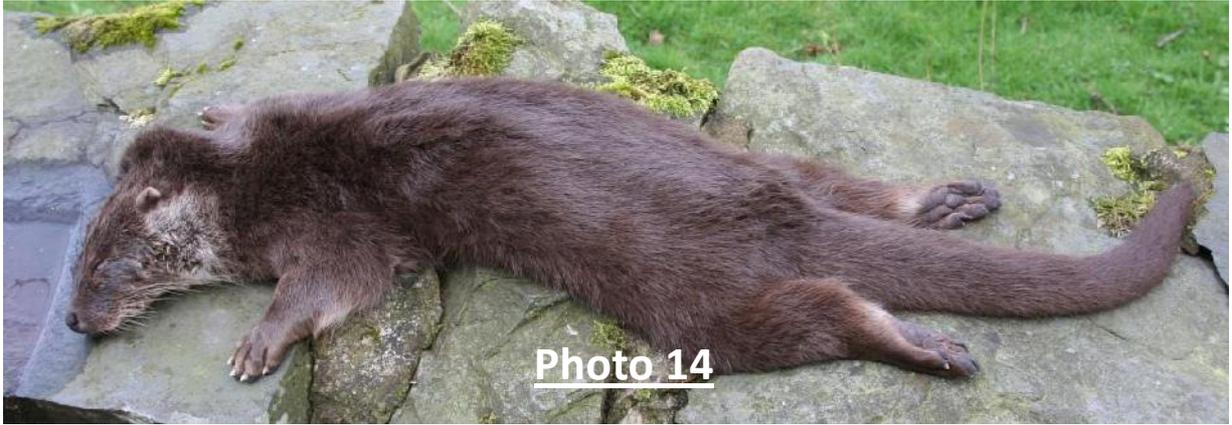
**Photo 14** shows a typical RTA casualty with little external trauma but instantly fatal internal impact injuries. In the Summer of 2011 the UK officially became the most densely populated country in Europe, and one of the most tragic consequences of this crowded life-style is the damaging effect this has on our beleaguered wildlife.

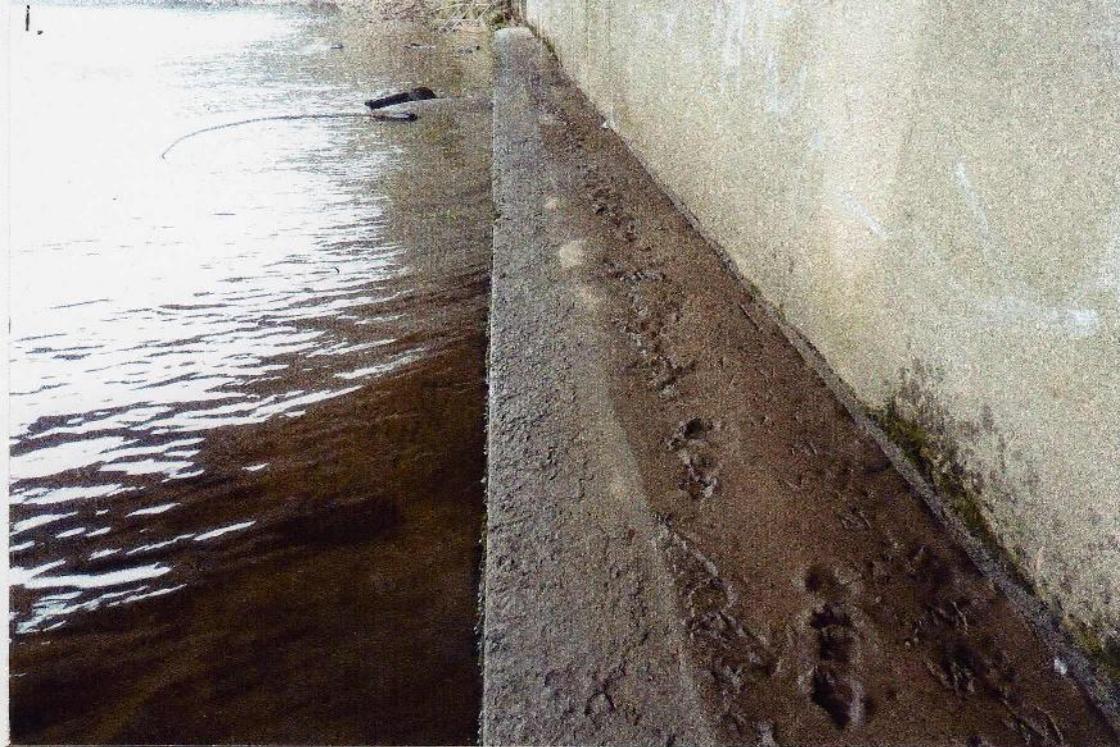
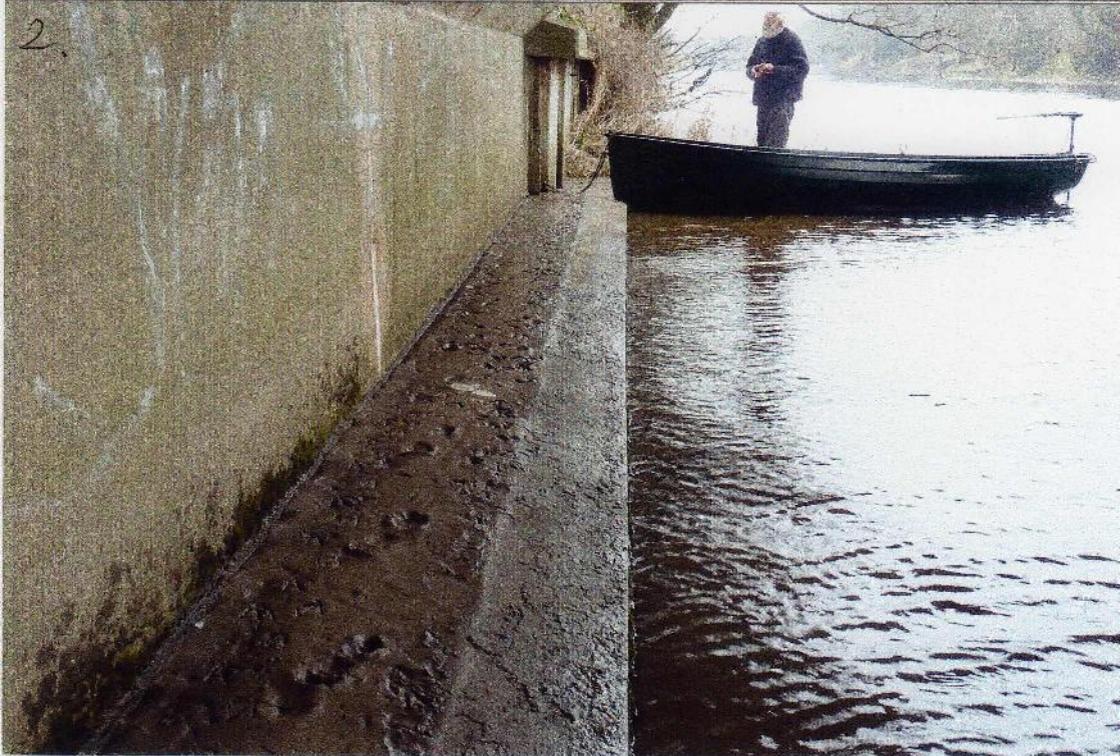
under M6 bridge - north side.

otter prints 1. looking downstream

2. looking upstream

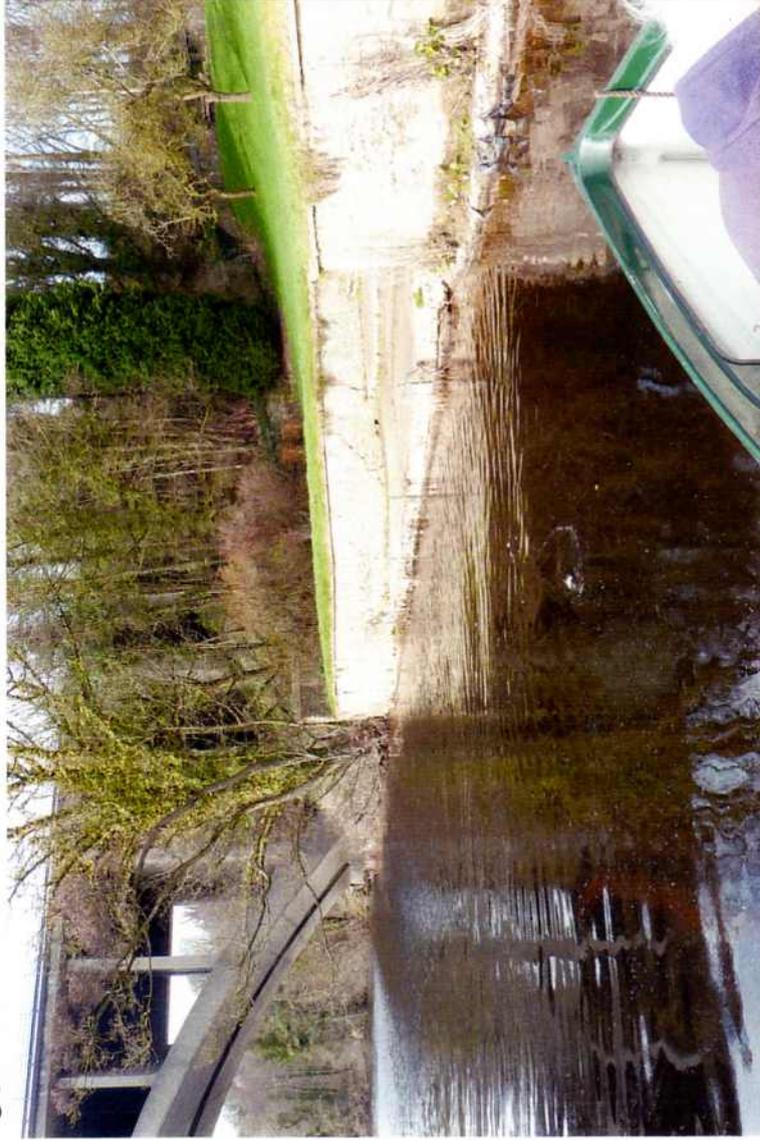
6.

Garden bankside  
adjacent to M6  
bridge,  
showing position  
of photos 7 and 8.

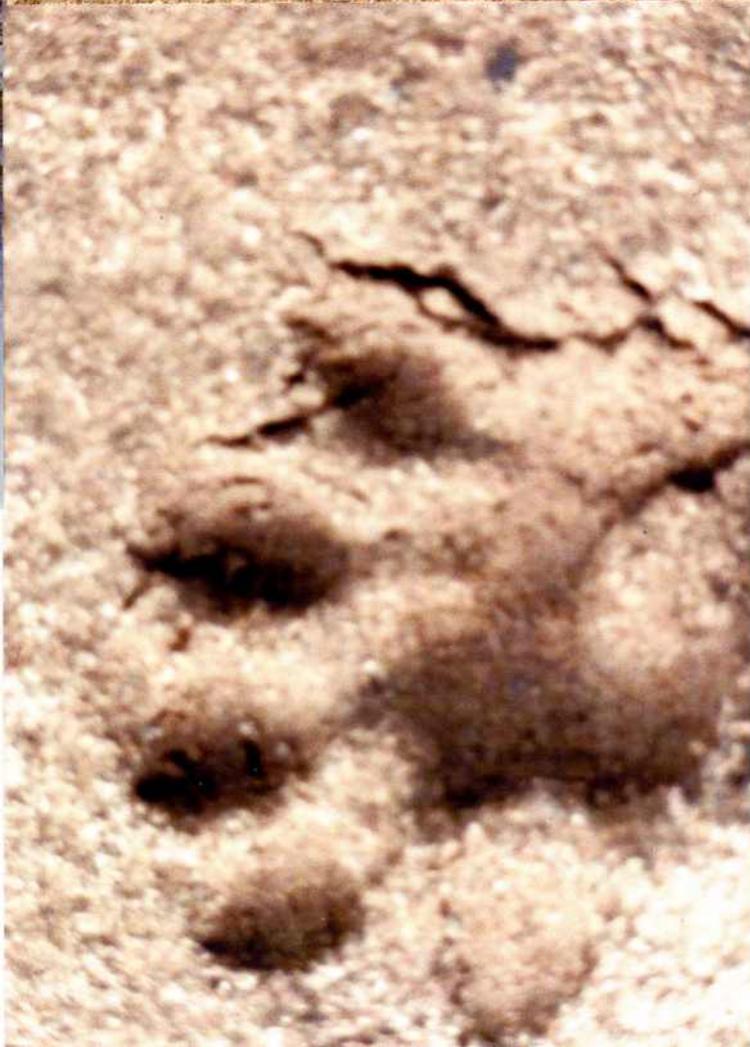
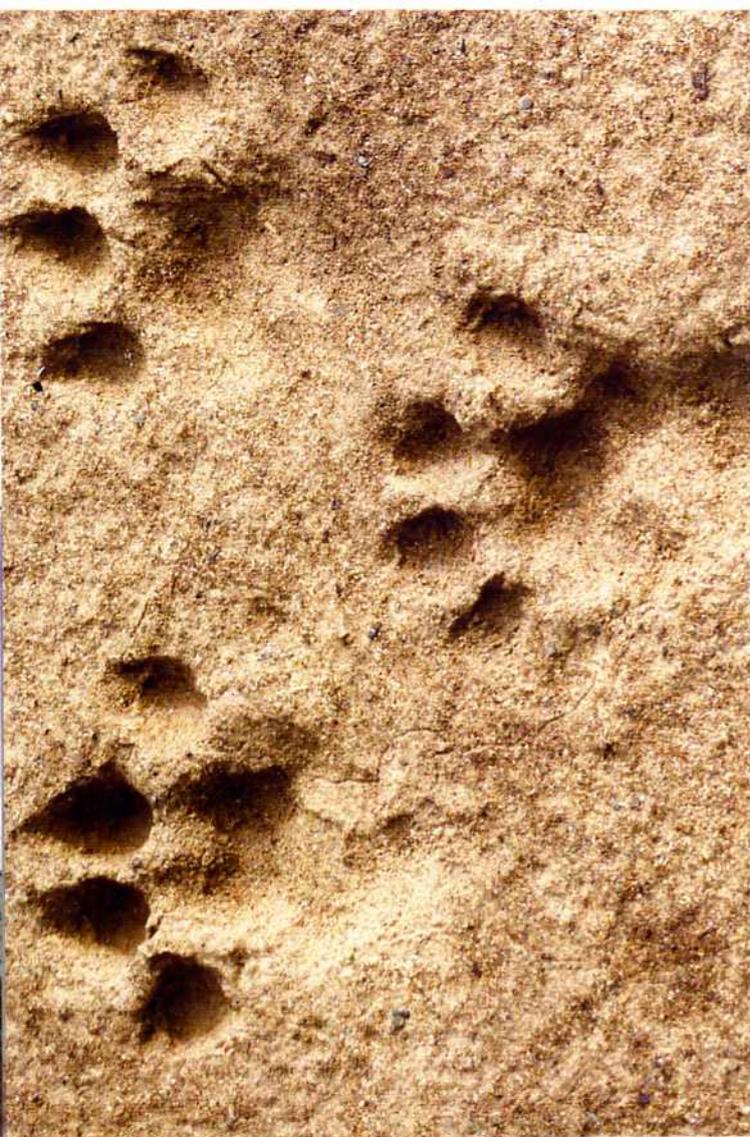
7 and 8 other prints  
in river silt on  
lowest step of photo 6.

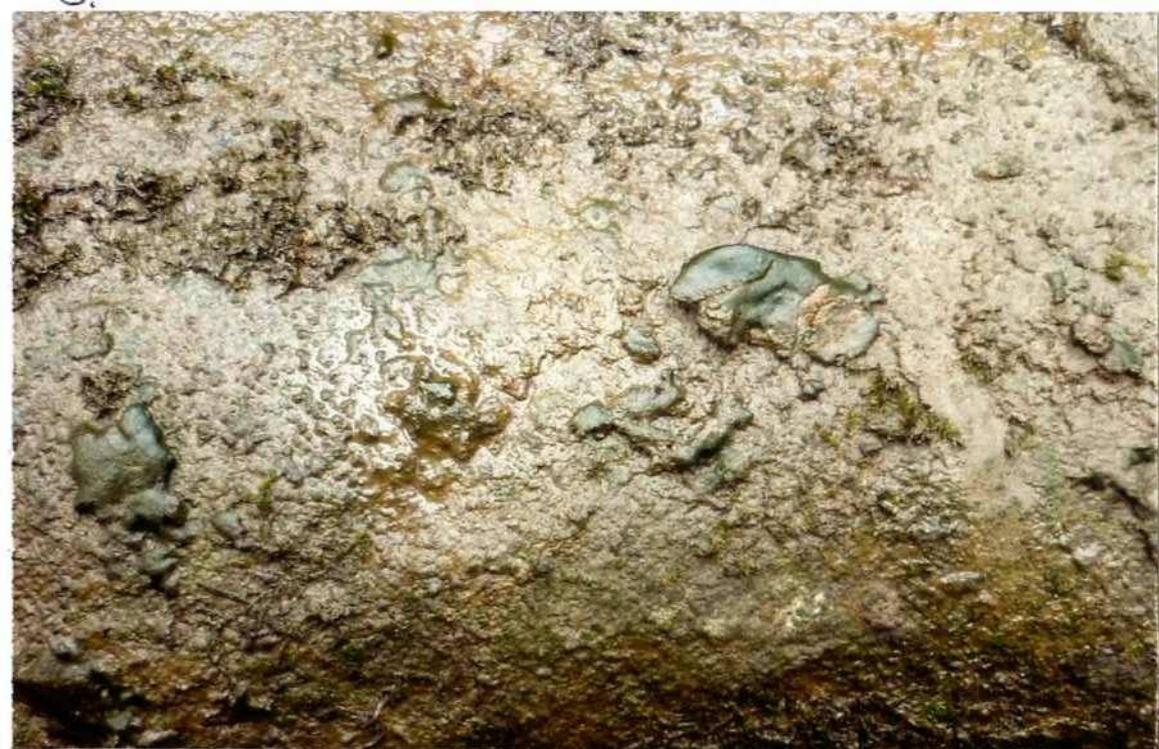
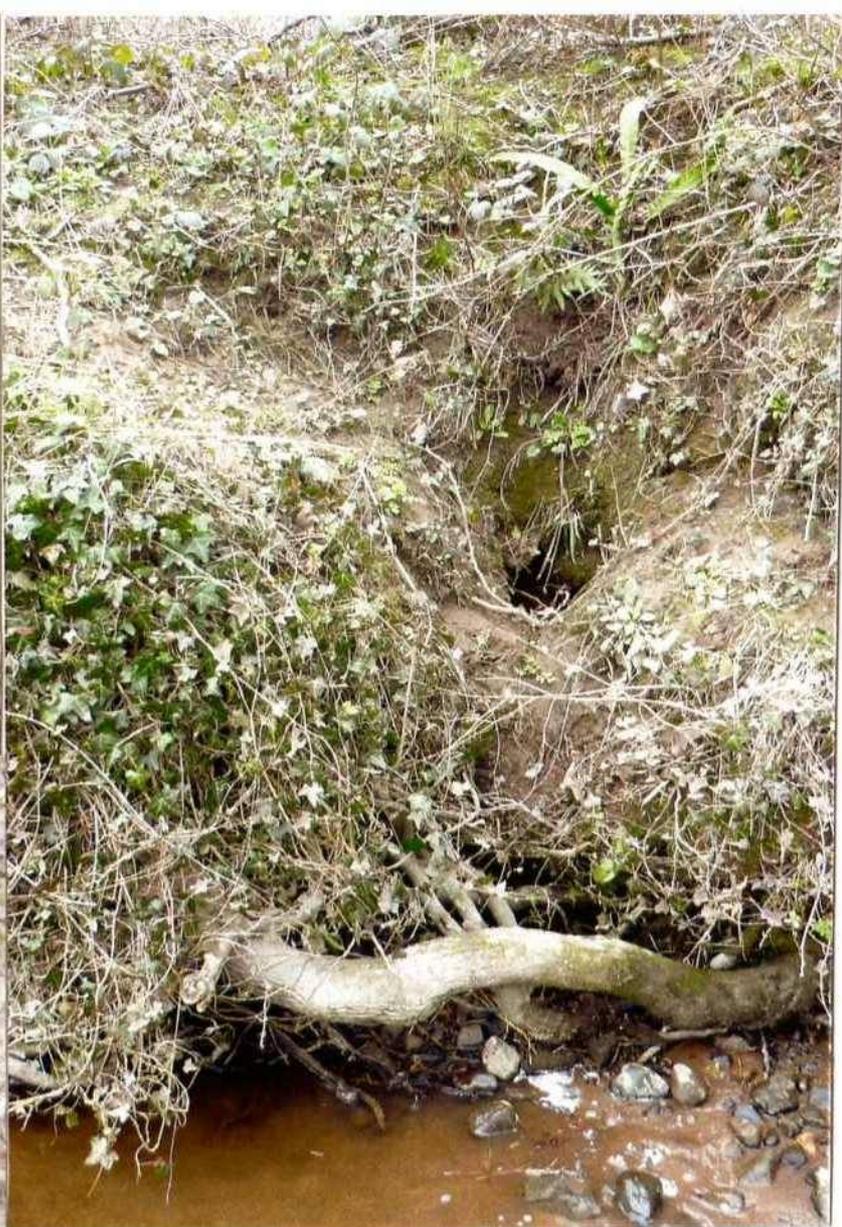
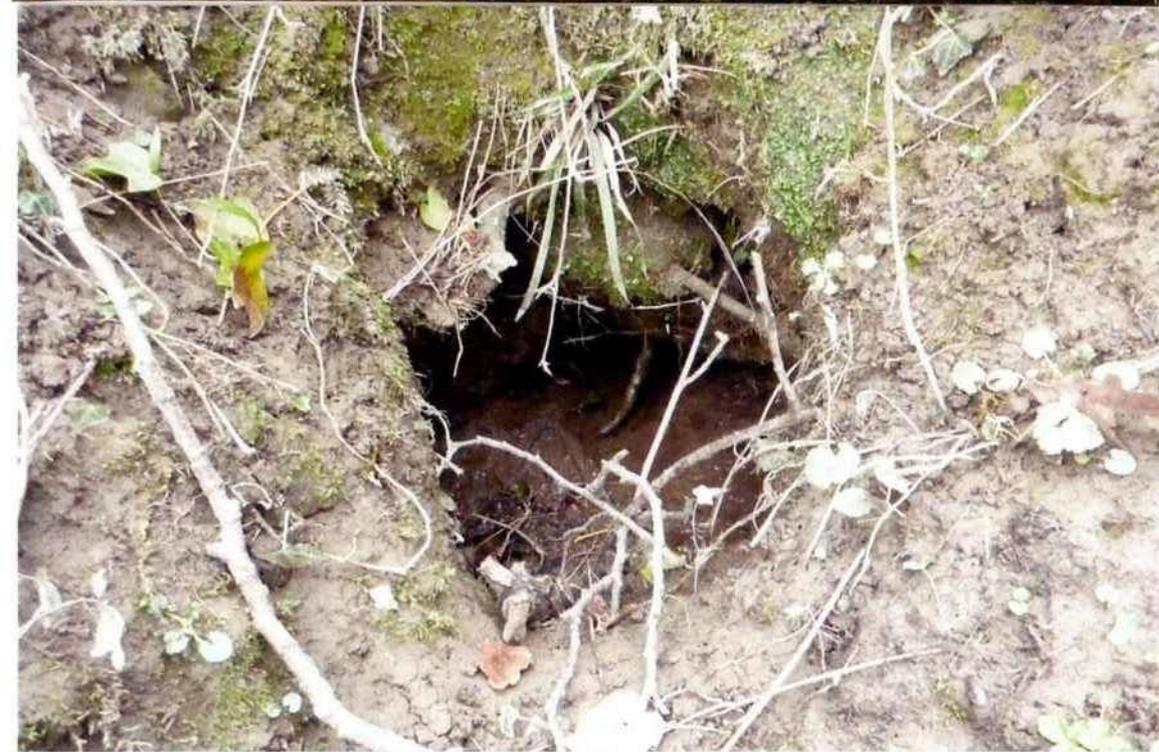
otter spraints and otter holt in woodland  
between Mb bridge and sewage works.  
Bottom photograph is a close-up.

5. Otter resting place, approx 50 metres downstream from centre of M6 bridge.

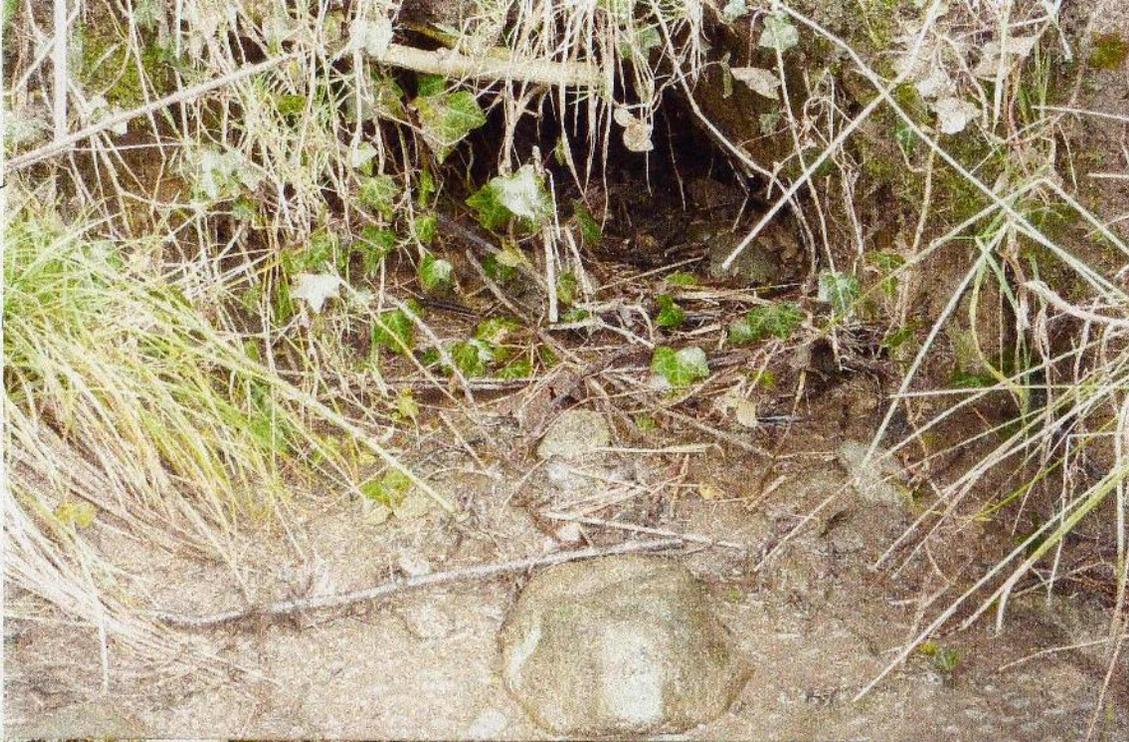
4. Otter spraints on muddy area in front of resting place (3).  
5. Otter prints at the same position.
