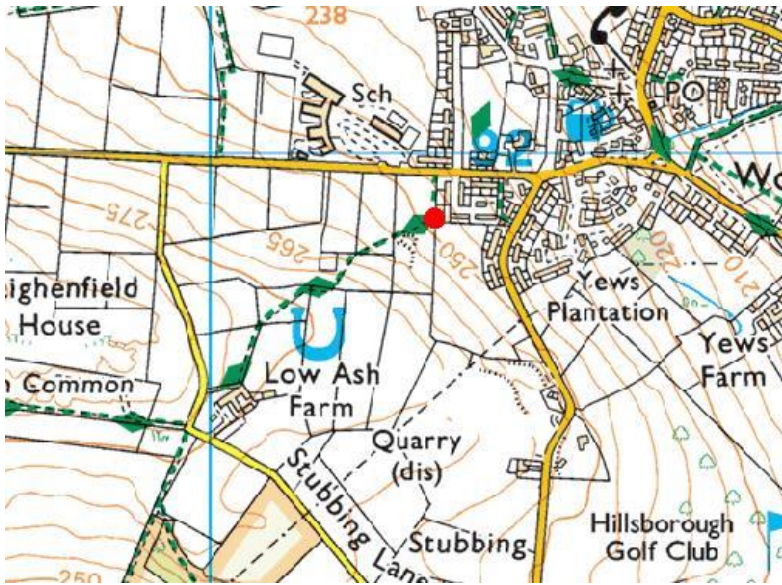
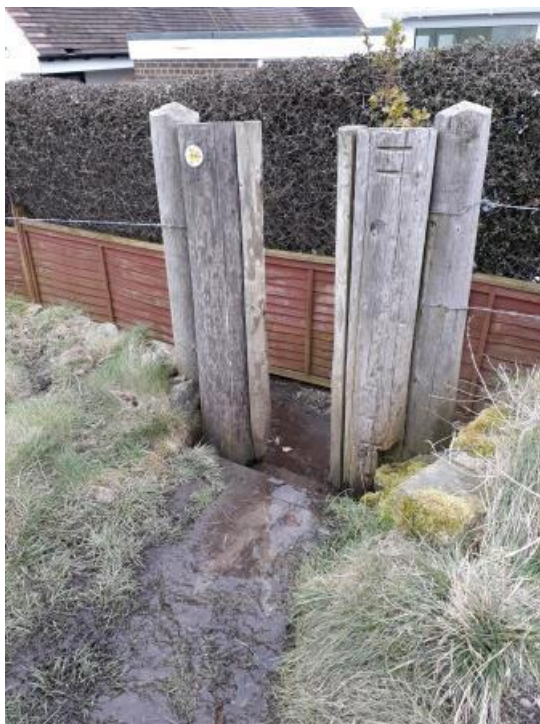
Location 1

Description of existing structure - Narrow squeeze stile

Install pedestrian gate at foot of steps opening out onto lower footpath. Landowner is James Melvyn Shepherd 07891175987

PROW Rangers to design and fit bespoke gate

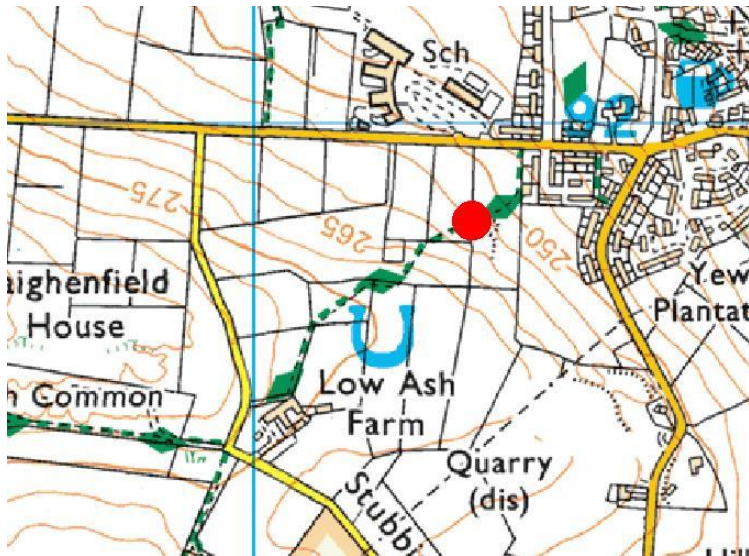
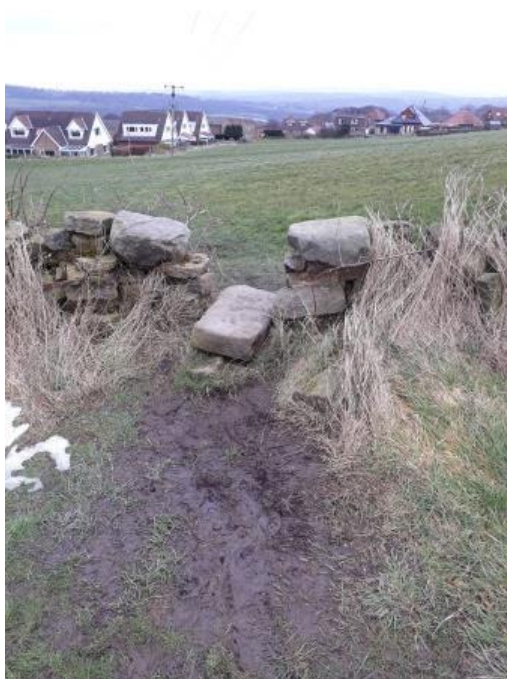
Location 2

Description of existing structure - Wobbly stone stile

Mortar up stone stile and add timber hand post. Add yellow footpath arrow to either side of the new hand post. Landowner is James Melvyn Shepherd 07891175987

RA Volunteers to complete. 110mm x 2400mm round post to be installed 750-900mm deep. Install on lower side of stile (far side in photo)

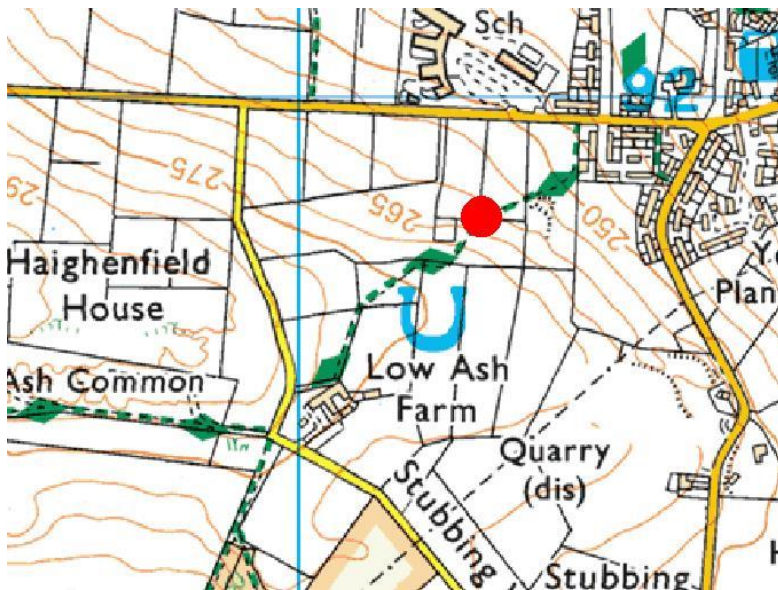
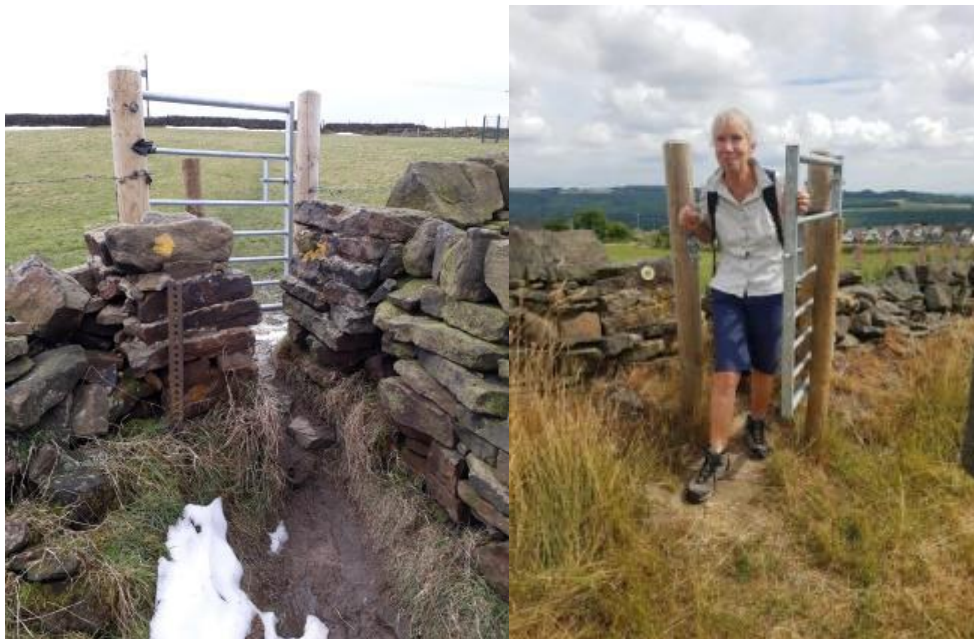
Location 3

Description of existing structure - Pedestrian gate and squeeze gap with timber post in front of gate

Move timber post out into the field slightly so that gate opens more fully. Landowners John and Patricia Webster, Low Ash Farm, Stubbing Lane, Sheffield, S35 0AP

RA Volunteers to complete. Probably only needs moving 100-150mm

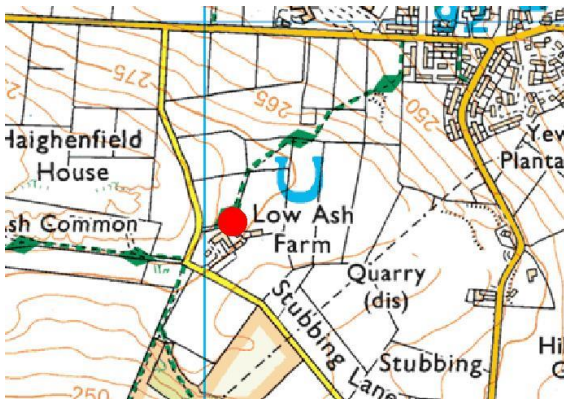
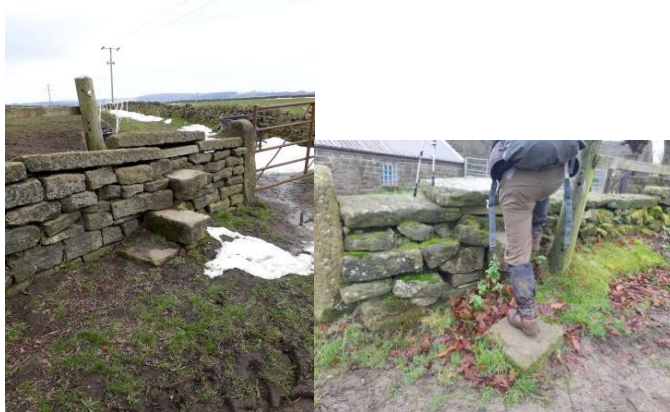
Location 4

Description of existing structure - Wobbly stone stile

Install two posts, one each side of the wall. Join them with a short rail. Ensure squeeze gap between the existing post and the new post on that side of the wall is small enough to keep livestock in. The new post to make squeeze stile should be 1ft-2ft taller than existing post. The rail will be angled across the top of the wall, as the two new posts will have to be offset.

Move the large top stone up to the gate post, to make that section higher and make the stile lower - may involve moving a few stones around. Also level up bottom step (right hand photo).

Two 110mm x 240mm round posts, install 750mm-900mm deep

One handrail, length 1500mm

100mm and 125mm galvanised steel nails

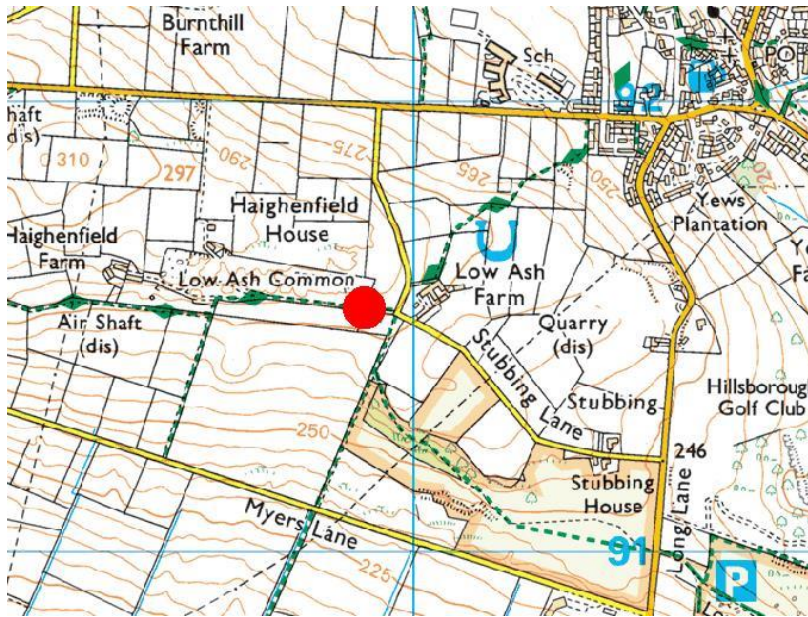
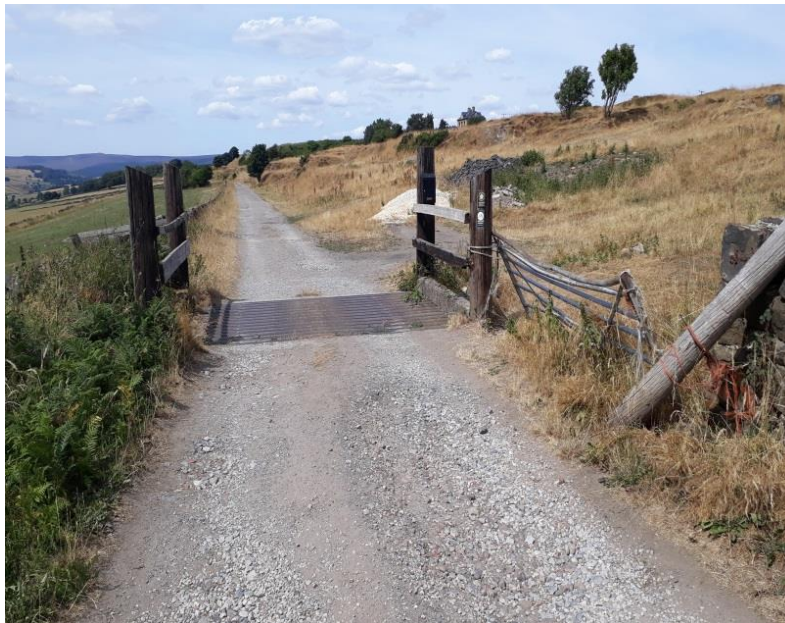
Location 5

Description of existing structure - Cattle grid

Install small KG tight up to wall corner in right hand side of photo. Block gap with old field gate. Landowner Jean Bond, Haighenfield Farm, jean.bond43@btinternet.com, 07885522257

External contractor to complete

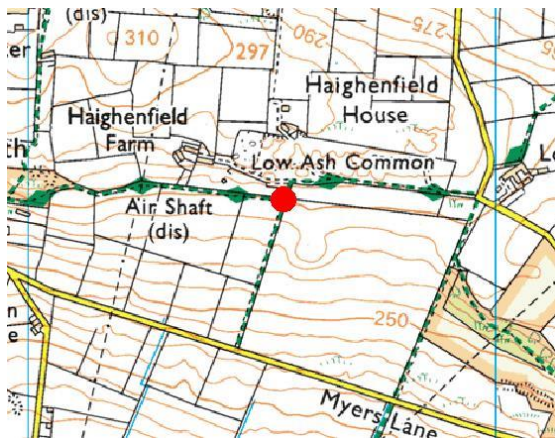
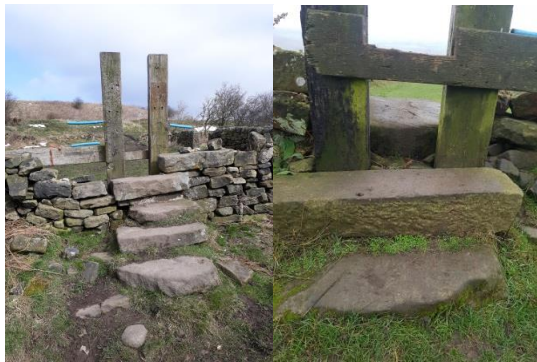
Location 6

Description of existing structure - Stone steps, stone stile with timber squeeze stile on top (note – the left post in left photo has since been shortened)

Install short timber handrail on right hand side of steps looking uphill (left photo, i.e. the side of the steps closest to the corner of the field) from existing post to a new post at side of steps.

Also try to level up the bottom steps on the downhill side (left photo) and put in a stone under the bar (in gap visible in right photo) to create an interim step before the wooden bar, if a suitable stone can be found nearby and it can be secured in place sufficiently.

One 110mm x 2400mm round post, and 1800mm handrail. Dovetail handrail into existing post somehow. 100mm and 125mm galvanised steel nails
Landowners are Jean Bond, Haighenfield Farm, jean.bond43@btinternet.com, 07885522257 and Trevor White, Trickett Edge Farm, tel 07729550989

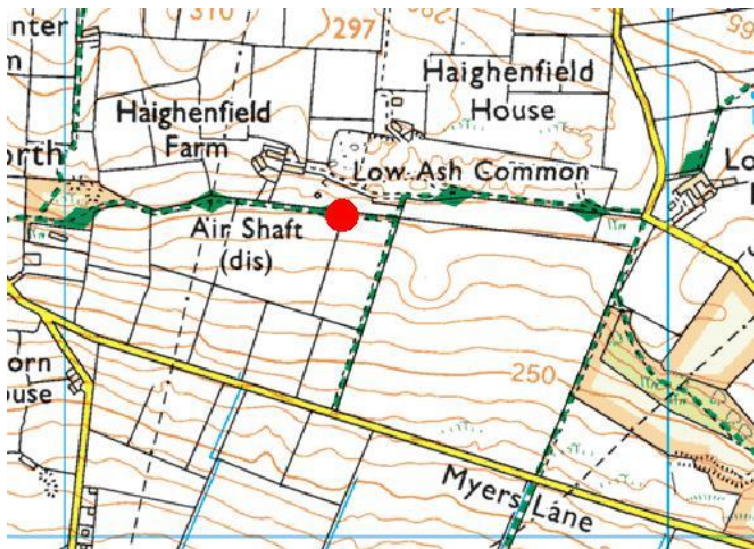
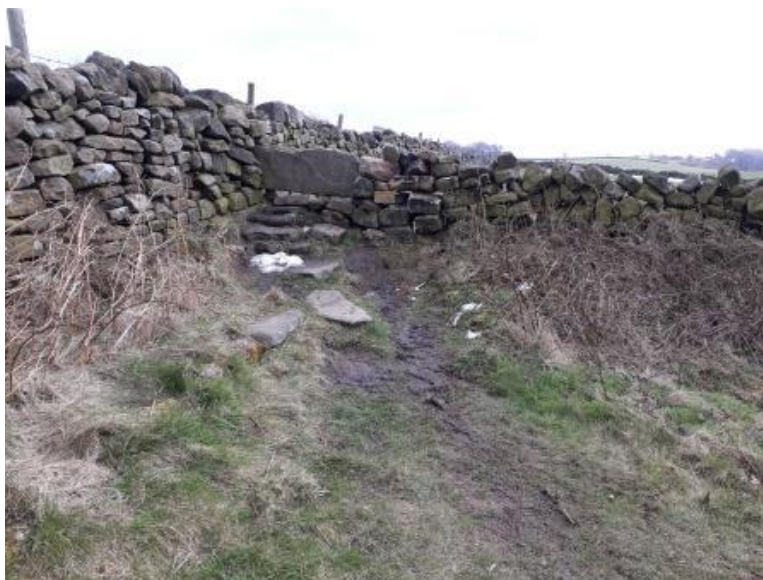
Location 7

Description of existing structure - High stone stile

Install timber handrail on uphill side of stile, tight up against the wall. Re-build stone steps either side of stile. Landowner is Trevor White, Trickett Edge Farm, tel 07729550989

RA Volunteers to install handrail and re-build steps. 2 quantity 110mm x 2100mm round posts and a 2100mm handrail. Install posts to 750mm-900mm deep. 100mm and 125mm galvanised steel rails

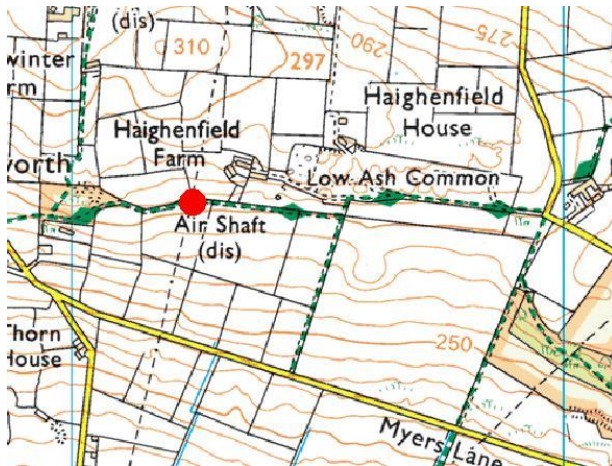
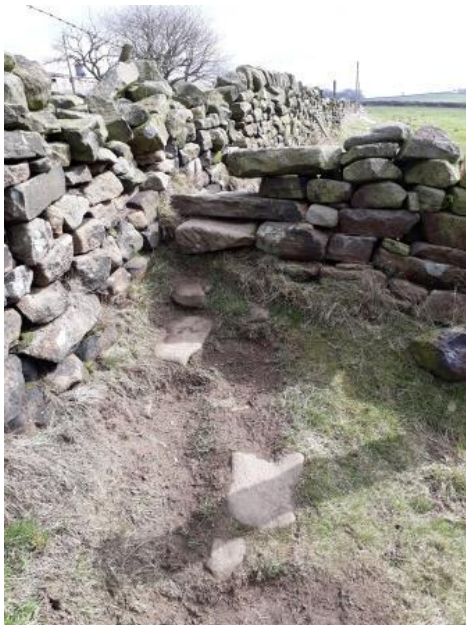
Location 8

Description of existing structure - Stone stile

Install timber handrail on uphill side of stile, tight up against the wall. Turn large stone round 90 degrees to widen stile slightly. Need to pull large stone back by removing smaller stones. 2 quantity 100mm x 2100mm round posts and a 2100mm handrail. Install posts to 750mm-900mm deep. 100mm and 125mm galvanised steel nails. Landowners are Trevor White, Trickett Edge Farm, tel 07729550989, and David Marshall, Green End Farm, tel 07538 232050, greenendfarm@yahoo.com

RA Volunteers to install handrail and amend top step

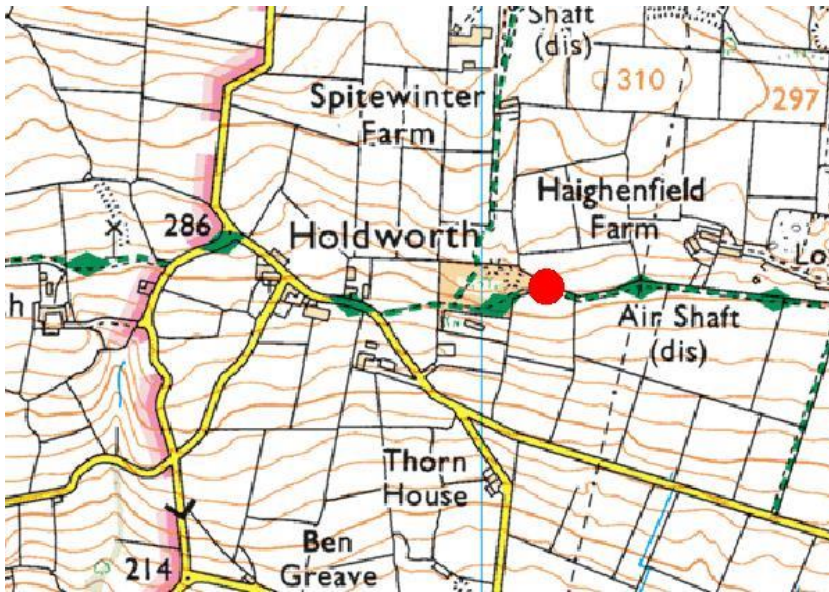
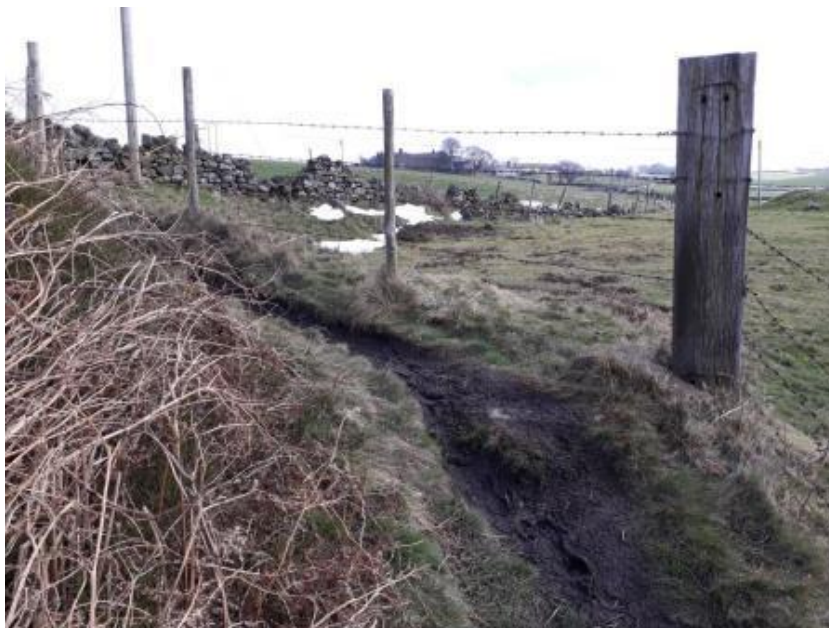
Location 9

Description of existing structure - Barbed wire fence obstruction (squeeze stile a few metres away)

Install kissing gate in fence line tight up to large corner straining post. Landowner is David Marshall, Green End Farm, tel 07538 232050, greenendfarm@yahoo.com

External contractor to install kissing gate

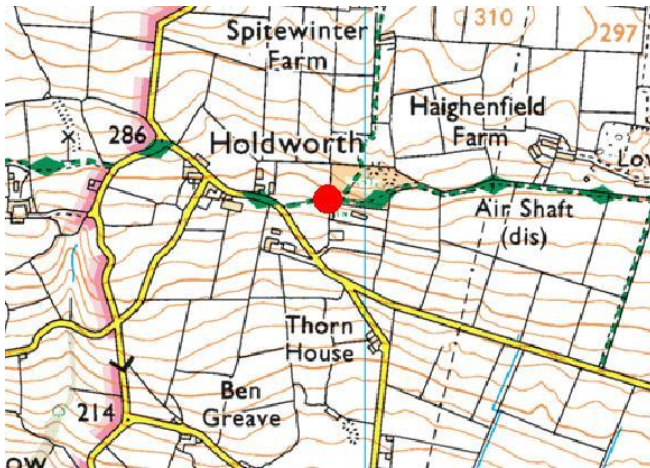
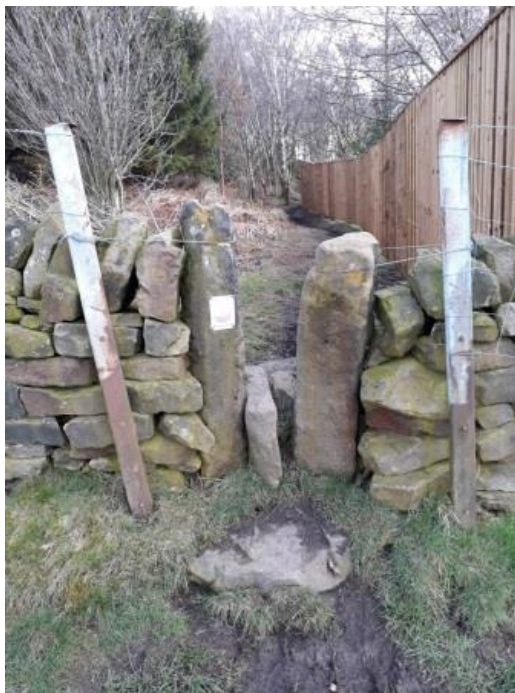
Location 10

Description of existing structure – Wobbly step in stone stile

Firm up rocks in centre of stile Do by lowering a few inches, by embedding existing stone in the ground, and wedging another stone into the gap also, to make stable and slightly lower. Raise, by a few inches, the step in front of stile as well.

RA Volunteers to firm up stone in centre of stile

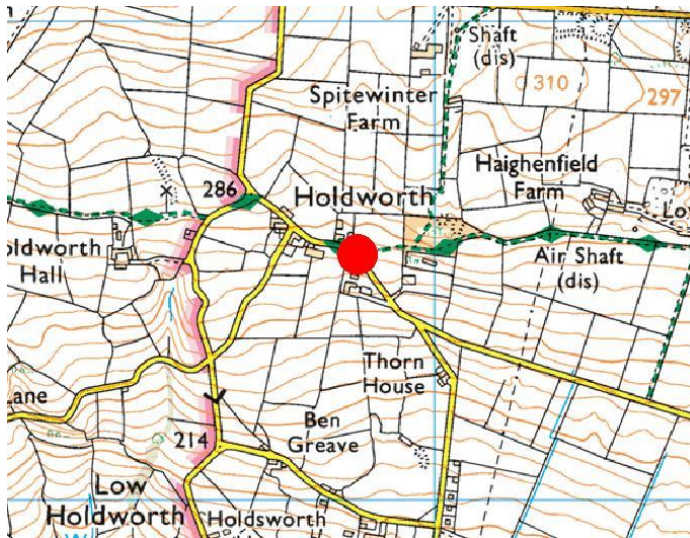
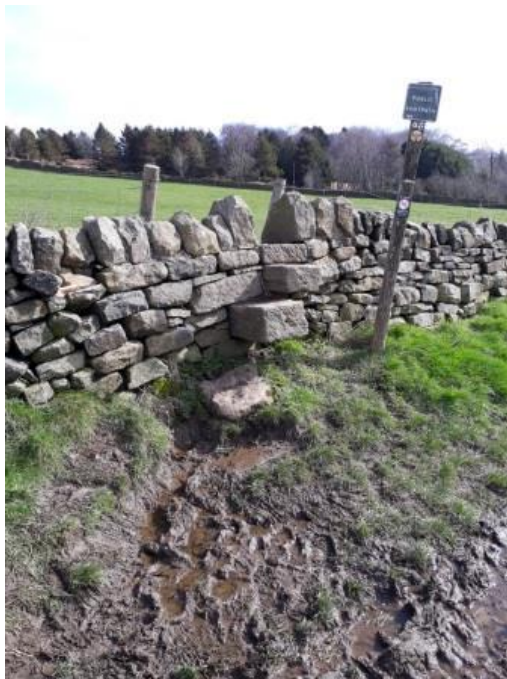
Location 11

Description of existing structure - Tall stone stile

Level and firm up lowest step on road side of stile. Replace post with tall round hand post and re-attach footpath plaque. Landowner is Trevor White, Trickett Edge Farm, tel 07729550989

PROW Rangers to re-set bottom step and install hand/finger post

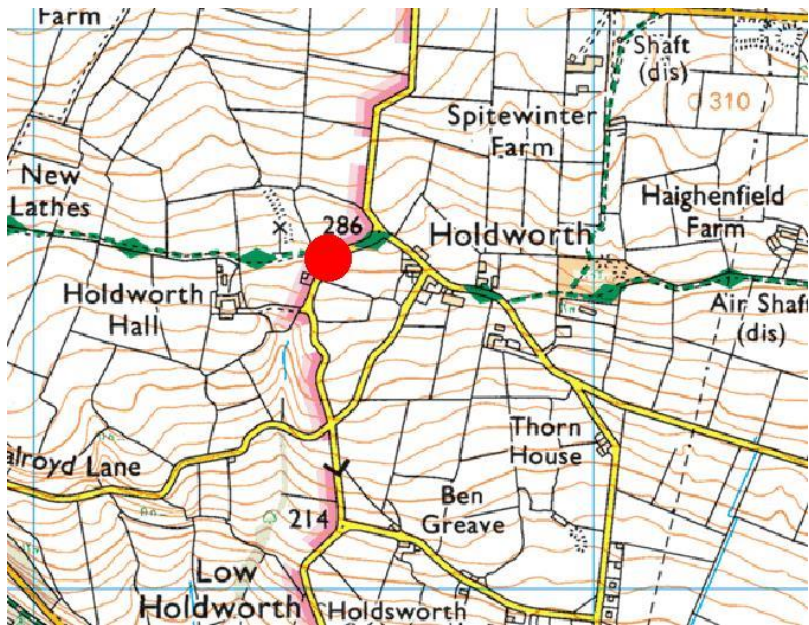
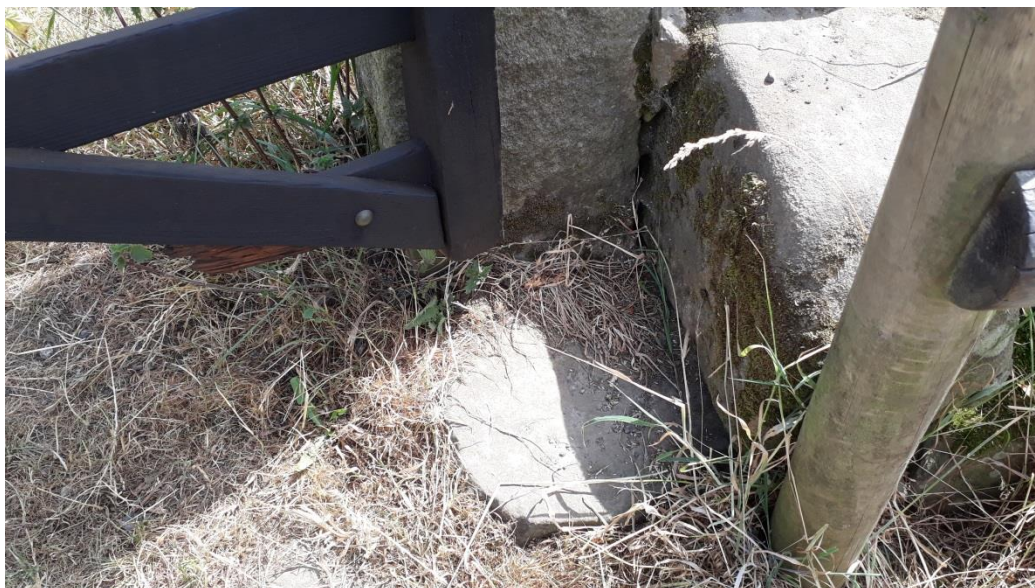
Location 12

Description of existing structure - Awkward stone stile and field gate

Raise lower step of stile using concrete, but not so high that field gate can't be opened. Landowner is Mrs Westhead, Ashley Cottage, Holdworth, S6 6LH, tel 0114 285 1285

PROW Rangers to amend step

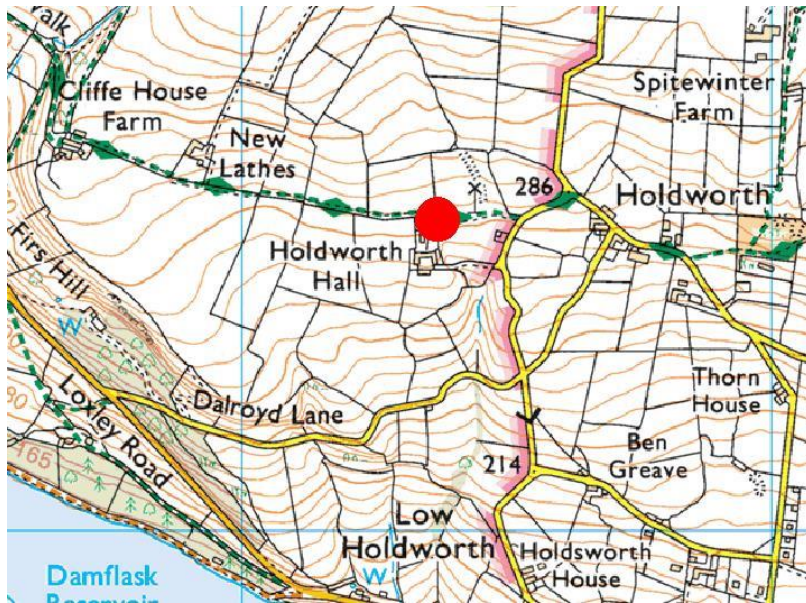
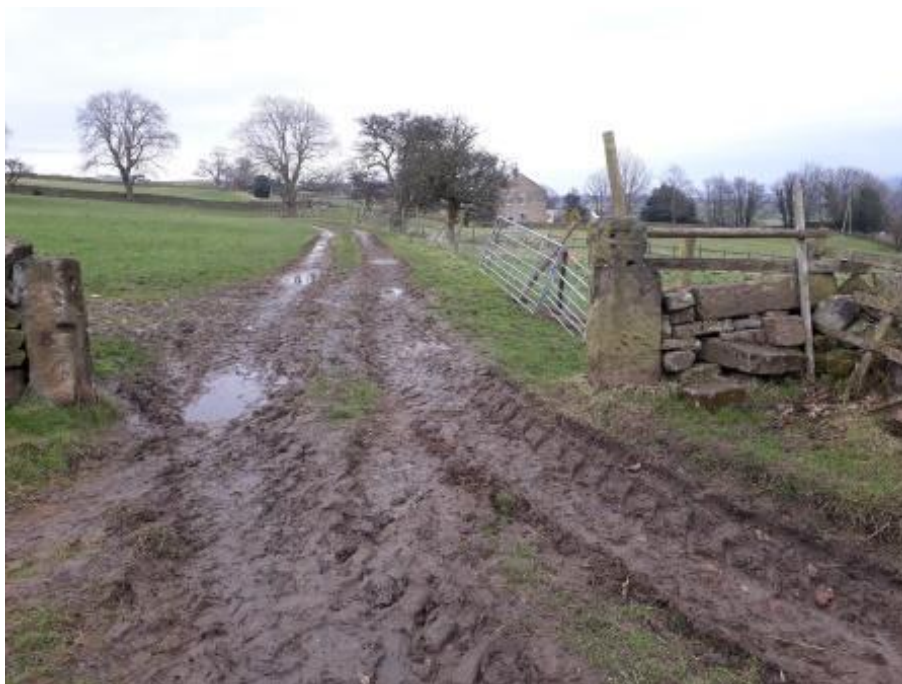
Location 13

Description of existing structure - Open field gate and blocked stone stile

Replace field gate with 2 in 1 gate. Landowner is Mrs Westhead, Ashley Cottage, Holdworth, S6 6LH, tel 0114 285 1285

PROW Rangers to install 2 in 1 gate

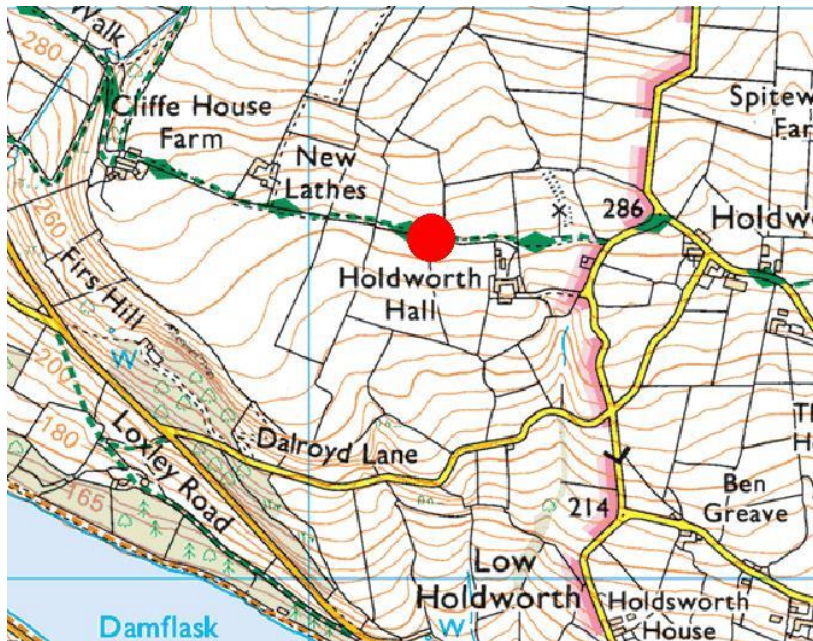
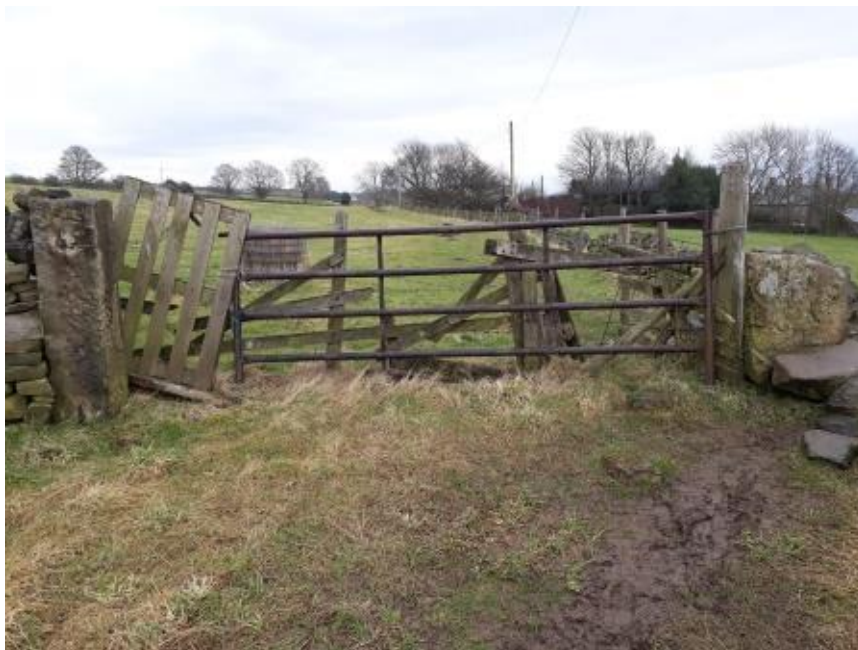
Location 14

Description of existing structure - Blocked gateway and stile

Install 2 in 1 gate in existing gateway. Landowner is Mrs Westhead, Ashley Cottage, Holdworth, S6 6LH, tel 0114 285 1285

PROW Rangers to install 2 in 1 gate

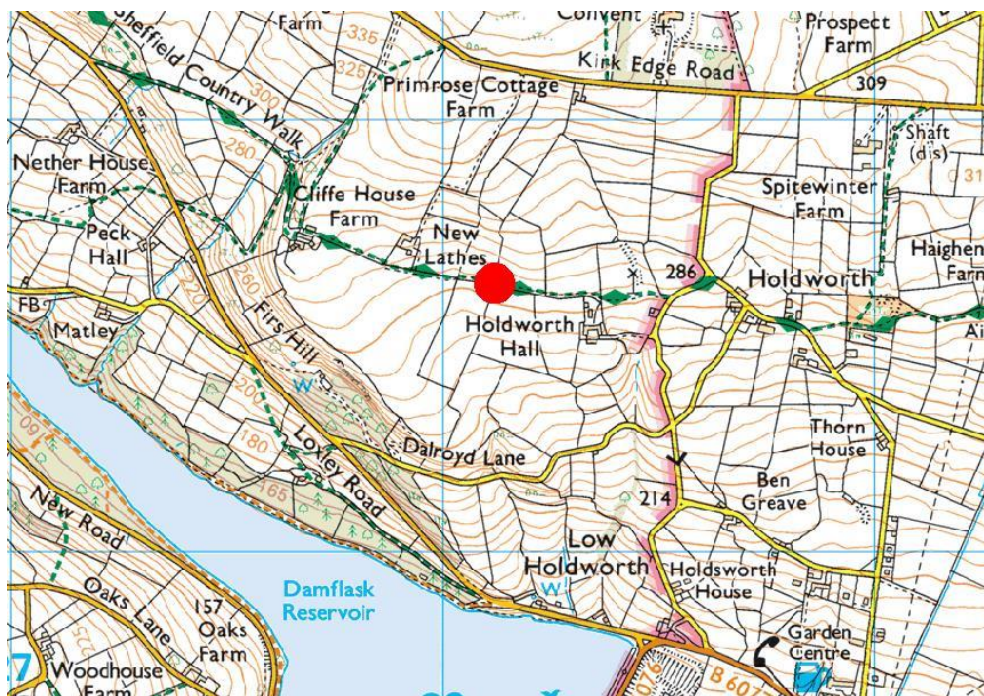
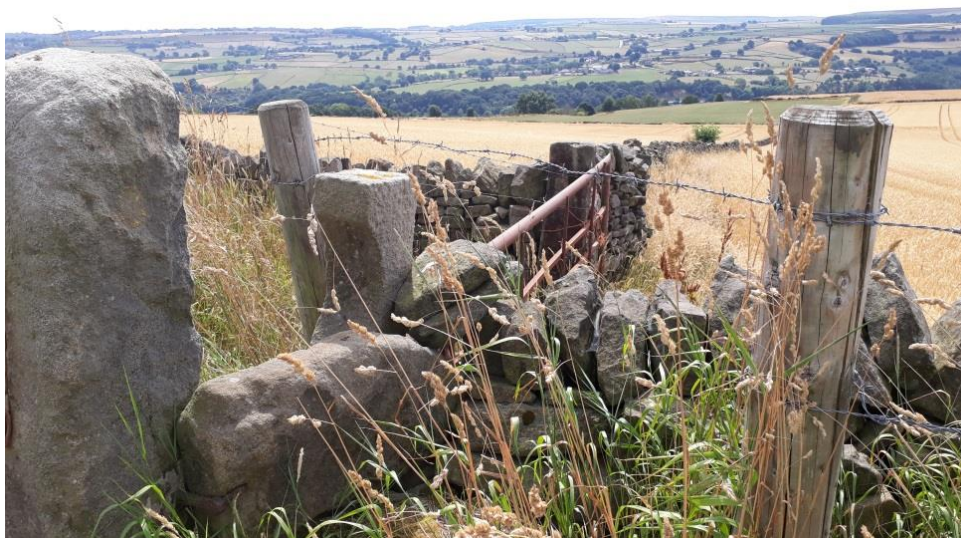
Location 15

Description of existing structure - Stone stile and open gateway

Replace barbed wire strand alongside stile with timber handrail. Landowner is Mrs Westhead, Ashley Cottage, Holdworth, S6 6LH, tel 0114 285 1285

RA Volunteers to install hand rail. 1500mm handrail, 100mm and 125mm galvanised steel rails

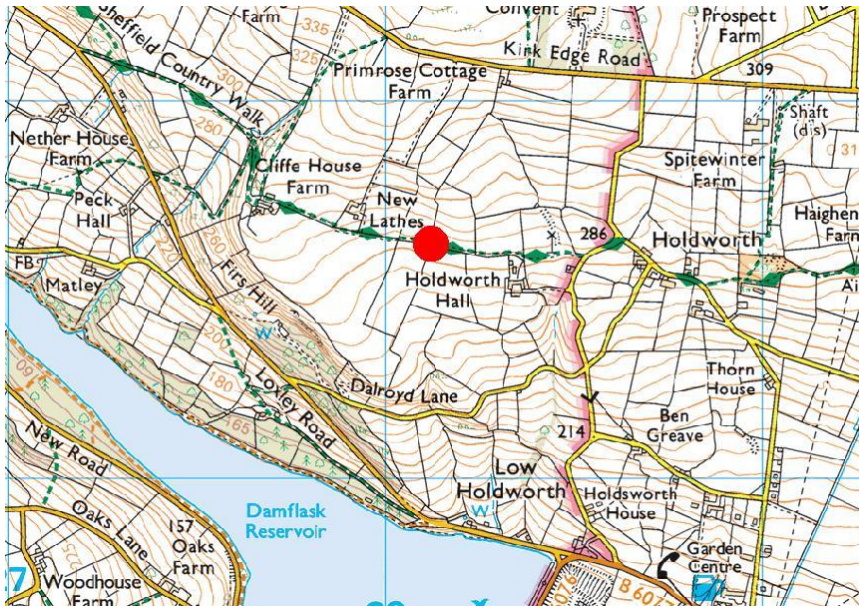
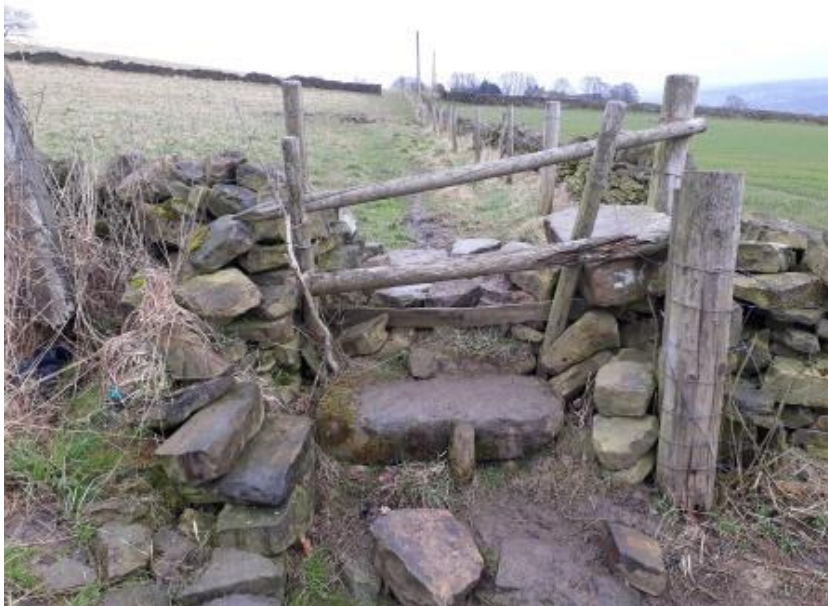
Location 16

Description of existing structure - Poor stile

Install kissing gate in place of stile. Landowner is Hague Farming. Contact Emma Hague, emma.hague@hague.uk.com or tel 0114 283 4970

External contractor to install kissing gate. PDNPA Rangers and volunteers to re-build wall ends

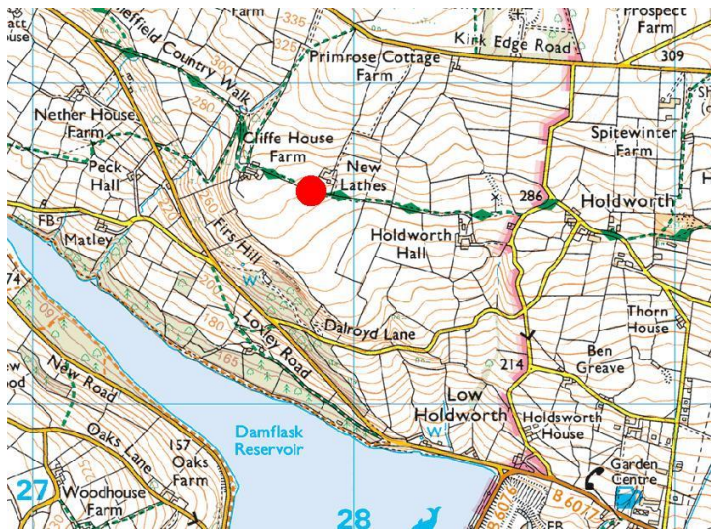
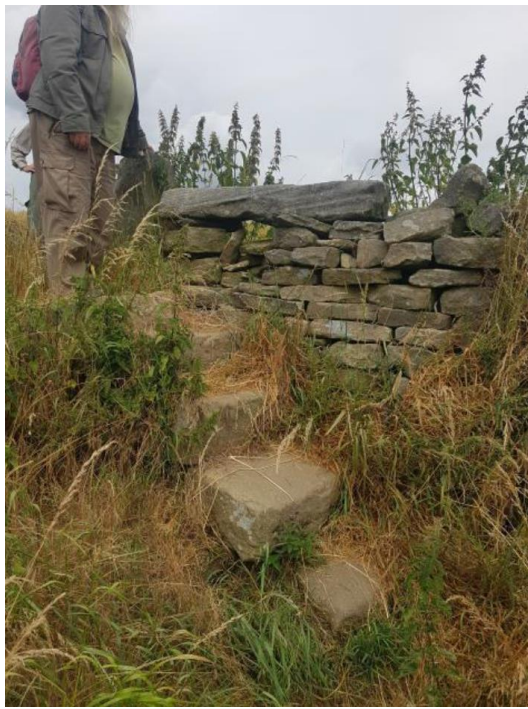
Location 17

Description of existing structure - Steep, worn, sloping steps

Re-build bottom two steps, install timber handrail. Landowner is Hague Farming.
Contact Emma Hague, emma.hague@hague.uk.com or tel 0114 283 4970

PDNPA Rangers and volunteers to re-build bottom two steps. PROW Rangers to install handrail

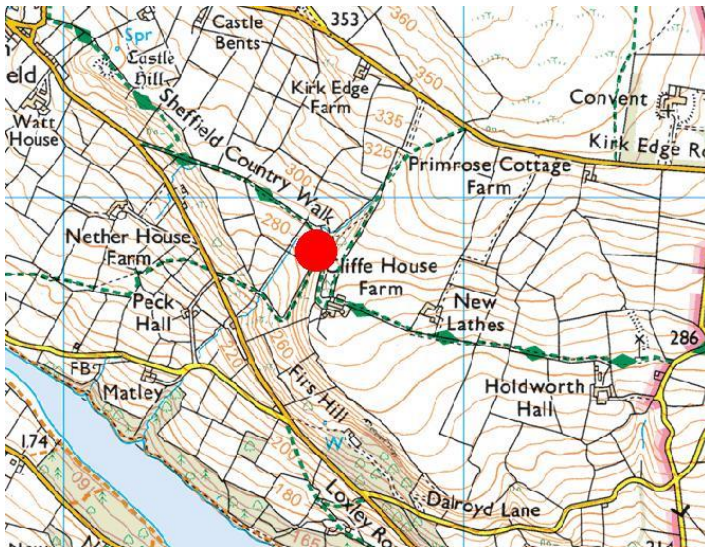
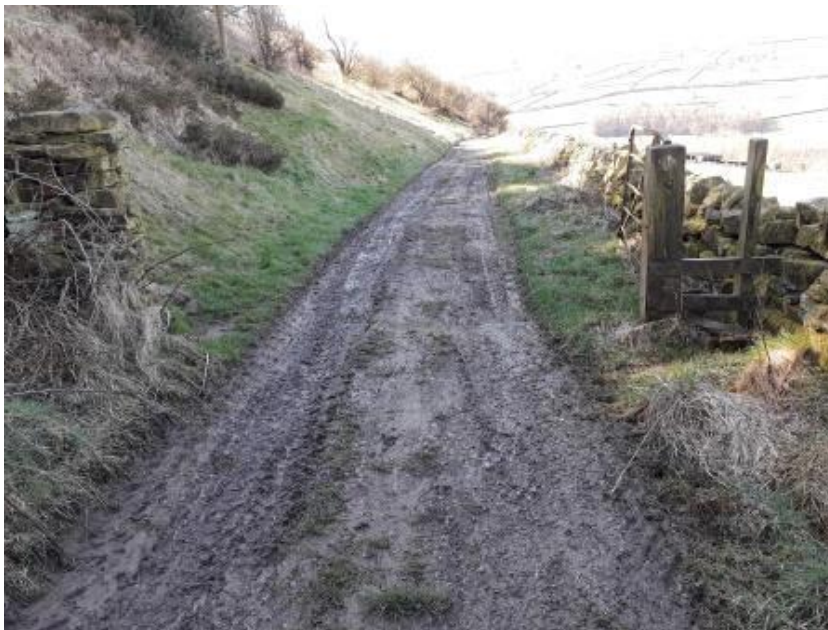
Location 18

Description of existing structure - Broken stile next to propped open field gate

Replace stile step. Landowner is Gordon Hinchcliffe, 23 Hanson Road, tel 07747746845

RA Volunteers to replace stile step. 1 quantity 225mm x 75mm step 1200mm long. 2 quantity 225mm x 75mm supports each 750mm long. 100mm and 125mm galvanised steel nails

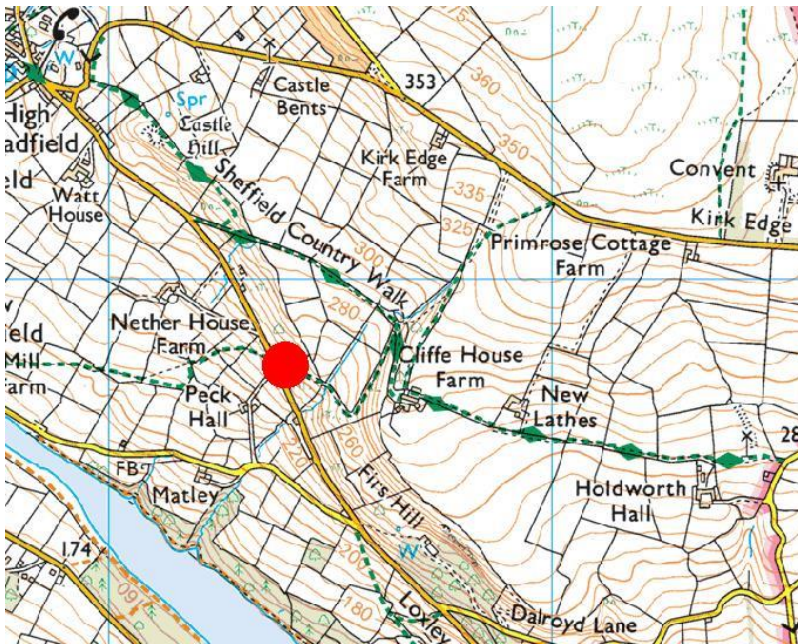
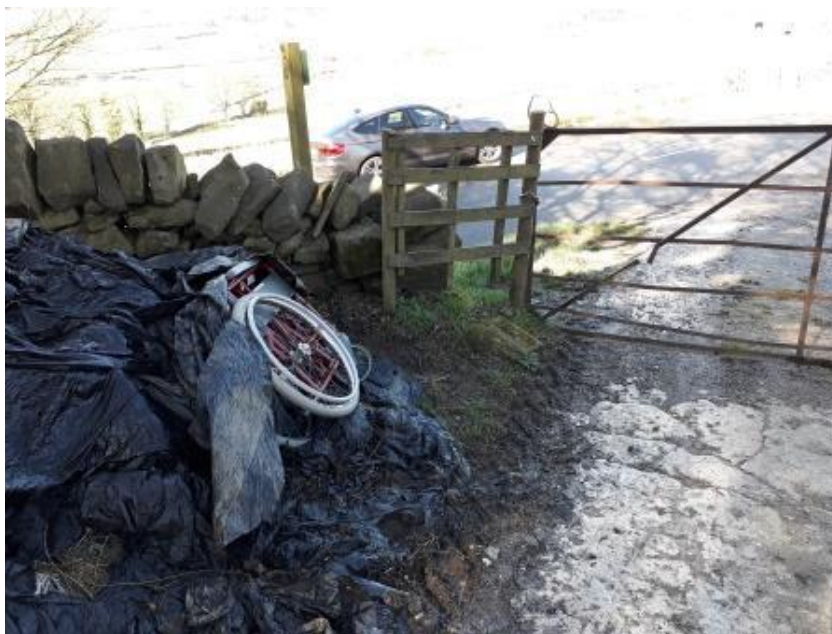
Location 19

Description of existing structure - Blocked stone stile and field gate

Install new slam post to gate and proper catch. Landowner is Gordon Hinchcliffe, 23 Hanson Road, tel 07747746845

PROW Rangers to install new slam post and gate catch

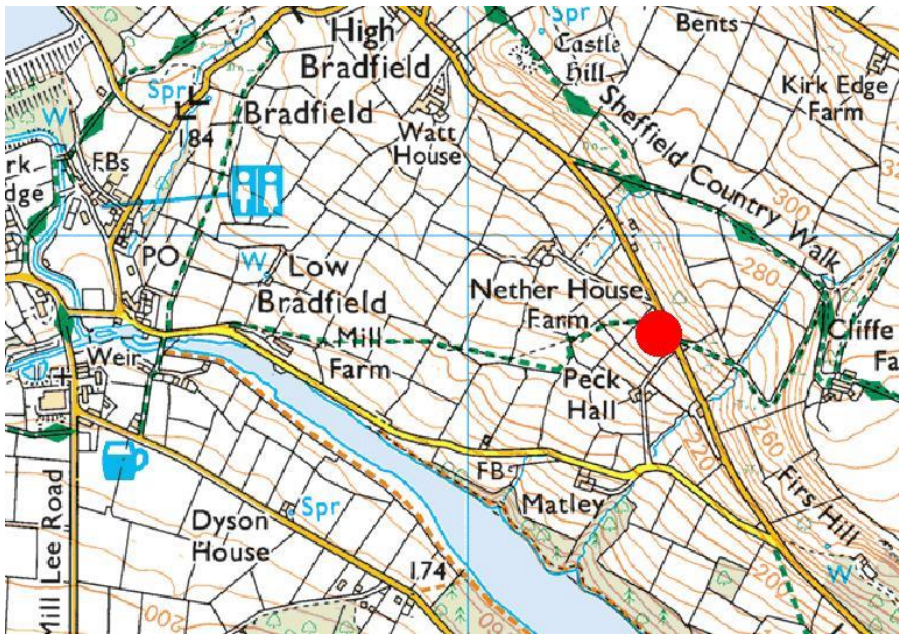
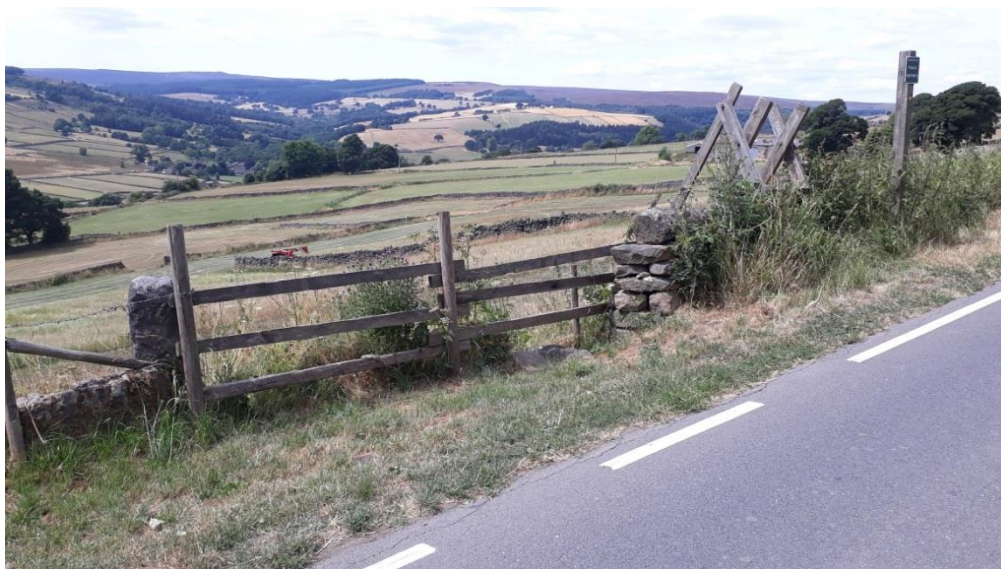
Location 20

Description of existing structure - Ladder stile over wall

Remove ladder stile and install kissing gate in fence next to stile. Landowners are The Shepherds of Rickett Field Farm and Peck Hall Farm sueshep3@btinternet.com and mfshepherd1960@tiscali.co.uk

External contractor to install kissing gate

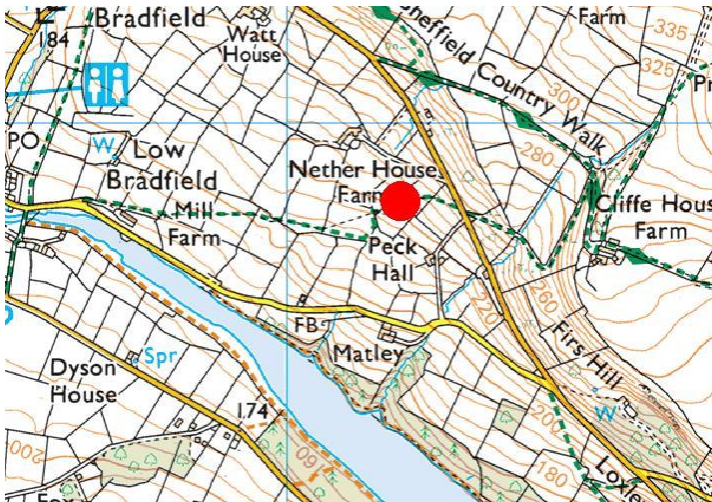
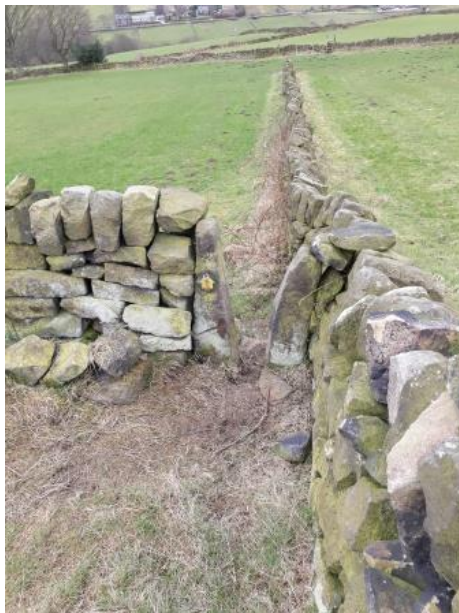
Location 21

Description of existing structure - Stone squeeze stile, difficult to spot from a distance

Clear undergrowth and install tall timber waymark post. Landowners are The Shepherds of Rickett Field Farm and Peck Hall Farm sueshep3@btinternet.com and mfshepherd1960@tiscali.co.uk

RA Volunteers to install 1 quantity 100mm x 100mm x 2400mm square post with chamfered top and add 2 quantity waymark arrows

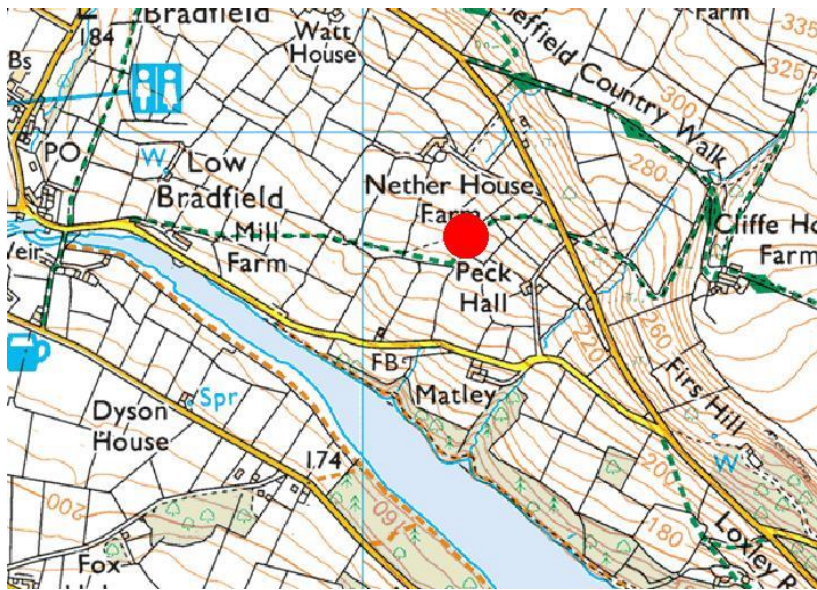
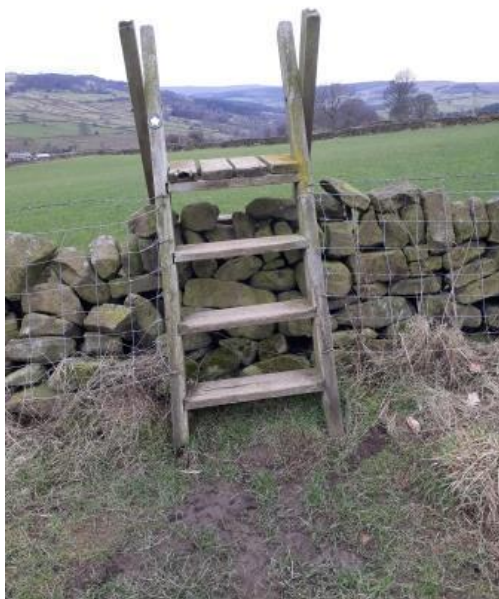
Location 22

Description of existing structure - Ladder stile beginning to rot

Install kissing gate in place of ladder stile. Landowner is Hague Farming. Contact Emma Hague, emma.hague@hague.uk.com or tel 0114 283 4970

External contractor to install kissing gate, PDNPA Rangers and volunteers to re-build wall ends

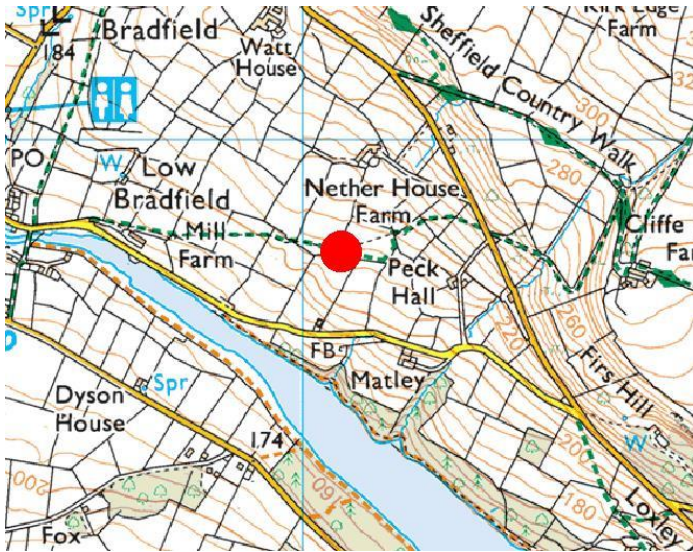
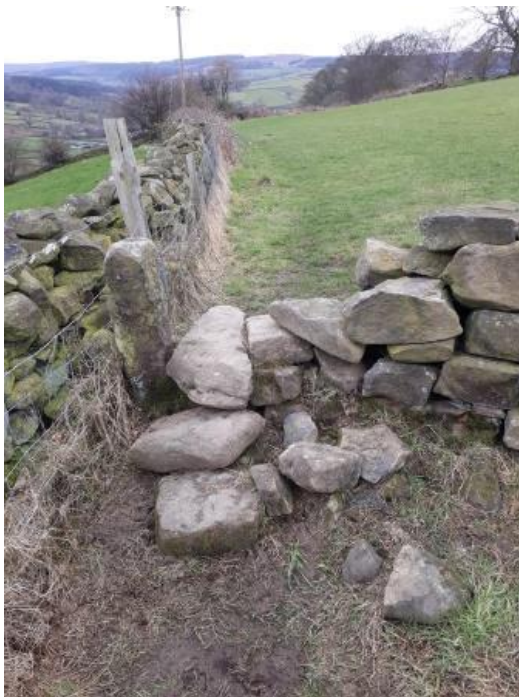
Location 23

Description of existing structure - Wobbly stone stile

Install kissing gate in place of stile. Landowner is Hague Farming. Contact Emma Hague, emma.hague@hague.uk.com or tel 0114 283 4970

External contractor to install kissing gate, PDNPA Rangers and volunteers to re-build wall end

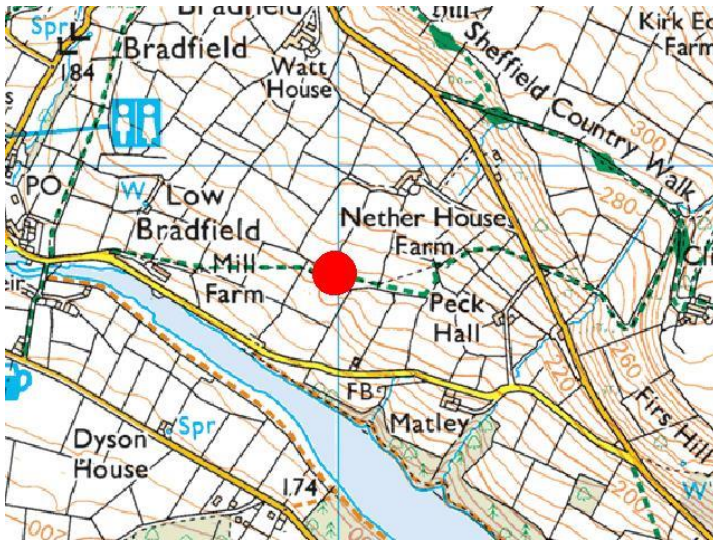
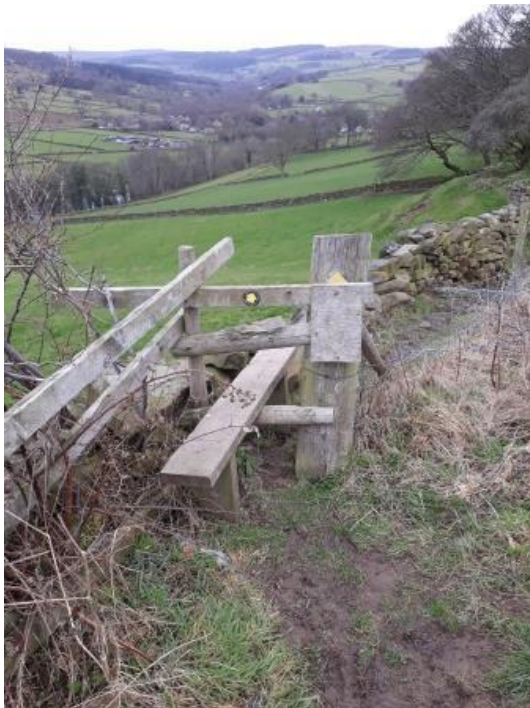
Location 24

Description of existing structure - Wobbly timber stile

Install new timber step over stile. Landowner is Hague Farming. Contact Emma Hague, emma.hague@hague.uk.com or tel 0114 283 4970

PROW Rangers to install new timber step over stile
