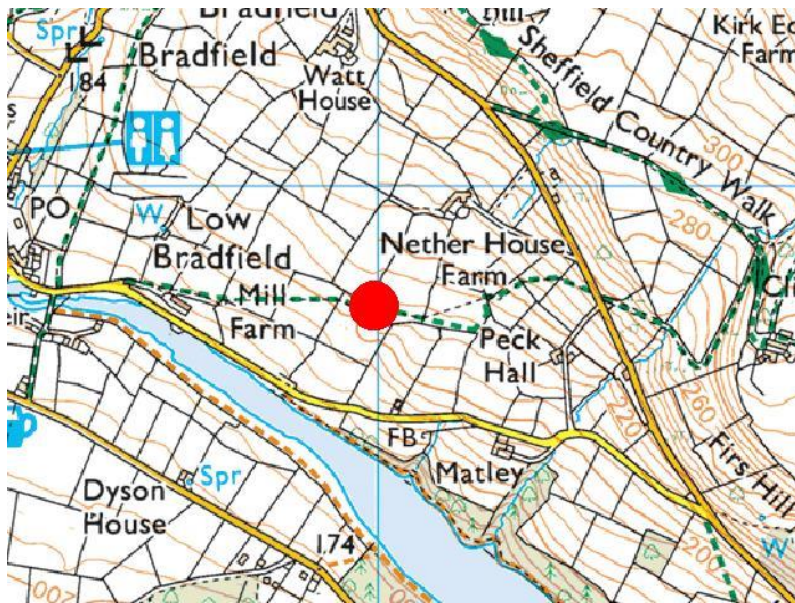
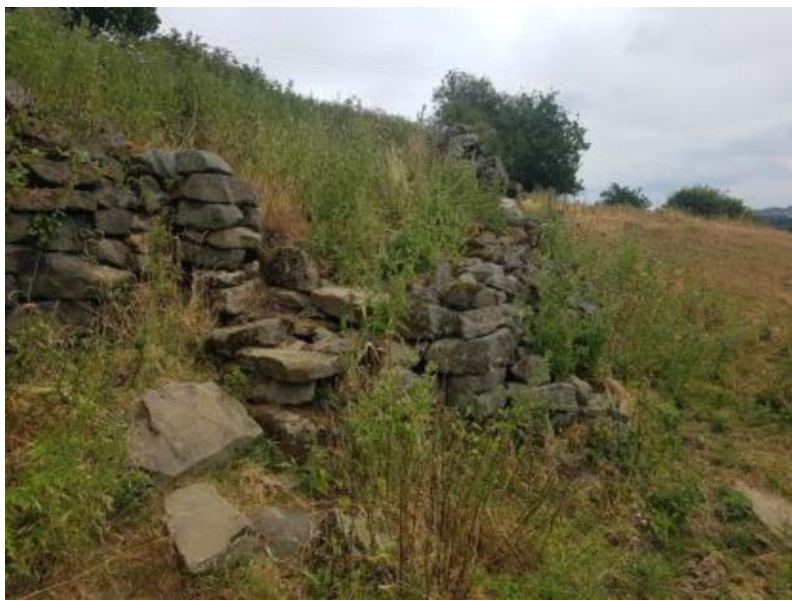
Location 25

Description of existing structure - Collapsed stone stile and length of wall

Clear away redundant length of wall and install timber steps up the slope.
Landowners are The Shepherds of Rickett Field Farm and Peck Hall Farm
sueshep3@btinternet.com and mfshepherd1960@tiscali.co.uk

PROW Rangers to install flight of timber steps

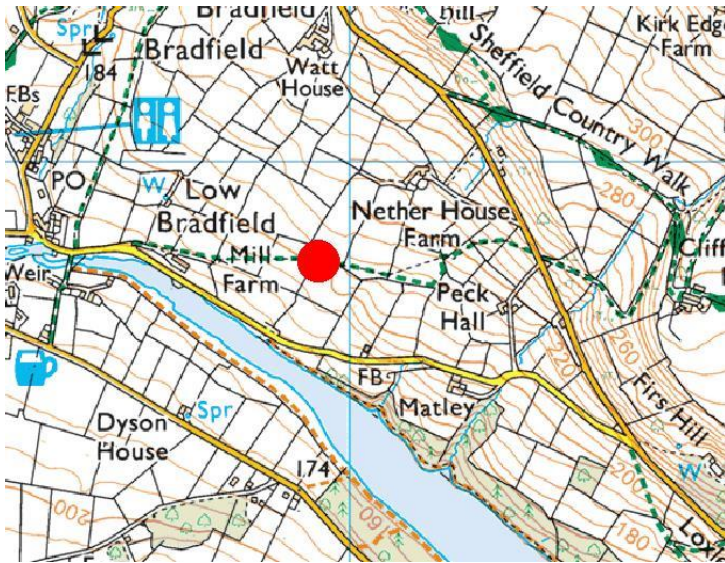
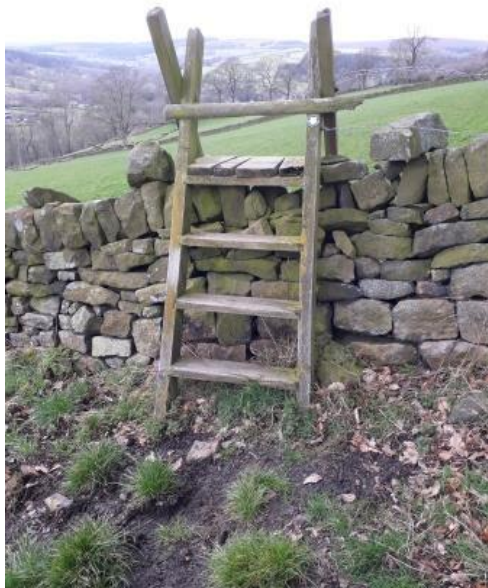
Location 26

Description of existing structure - Ladder stile beginning to rot

Install kissing gate in place of stile. Landowners are The Shepherds of Rickett Field Farm and Peck Hall Farm sueshep3@btinternet.com and mfshepherd1960@tiscali.co.uk

External contractor to install kissing gate. PDNPA and volunteers to re-build wall ends

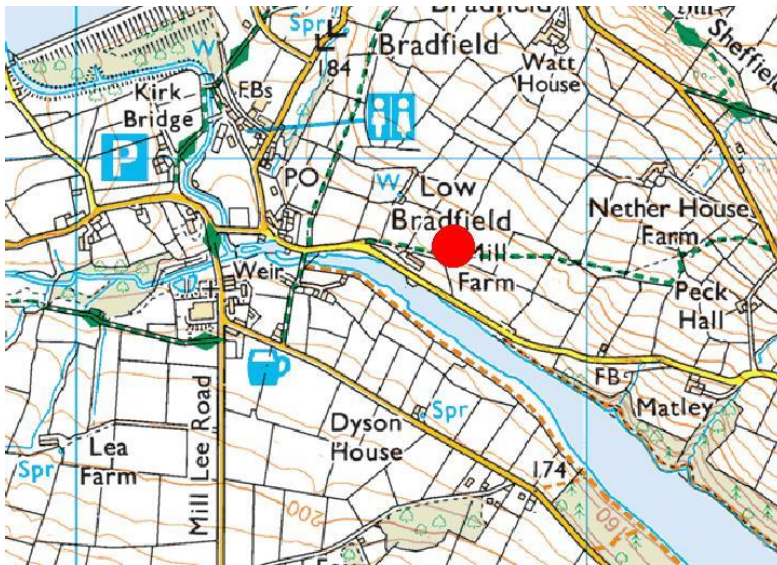
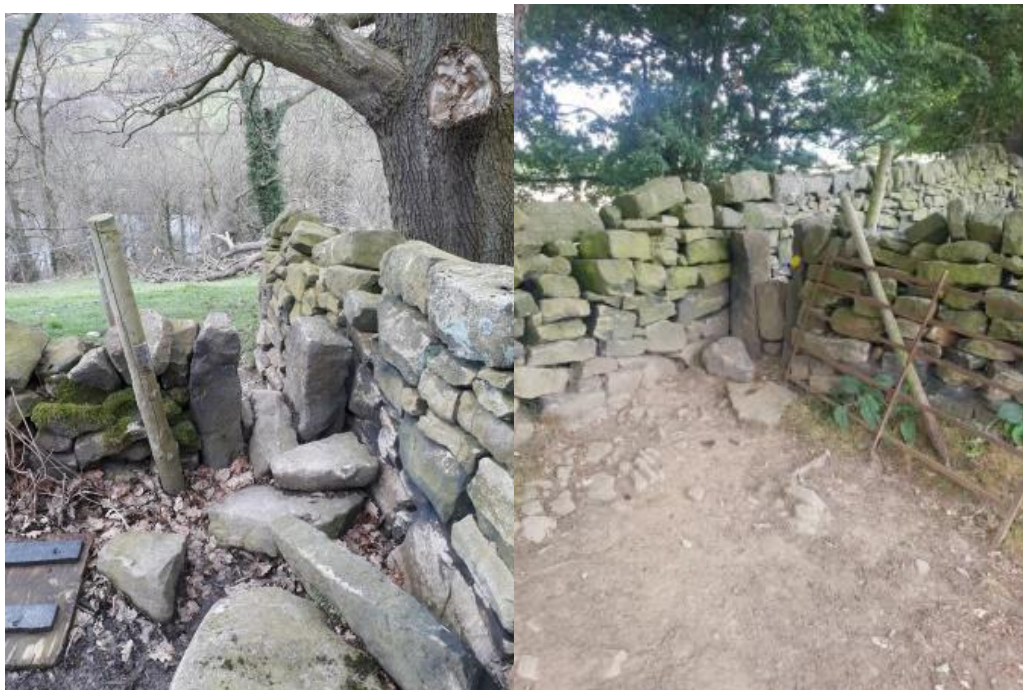
Location 27

Description of existing structure - Partially blocked stone stile

Move large stones, install kissing gate in front of stile and retain ancient stile. Landowners are The Shepherds of Rickett Field Farm and Peck Hall Farm sueshep3@btinternet.com and mfshepherd1960@tiscali.co.uk

External contractor to install kissing gate

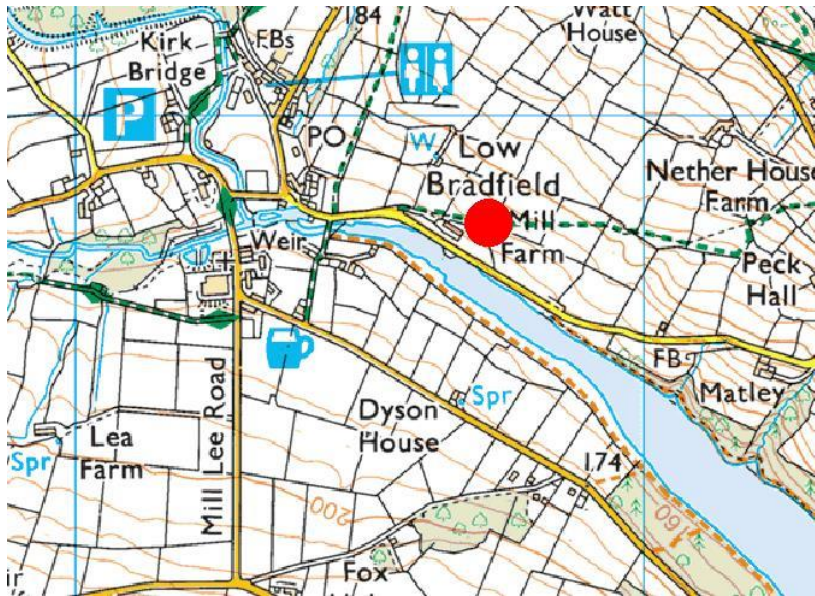
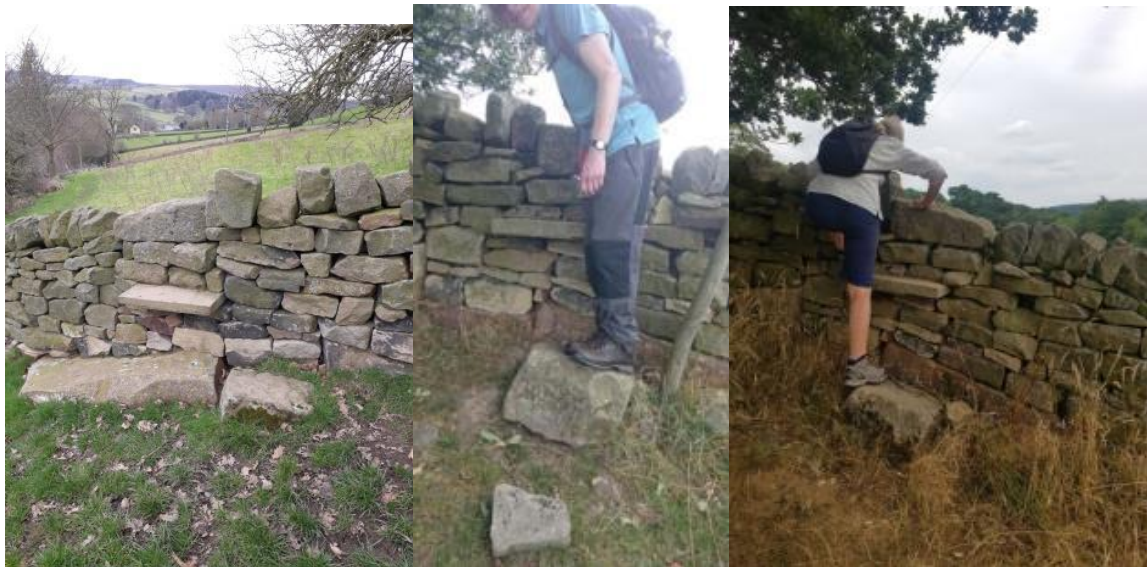
Location 28

Description of existing structure - Very tall stone stile

Install kissing gate in place of stile. Landowners are The Shepherds of Rickett Field Farm and Peck Hall Farm sueshep3@btinternet.com and mfshepherd1960@tiscali.co.uk, and George Hawk, Cross Farm, tel 0114 285 1326

External contractor to install kissing gate. PDNPA and volunteers to re-build wall ends

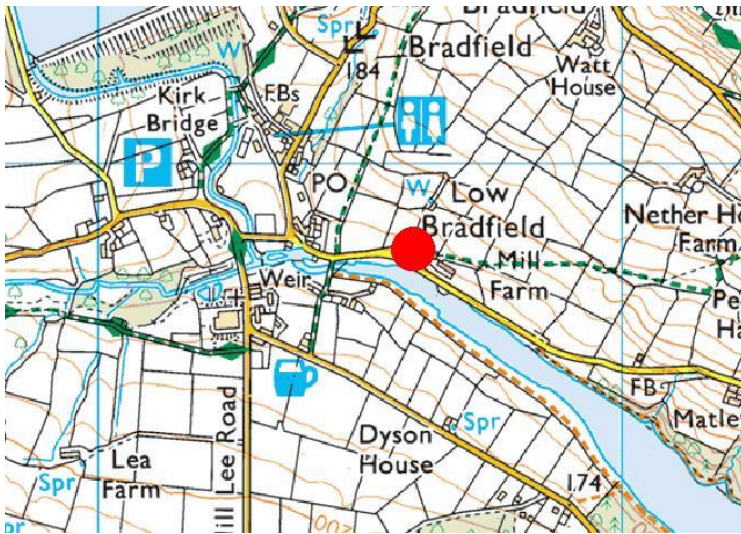
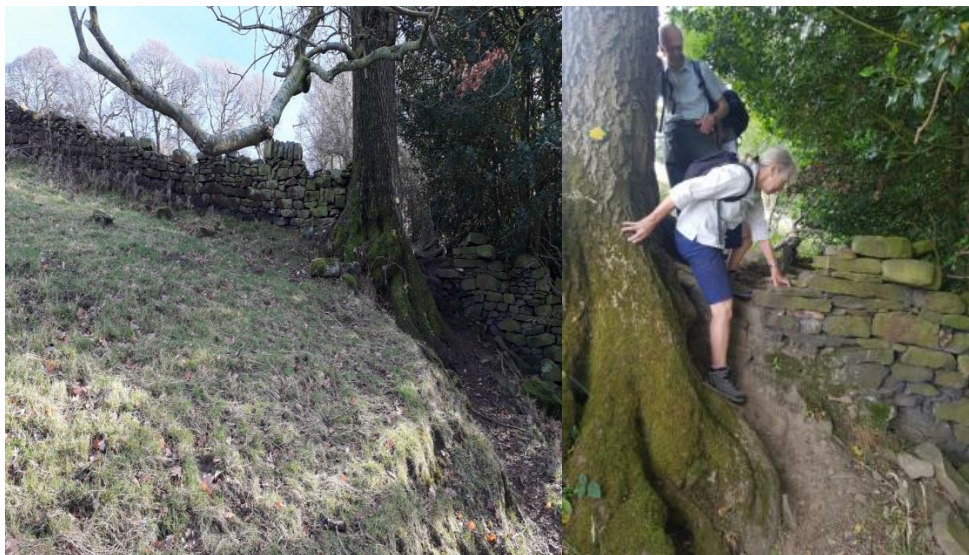
Location 29

Description of existing structure – Collapsing drystone wall and low hanging tree bough

Remove large tree branch, install kissing gate in wall, block up gap below tree with short section of timber fencing. Landowner is George Hawk, Cross Farm, tel 0114 285 1326

External contractor to install kissing gate. PROW Rangers to remove bough and install fence

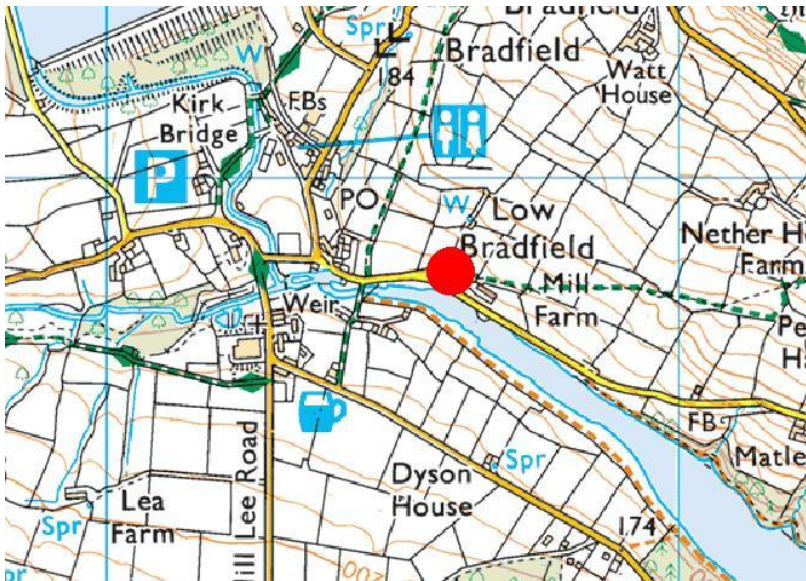
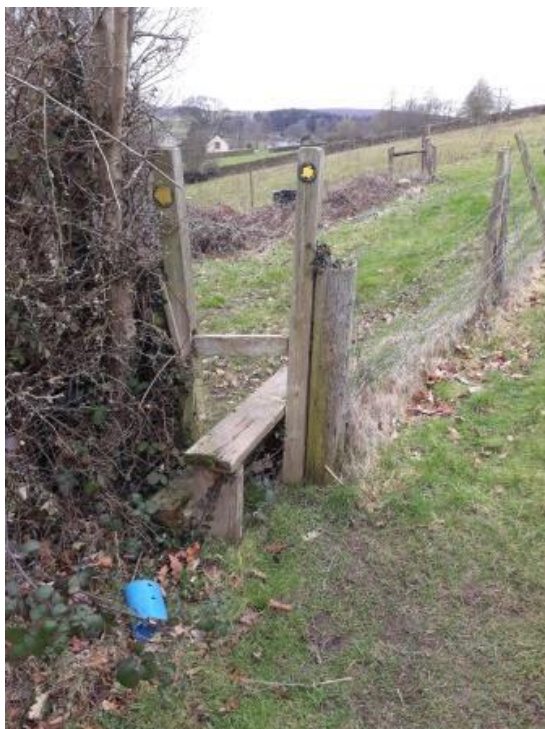
Location 30

Description of existing structure - Timber stile beginning to rot

Install kissing gate in place of stile. Landowner is George Hawk, Cross Farm, tel 0114 285 1326

External contractor to install kissing gate.

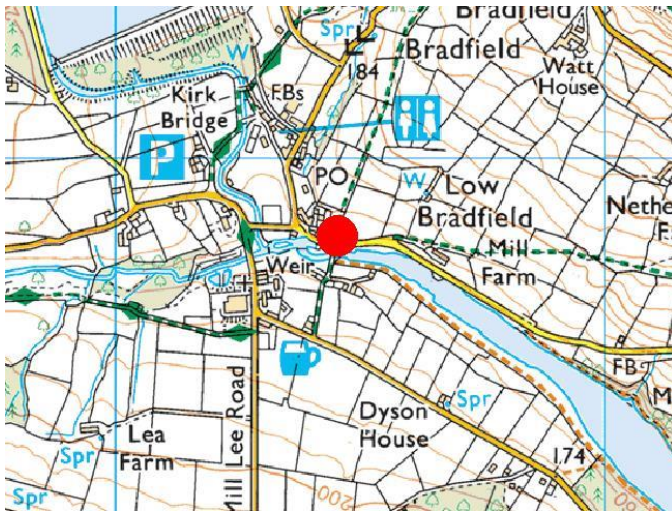
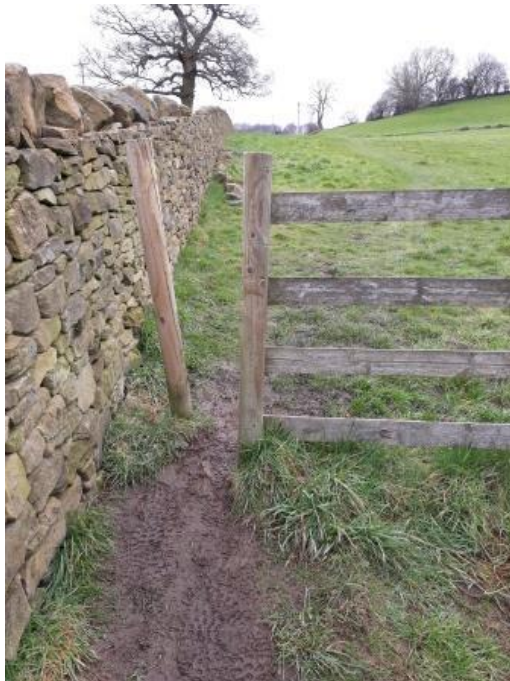
Location 31

Description of existing structure - Narrow squeeze gap

Install kissing gate in place of squeeze gap. Landowner is Mr Russell, Thorn House, tel 0114 285 1227

External contractor to install kissing gate.

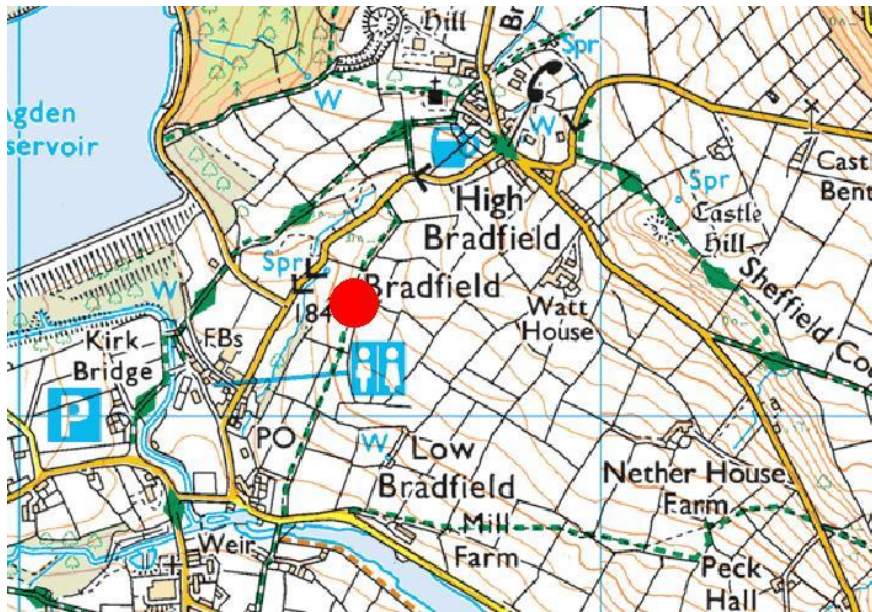
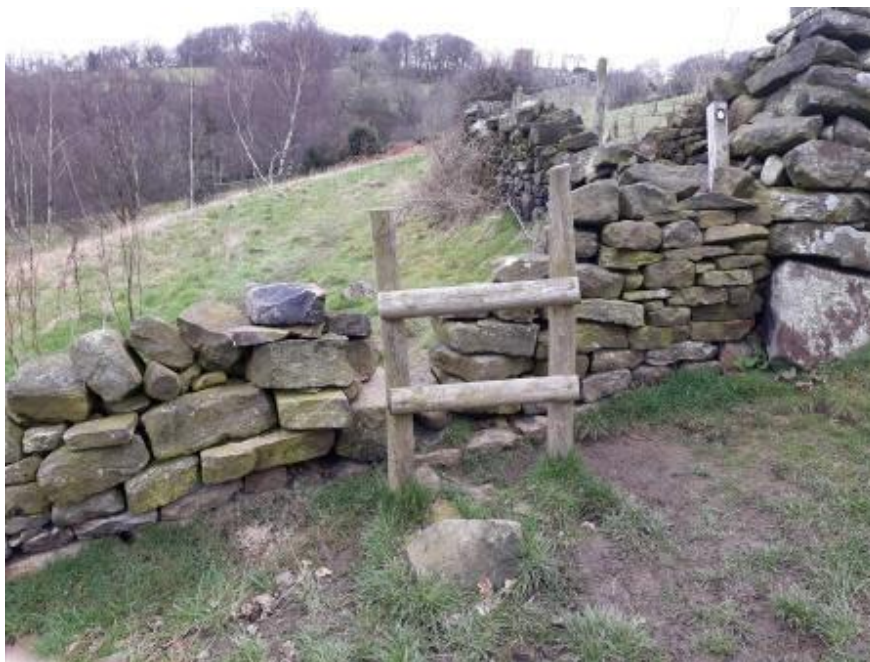
Location 32

Description of existing structure - Blocked stile

Install pedestrian gate in place of existing timber structure. Landowner is Mr Russell, Thorn House, tel 0114 285 1227

PROW Rangers to install pedestrian gate

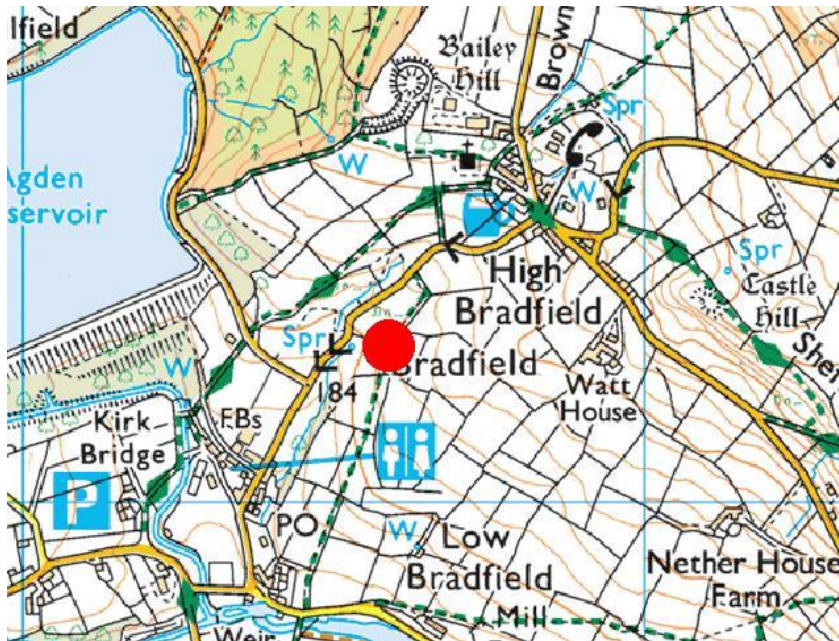
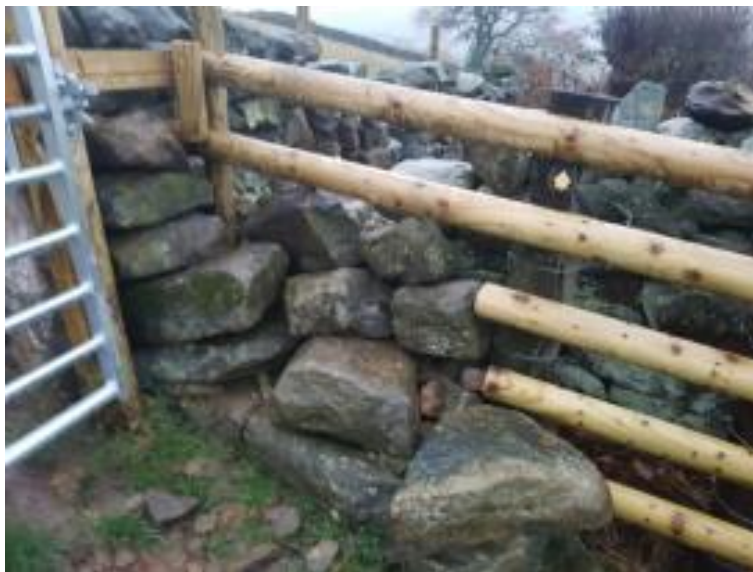
Location 33

Description of existing structure - Blocked stile

Install pedestrian gate in place of timber structure and remove stones from gap.
Landowners are Susan Gill, Watt House Farm, and Andrew Charlesworth, Old Wheel Farm, tel 0114 234 5179

PROW Rangers to install pedestrian gate and remove stones

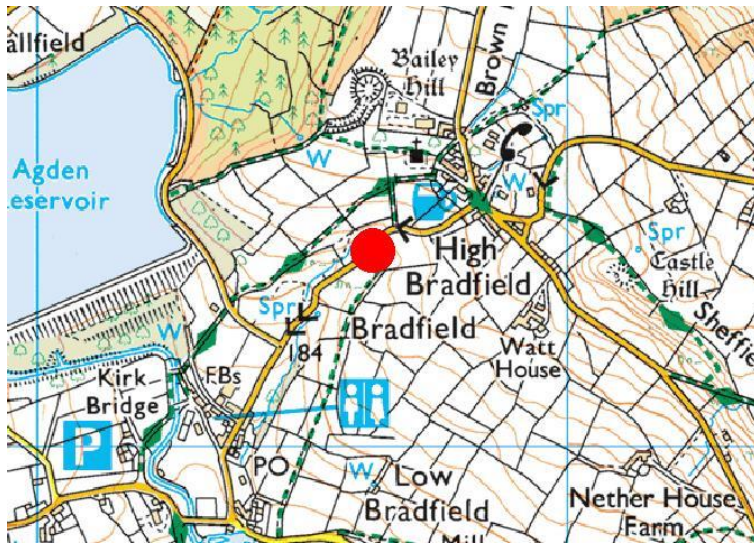
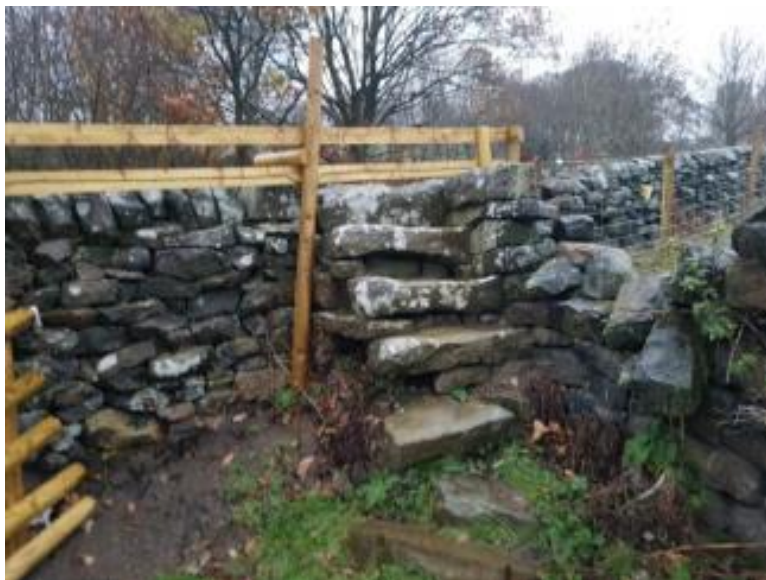
Location 34

Description of existing structure - Very tall stone stile

Install two timber handposts linked by a short handrail. Landowner is Susan Gill, Watt House Farm

PROW Rangers to install handrail on road side of stile. RA Volunteers to install handrail on field side of stile
