**A Review of Redmore Environmental's
Air Quality Monitoring Results
(May 2019), High Lane**

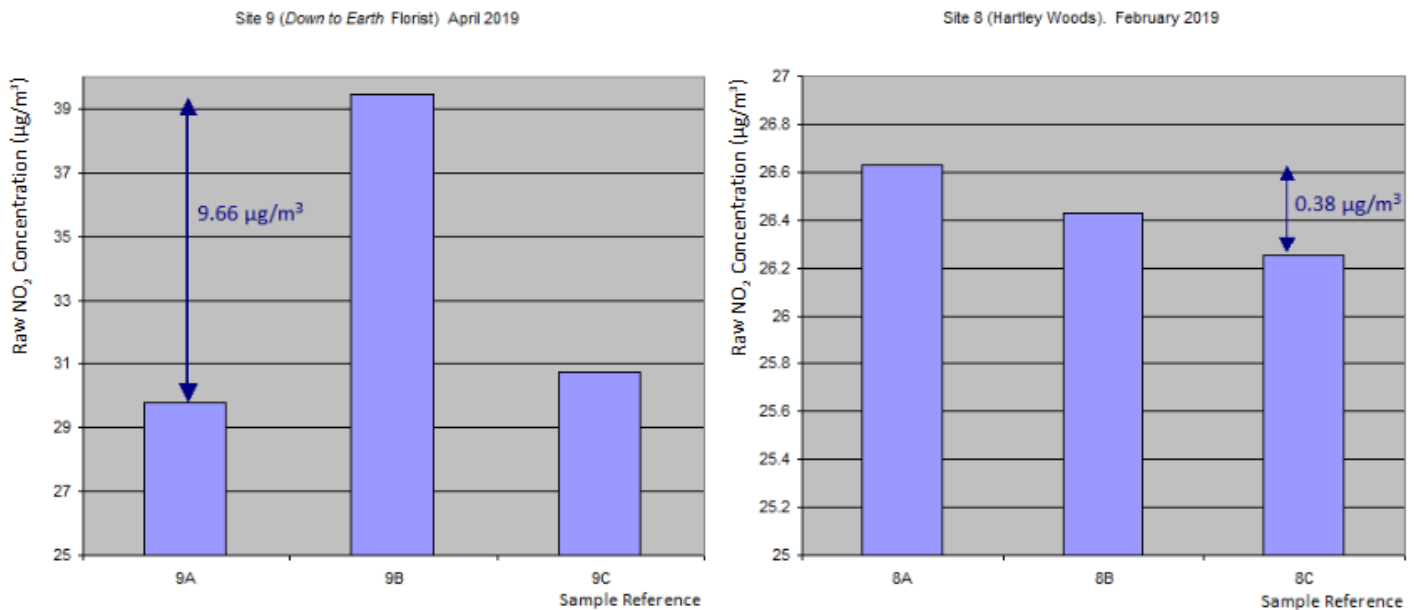
The above plots illustrate the range of readings from the triplicated diffusion tubes. The first set of three are the April 2019 measurements from Location 9 (which show the greatest variation) and the second set are the February 2019 measurements from Location 8 (which show the least variation). With perfect precision, all three values within each set would be completely identical to each other. Obviously, there will be real-world variations from numerous potential sources that mean that perfect precision is unlikely to be achieved in practice, but the more samples that are taken, the better the precision can be assessed. The Redmore study used **three** passive diffusion tubes at each location [ref. 1, paragraph 3.3.1] per month; the Atkins study used only **two** [ref. 2, section 2.0, p. 5 of PDF].
