## Green Flag Award 2021 – Combined Feedback Desk Assessment and Mystery Shop

**Name of Site:** Keston Common

**Managing Organisation:** London Borough of Bromley & Id Verde

# Green Flag Award Mystery Shop Assessment

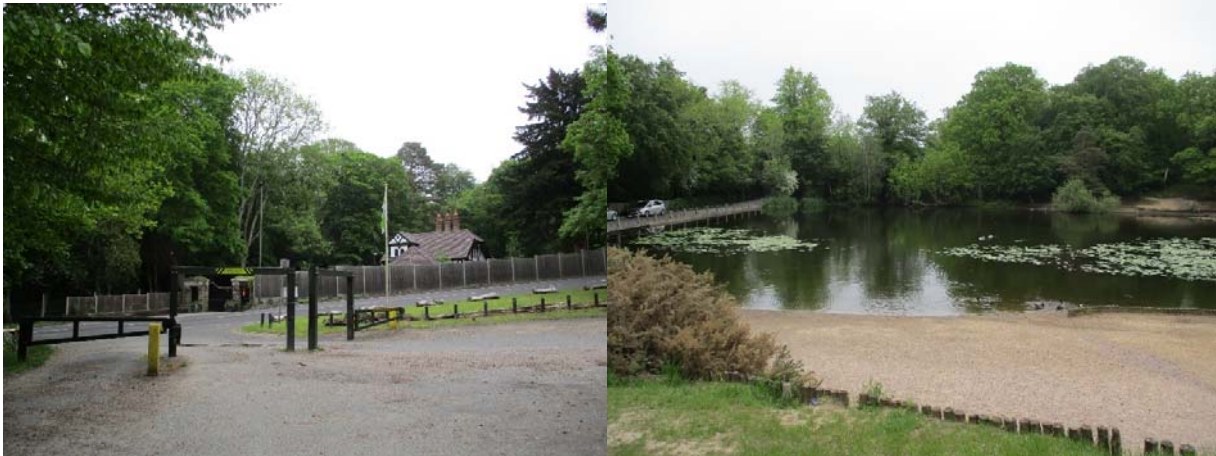
1. Is the site welcoming?	NG	G	A	R	The site, although surprisingly complex in terms of layout and topography, still had a good welcoming effect; this was particularly evident around the main or more popular entry points into the Common such as round car parks and lakes (Figure 1).  However, some edges of the site will need attention and careful opening up, where sightlines and views into it are becoming enclosed or dense.
		X

**Figure 1. Views of Keston Common showing open views into key or more popular areas of site, with open and welcoming views and access to surrounding roads and paths.**

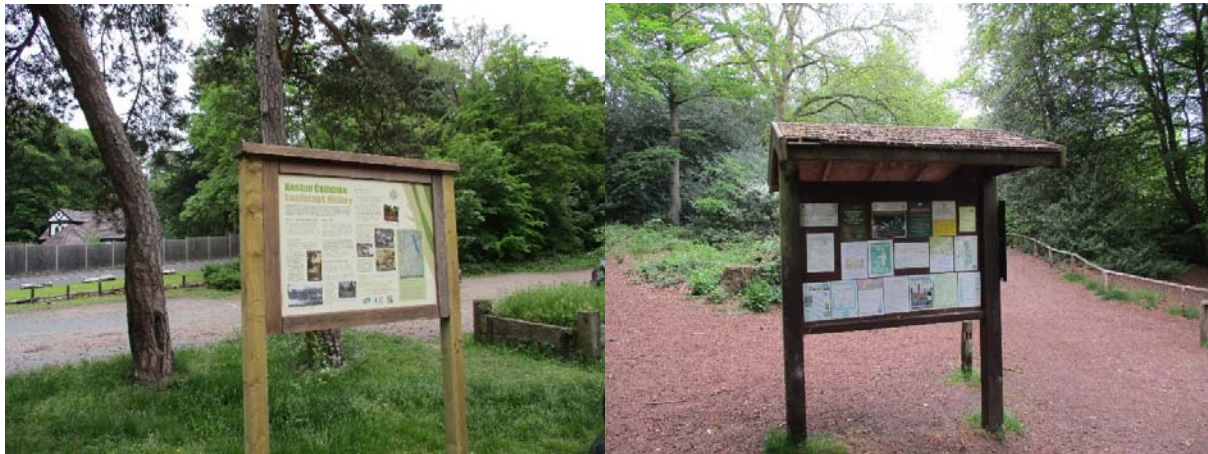
3. Is signage in good condition?	NG	G	A	R	Entrance signage and notice boards around the main or busiest parts of the Common were well located, clean and well maintained, containing relevant and up to date information (Figure 2).  Some of the older on-site interpretative or other information signage was showing its age, with some wooden frames distorted or metal panels showing weathering and discoloration (Figure 3).  Although still perfectly readable and useable, monitor this signage and repair or replace as necessary and as resources permit.
		X

**Figure 2. Examples of entrance signs and notice boards on Keston Common, with relevant information, well located and in good condition.**

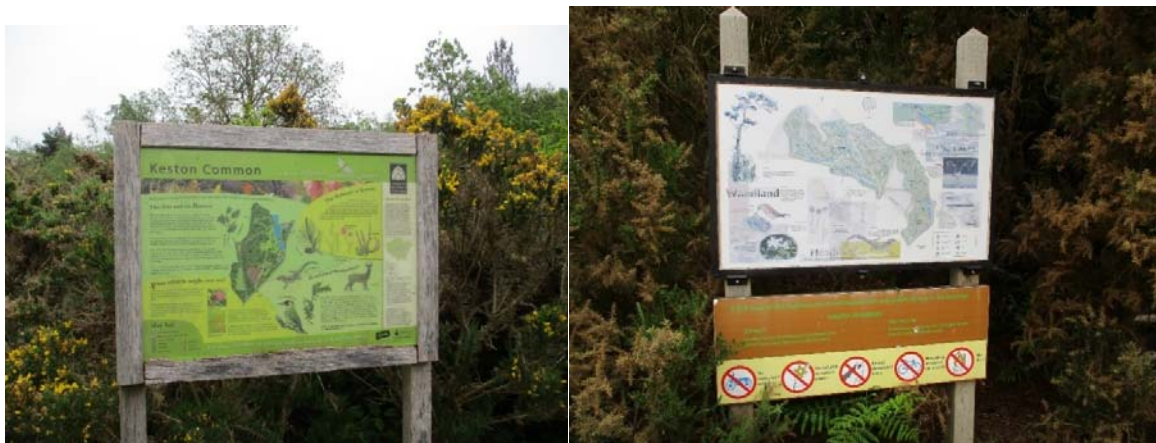
**Figure 3. Examples of other signage on Keston Common, that may require some repairs, cleaning and eventual replacement or upgrading.**

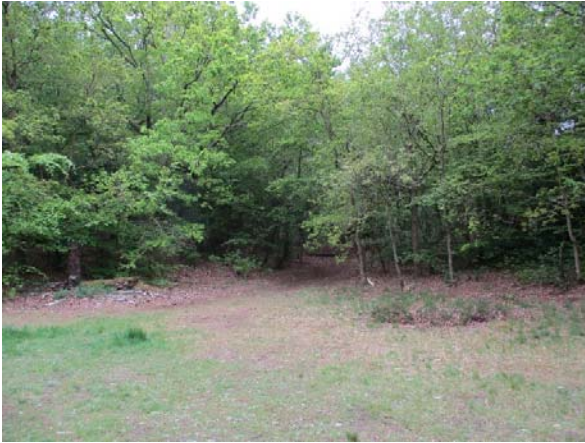
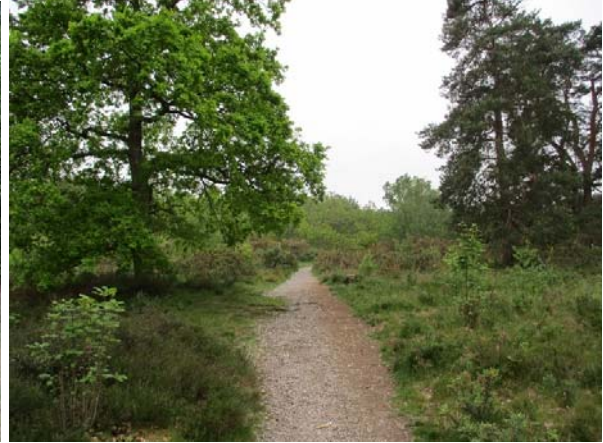
4. Is the site accessible to all user?	NG	G	A		<p>For such a complex site in terms of topography and gradients, it is still relatively accessible for most users and in most key locations, with good low graded paths and open views (Figure 4).</p> <p>There were some old wooden sleeper steps near the main heath area that were in poor condition and deteriorating rapidly (Figure 5). There need repairing or replacement as they pose a growing public safety risk.</p> <p>The recent prolonged periods of heavy rain, combined with heavy footfall, had made some paths around the main ponds boggy and impassable (Figure 6).</p> <p>Hopefully these will sort themselves out with improved weather, but if not then look at temporarily fencing them off and some appropriate intervention to allow them to reinstate themselves and become safer.</p>
		X			
<b>Healthy, Safe and Secure</b>

**Figure 4. Examples of good accessibility to key areas on Keston Common, with well graded and level paths or appropriate views and entrances.**

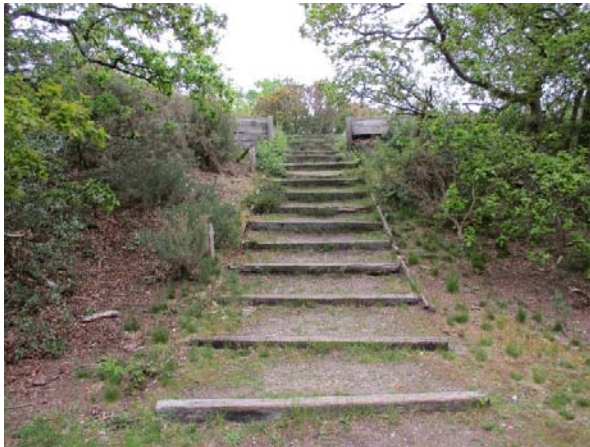
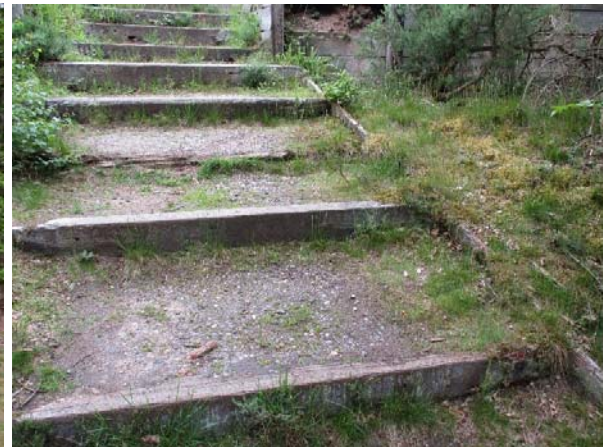
**Figure 5. Degrading wooden steps on part of Keston Common, which pose a growing accessibility issue for less abled users.**

11. Are buildings and infrastructure such as walls, paths, steps and structures in good condition?	NG	G	A	R	<p>Generally the management and maintenance of key facilities, including paths, bridges, walls and steps is good. However, some steps and pond banks will need repair or replacement (Figures 5 and 8), so these should be prioritised for action and resolution if possible.</p>
		X

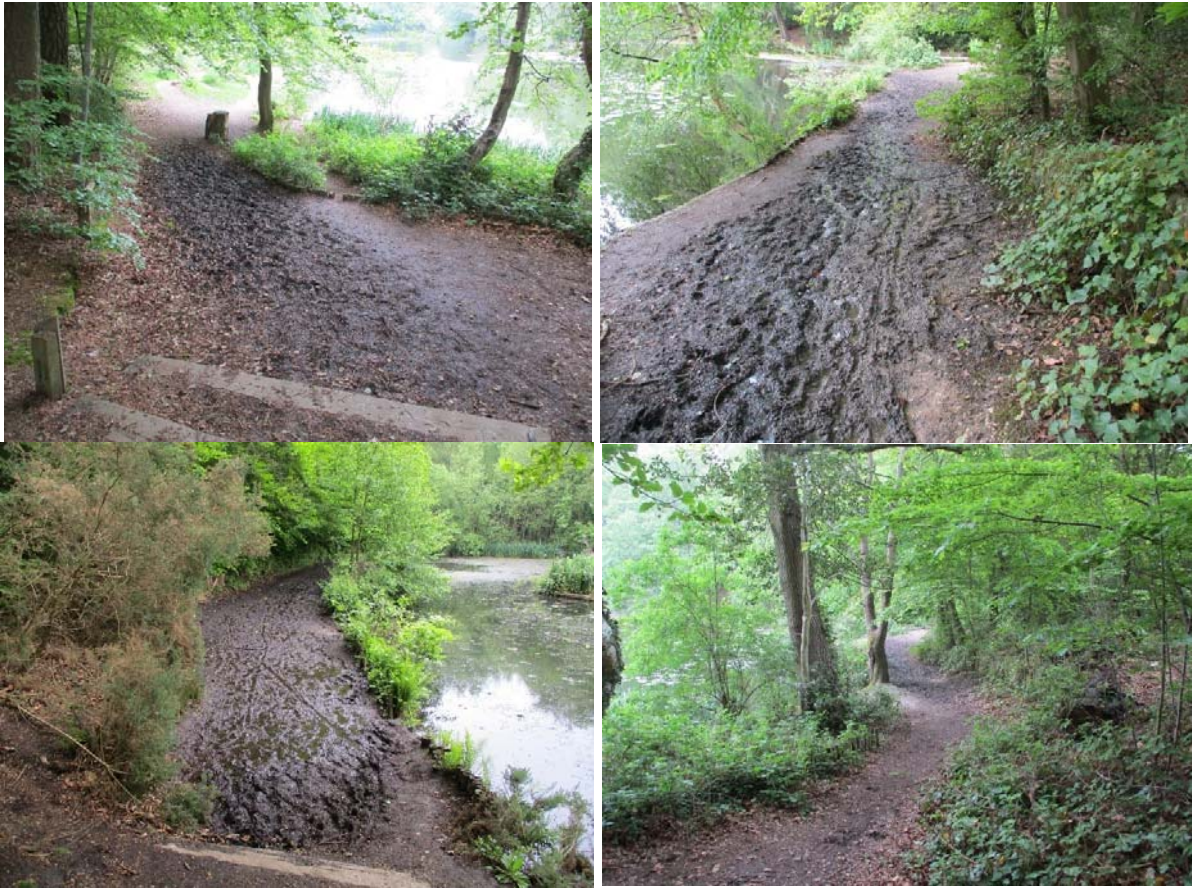
**Figure 6. Sections of natural surfaced paths around edges of ponds on Keston Common, which although due to the recent prolonged wet weather, will need careful monitoring and attention.**

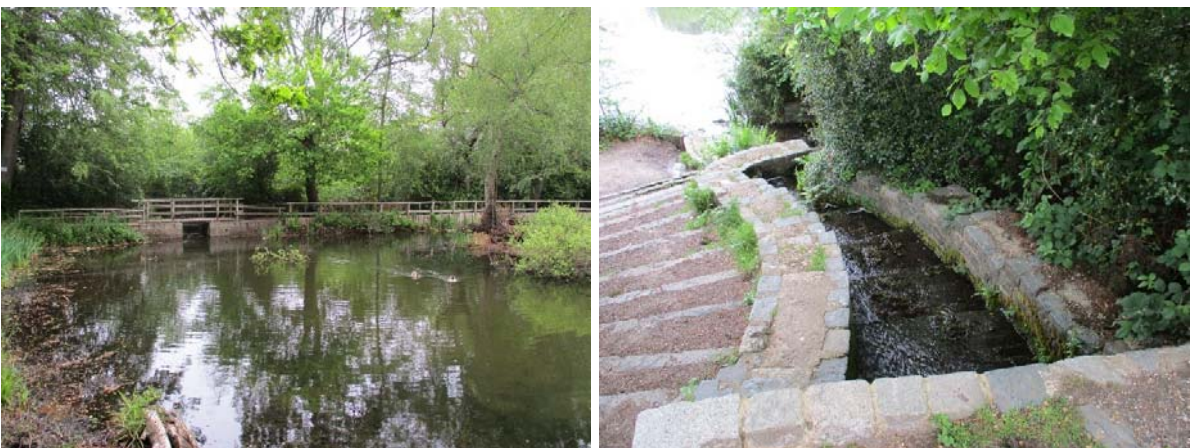
5. Are facilities on site in good and safe condition?	NG	G	A	R	<p>Most of the fixed infrastructure on the Common was secure, sound and in good condition, especially walls, bridges, fencing, pond cascades and most pond edges (Figure 7).</p> <p>There was a section alongside the western edge of the upper (southernmost) pond, where the bank was continually eroding and collapsing into the pond, which was also affecting the path (Figure 8).</p> <p>This is something that won't be easy to resolve or find an immediate solution to, but consider a number of temporary or stopgap measures to help divert path users, fence off the bank and install new revetments or bankside planting so it can be allowed to reinstate and be less of a safety and access risk.</p>
		X

**Figure 7. Examples of infrastructure on Keston Common, which are heavily used by the public and are being well maintained.**

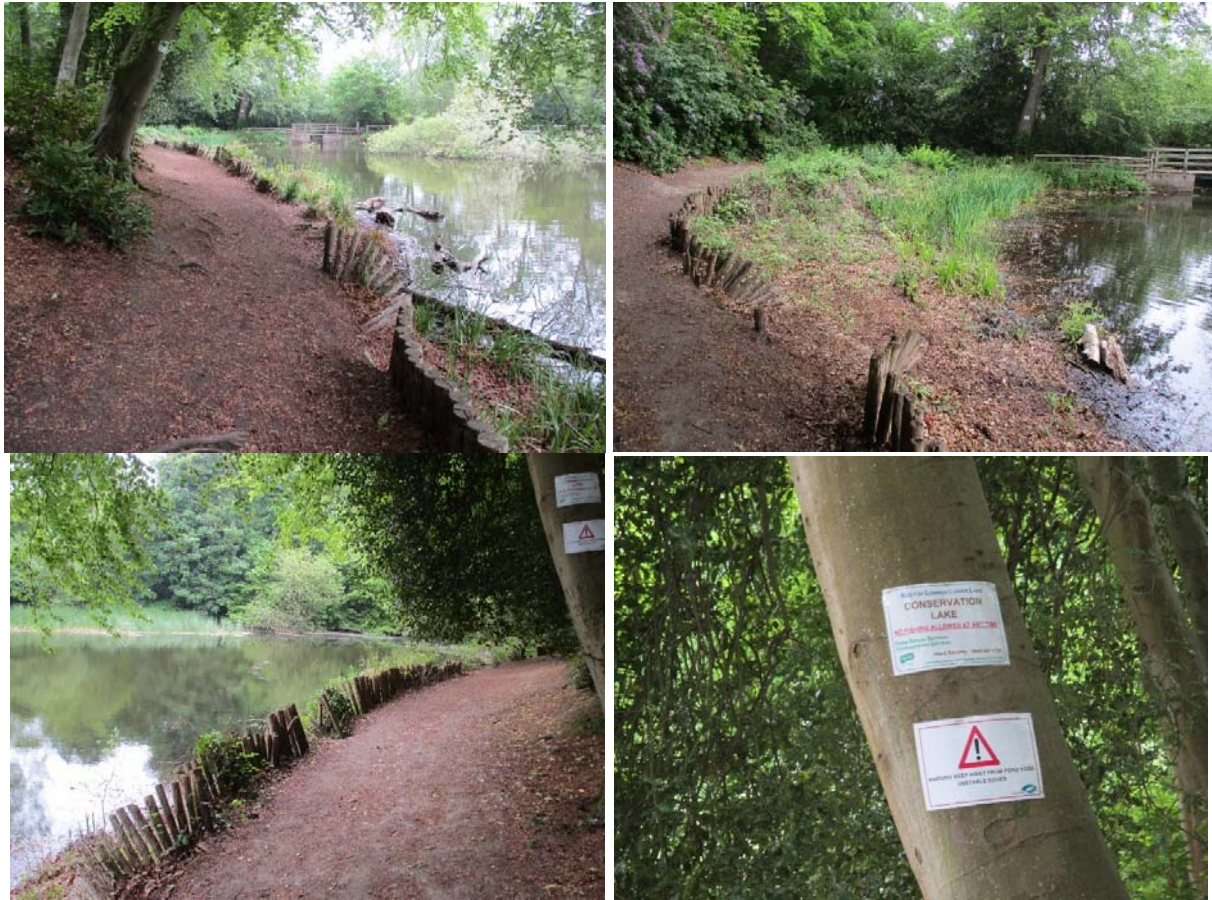
**Figure 8. Sections of path alongside the western side of the upper pond, which is suffering from continual erosion and progressive bank collapse into the pond.**

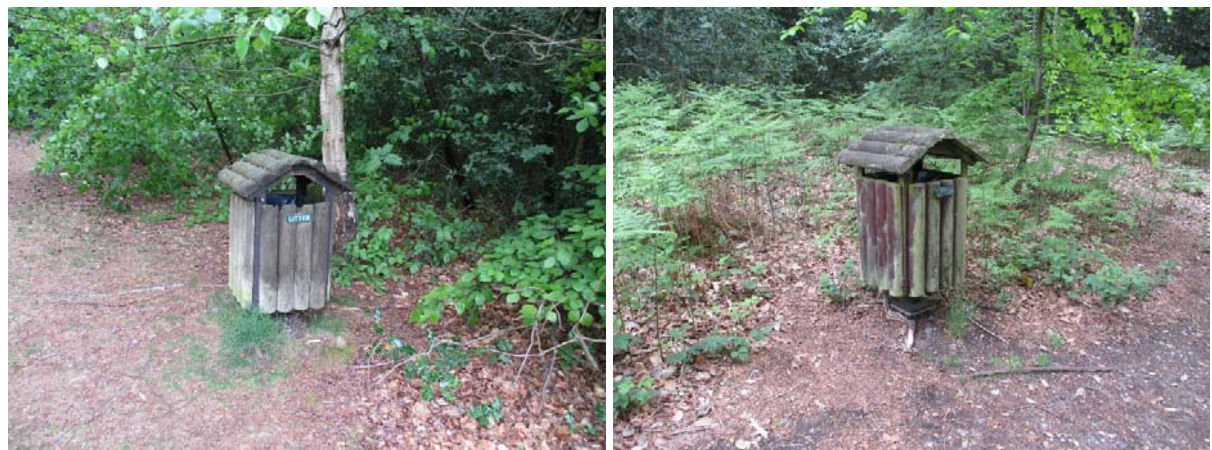
Well Maintained and Clean					
8. Is litter, waste and recycling managed?	NG	G	A	R	<p>Litter and waste management across the site was very good, and there was no evidence of waste build up. Recycling was being promoted on signage and notice boards and to take litter home where possible.</p> <p>Some of the older wooden bins are looking a bit tired and might not be in the best locations as user patterns change (Figure 9), so consider replacing with larger or more durable bins and in alternative locations, as and when resources allow.</p>
		X

**Figure 9. Ageing wooden litter bins on Keston Common, which may need replacement and or relocation depending on changes in how the public use the site or further deterioration.**

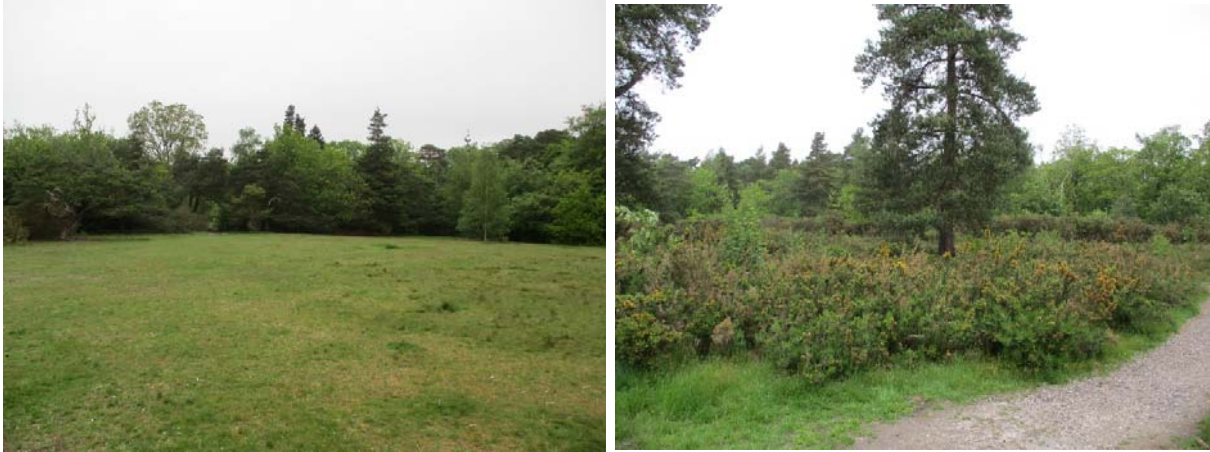
9. Is there a good standard of horticulture maintenance?	NG	G	A	R	<p>Not a site that has any formal horticultural assets, so the management is focused on maintaining a diversity of natural and semi-natural habitats to conserve biodiversity and landscapes. The style and level of such maintenance was appropriate and acceptable, and is promoting key habitats like woodland, heathland and meadows (Figure 10).</p>
		X

10. Is there a good standard of arboriculture maintenance?	NG	G	A	R	<p>A very complex site in terms of its tree cover and diversity. The style and management of tree and hedge maintenance is good, and is focused on keeping key entry and access points/routes open and safe, and preventing encroachment of trees onto sensitive open habitat, e.g. heathland (Figure 10).</p>
		X

**Figure 10. Examples of appropriate standards of horticultural maintenance on Keston Common, which is focused on protecting and improving a range of natural habitats and landscapes.**

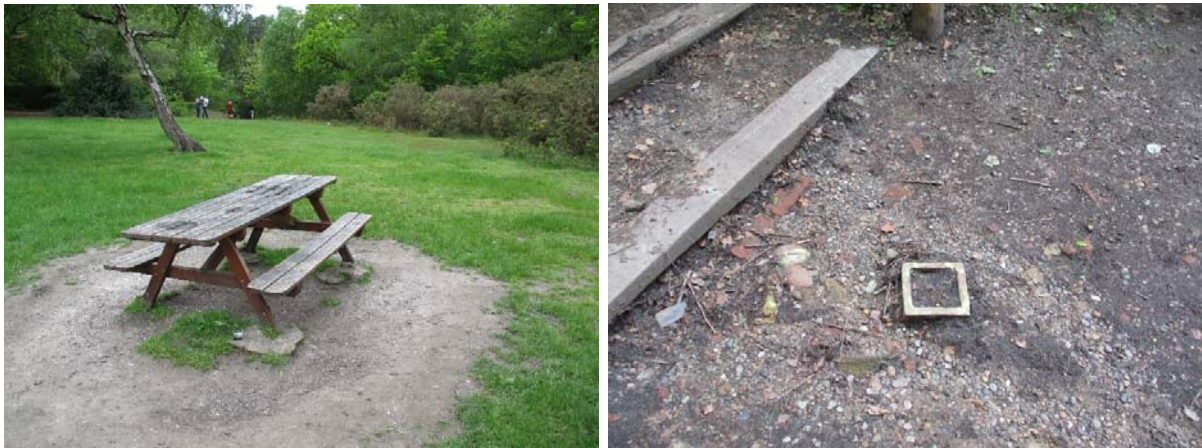
12. Is equipment used by the public and staff in good condition?	NG	G	A	R	<p>Most equipment in use by the public are in good condition. However, one or two wooden benches show signs of BBQ and/or fire damage (Figure 11) so these need monitoring and/or repair or replacement if they get damaged further.</p> <p>There were some exposed old water hydrant or valve housings near steps to the eastern side of the upper pond, which need removing or covering over/reinstatement as these are a growing public safety risk (Figure 11).</p>
		X			
Environmental Management

**Figure 11. Furniture or features used by or accessible to the public that may need repair or removal/replacement, including fire-damage bench and exposed hydrant cover near steps.**

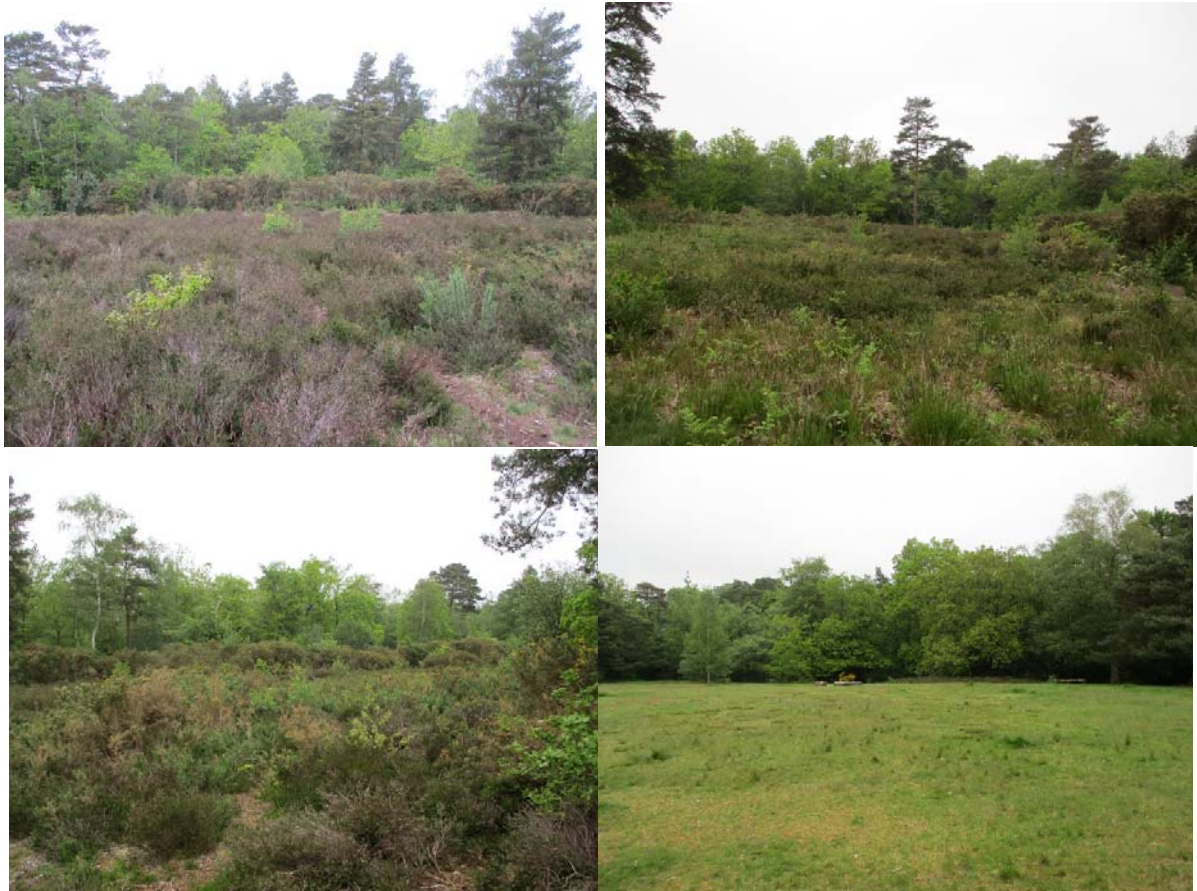
13. Is there evidence that the site is managed to have a positive impact on the environment?	NG	G	A	R	<p>Excellent approach to the protection, retention and management of key wildlife habitats on the Common, especially the restored areas of open heathland, meadows and acidic grassland (Figure 12).</p> <p>Plenty of evidence that greenwaste from conservation operations is recycled on site and used as mulch or to provide dead hedges or wildlife ground cover.</p>
		X

**Figure 12. Views of progressive, appropriate and sensitive wildlife habitat management on Keston Common, including heathland, scrub, grassland and meadows.**

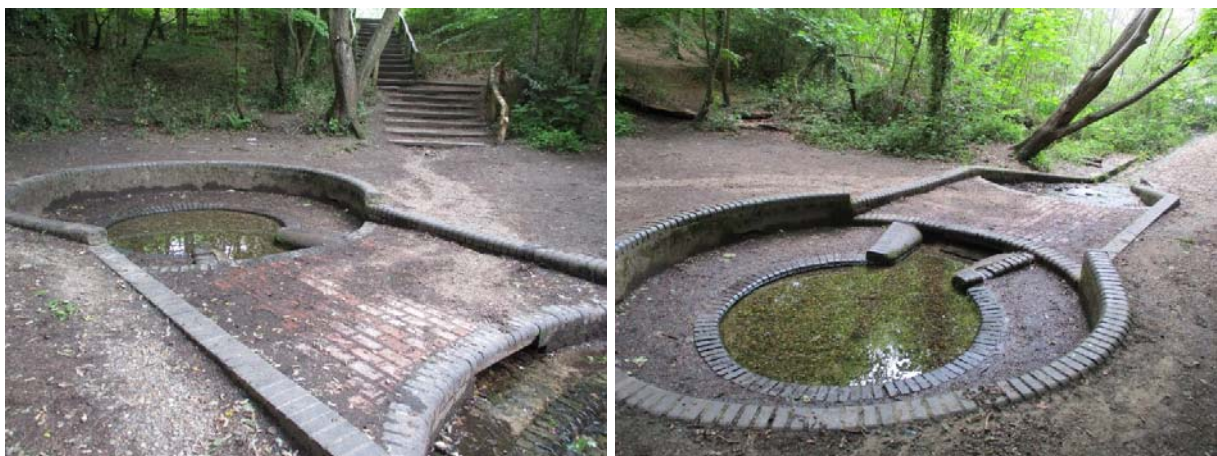
Landscape and Heritage					
14. Are heritage and/or landscape features in good condition?	NG	G	A	R	<p>The management plan recognises the need to protect and conserve a number of important landscape and heritage features; it was evident that these priorities are being delivered on site, e.g. restoration of Caesar's Well and hidden archaeological features.</p> <p>However, the Well would welcome some appropriate interpretation signage beside it, to help explain it and its recent restoration.</p> <p>Management of key habitat compartments is also protecting important landscapes, especially open views into and across meadows and open grassland.</p>
		X			
Community Involvement

**Figure 13. Views of the restored Caesar's Well spring, a key heritage feature, with central gravel bed and surrounding brickwork.**
