# *Archaeological Remains near The Grange, Northwood*

by Simon Morgan

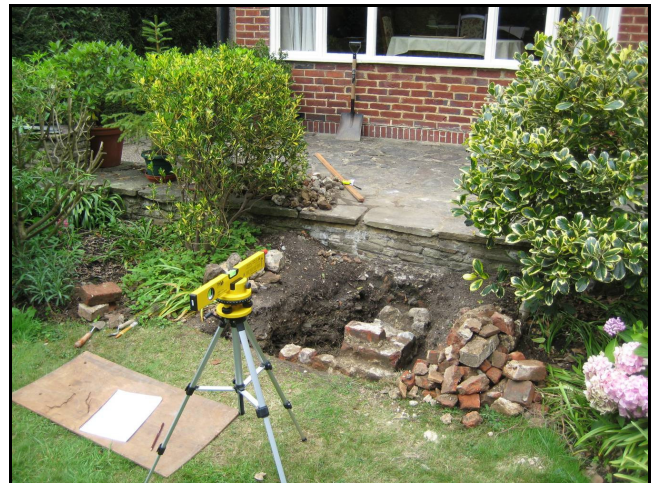
**Excavation and surveying in progress  
See Figs 1 and 2**

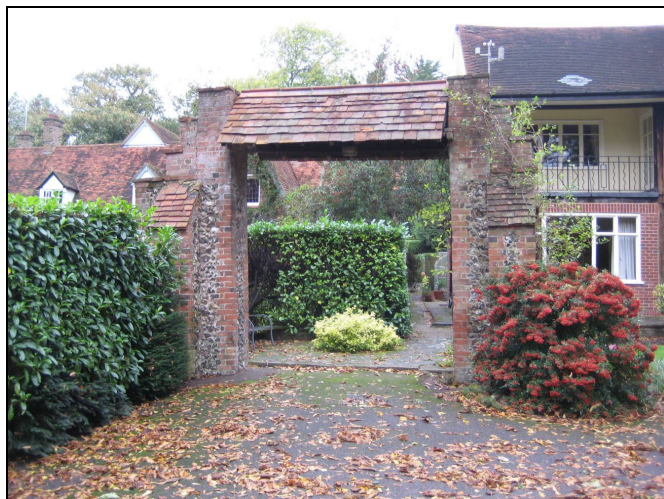
**Fig. 3 - The archway that spanned the 19th century drive to The Grange, with Green Close (left) and Westwood behind**

Surveying with a laser level indicated that the excavated wall was, to the accuracy of the survey ( $\pm 3$  degrees), orthogonal to the pillars of an archway (Fig. 3) standing in the front garden of Westwood. This arch spanned the main approach to The Grange in the late 19th century and possibly earlier. It is of uncertain date and constructed mainly of flint with brick dressings. It is therefore of very similar construction to the excavated wall, with bricks of a comparable size and colour.

The roof of the arch is modern as are brick extensions to the tops of the pillars that give it a total height of 4.1 m. The older flint construction

extends to 2.7 m above ground level, indicating that the height of the original construction was at least this.

There seems little doubt that the excavated wall was connected to this arch, particularly in view of the rough nature of the arch's eastern face, indicating that adjacent masonry was crudely removed. The west-facing edge of the arch has been neatly finished, perhaps done in the 19th century when the remainder of the structure was removed. From the extent of the demolition evidence on the east face, we may conclude that the wall it was joined to was at least 2.7 m high.

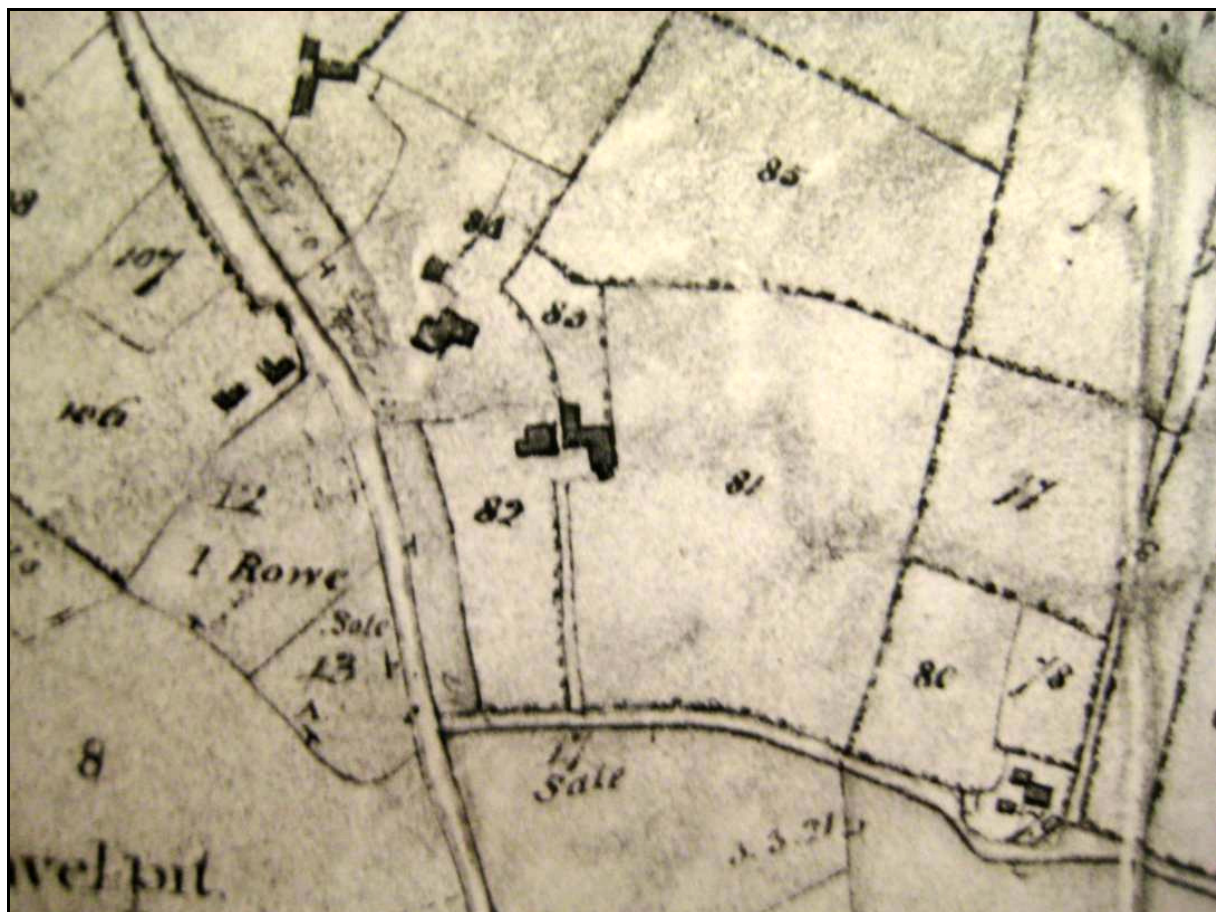
Fig. 6 - Detail from the Ruislip Enclosure Plan of 1806<sup>5</sup>

Earlier maps are less detailed than the OS ones but might help explain this wall. The enclosure map of 1806, Fig. 6, shows The Grange as two separate buildings, but with a substantial projection to the south on the eastern one. An indenture of 1864, Fig. 5, has a detailed map attached that covers most of Northwood. I have shown previously<sup>2</sup> that this map bears such a close resemblance to the enclosure map of 1806, and has so little in common with the first OS map produced the following year, that it cannot possibly have been based upon a contemporary survey. It must have been copied from the same

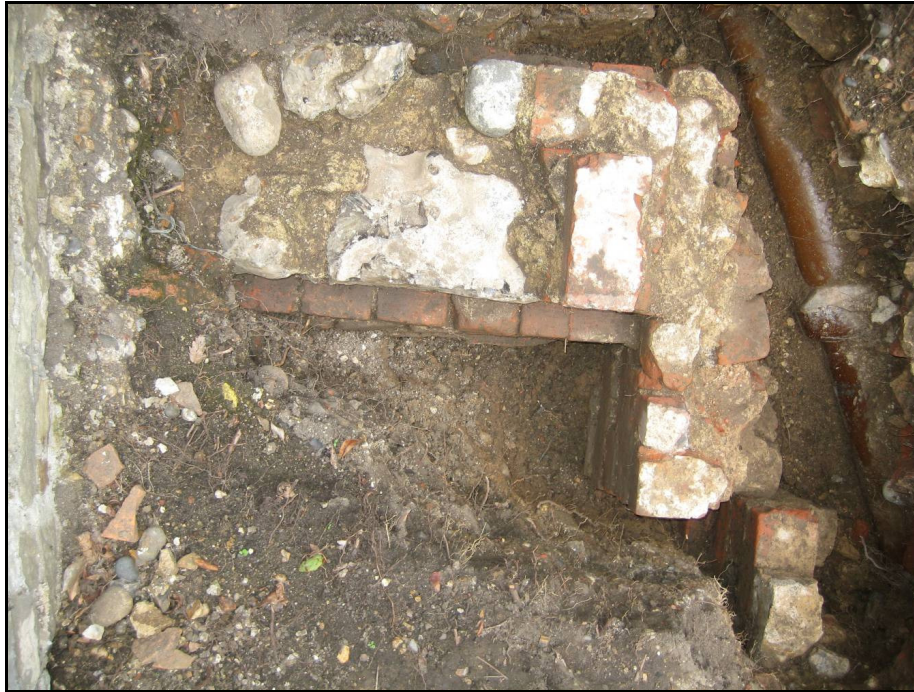
**Fig. 7 - The entire excavation from above**  
**A 1930s drainage pipe cuts through the archaeology at the south**

At its southern end, a trench for a clay drainage pipe had been cut through the wall, probably in 1930s when the adjacent house was built. To the north the wall continued under a paved terrace that prevented further excavation without causing major disruption, but between these limits about one metre of wall was visible. More of the wall might therefore be found one day by excavating beyond these limits.

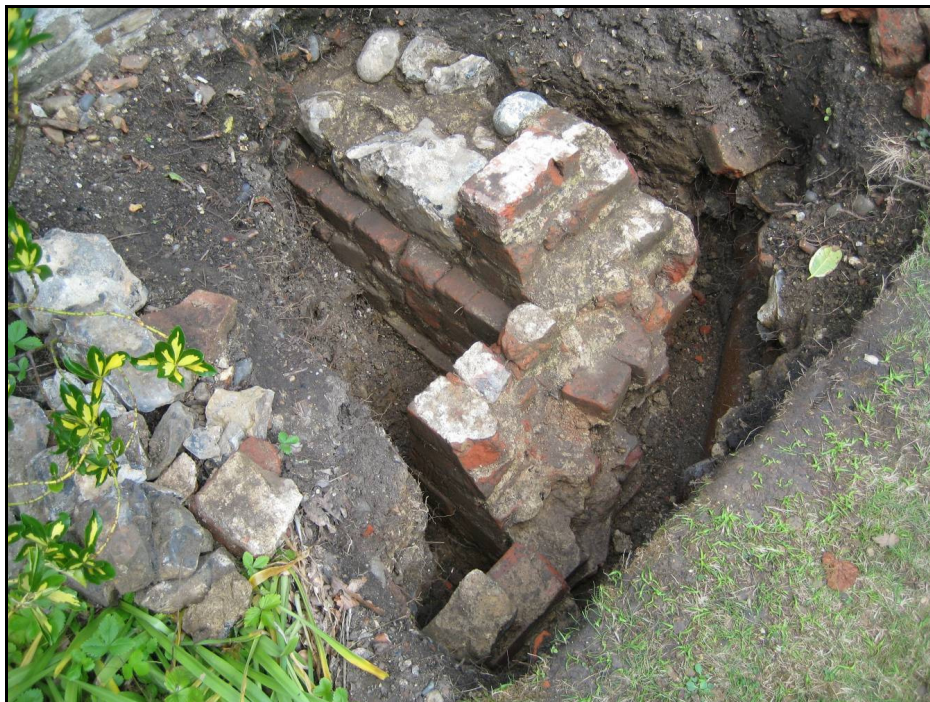
**Fig. 8 - The excavated wall from the south**  
**A brick and a flint at the bottom are newer work built against a buttress of the main wall.**

It initially appeared that the wall made a turn to the west and that a corner had been found. But further excavation revealed that it extended west for only 310 mm before ending with a fair face. This could have been an opening in the wall, but is probably better interpreted as a buttress, as the foundation also ends here. A later wall seems to have been constructed against this buttress that does extend further west. This wall is narrower, but also constructed of brick and flint. Its brick foundation (one brick length, 210 mm wide) is 160 mm below that of the main wall. It has not been possible to associate this newer wall with any line on a map, so perhaps it was an internal division within the postulated barn and demolished at the same time as that building.
