Access audit at Guild Hall, Walkden

Conducted on 23rd February 2015

Introduction: Access 2 All Areas were invited to conduct an audit at the Guild Hall, Walkden

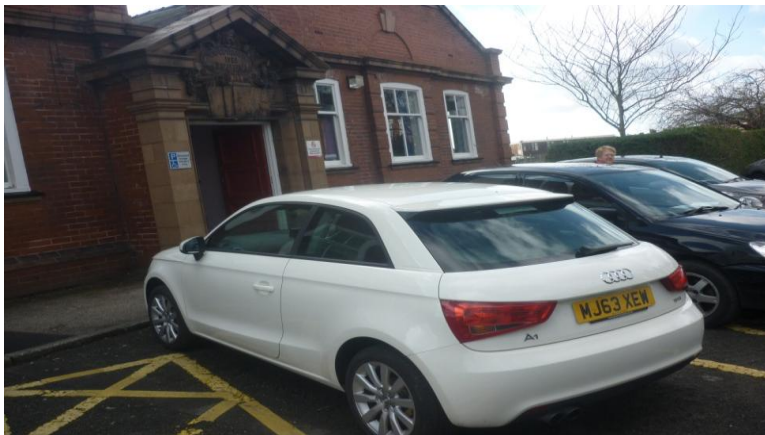
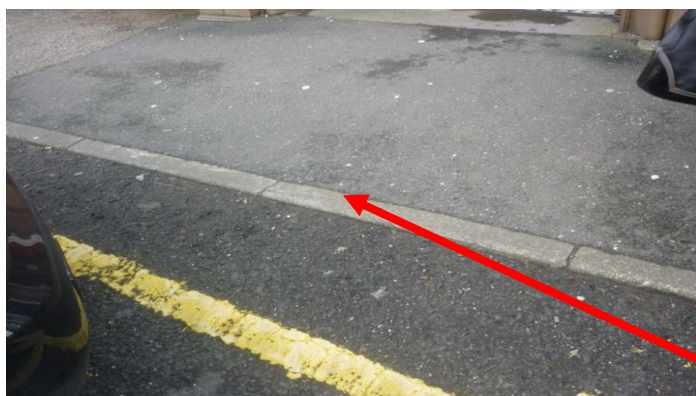
Entrance

Access to the Guild Hall is off Guild Avenue. There is one disabled parking bay situated at the main entrance to the Guild Hall. When we visited there was a car parked in the disabled bay which was difficult to negotiate for wheelchair users as it obscured the dropped kerb.

2. The corridor floor surfaces could be painted in bright colours to assist those with a visual impairment.
3. Parking at the front of the building is extremely limited and there is only one disabled space. If this space is occupied it means access to the dropped kerb is very difficult. We would recommend that the disabled parking space be re-located to the right or the left of the current bay.
