Render and Window Project Edition 03 – 28 July 2018

Render and Window Project

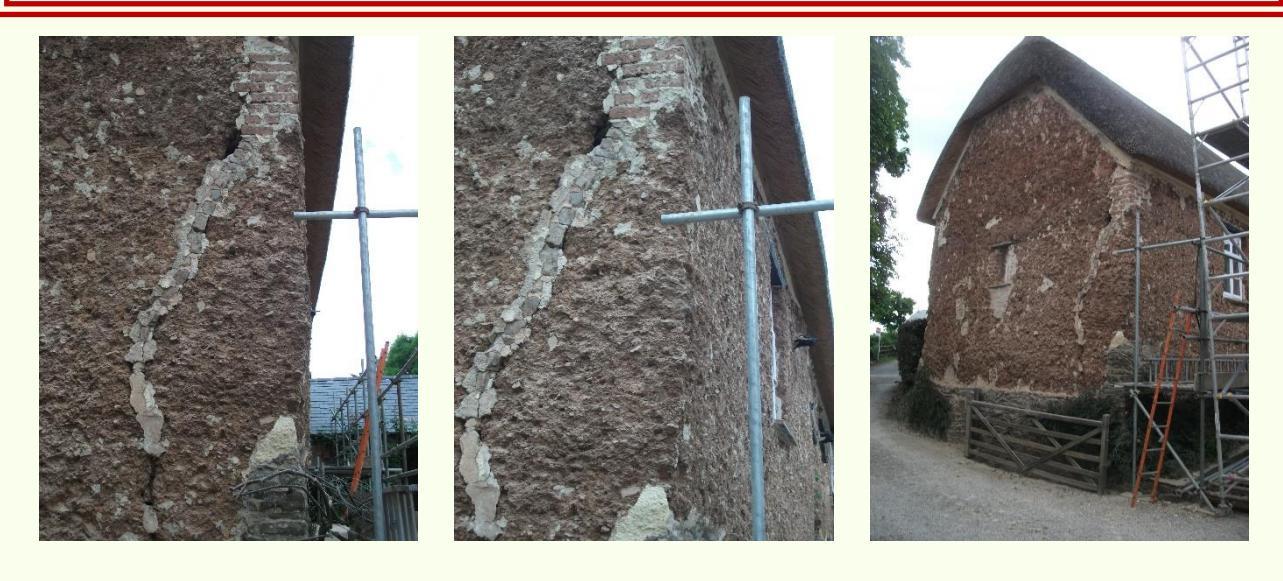
Removing the render exposed a historic a crack and repair in the corner of the west wall and south wall. Cob blocks had been fixed to the top of the walls just below the roof where there appears to have been some damage at some time in the barn's / hall's past. The size and shape of the crack suggests the top of the wall move outwards or failed at some time and this created a movement in the cob down to the stone foundations. A repair of small stone and cement mortar had been used to repair the crack. As a remedy to this problem it is proposed that stainless steel Helifix bars are driven into the cob, across the joint, where the most serious gap exist fix cob blocks, fill the remaining crack using lime mortar, and render over.

The photographs below show the crack and its location on the building.

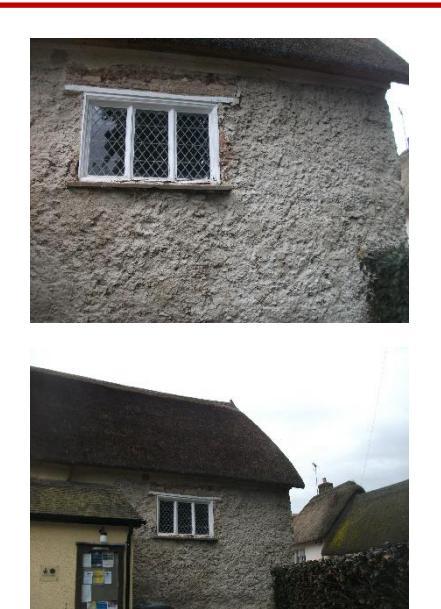
With the old render removed applying the first coat of lime plaster has started. This is known as Harling. Harling is also known as Scat Coat, Thrown Coat or Rough Cast. Harling is a technique for applying a coat of render or plaster. The lime mortar has extra water added to bring it to a runny consistency. It is then cast on the wall using a special tool called a harling trowel which has a curved blade. It provides a rough texture when cured that gives extra key for the next trowelled coat and also controls suction with very thirsty materials such as cob.

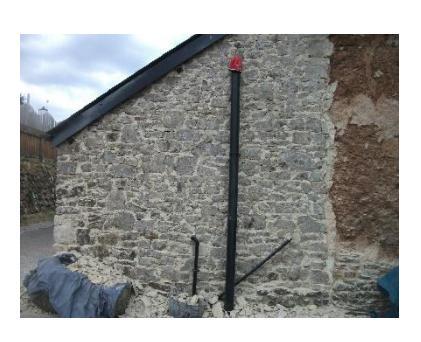
In conjunction with the Render and Window project the external conservation of the kitchen area of the Hall is continuing. This aspect was not completed earlier in the year due to the weather conditions. On removing the old render from the west wall of the kitchen the original stone was exposed. The photograph clearly shows where this extension lean-to was added to the original barn.
