# East Worlington Parish Hall News|etter

## Render and Window Project Edition 01 – 20 July 2018

## Render and Window Project

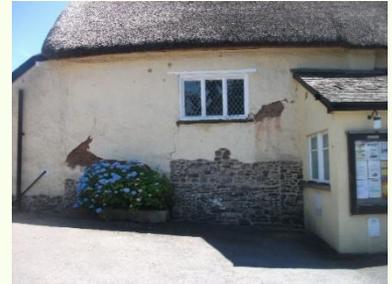
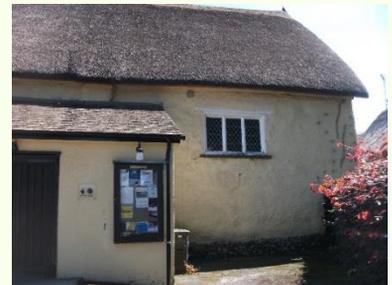
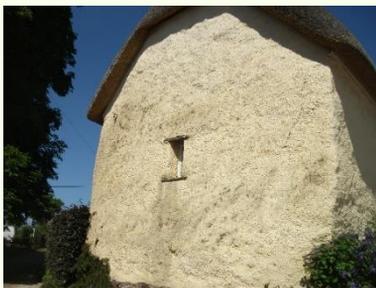
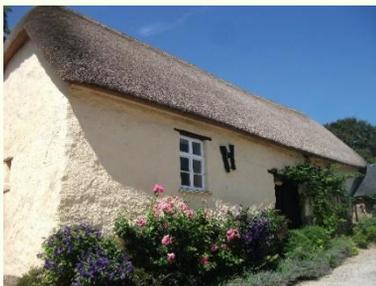
Due to water penetration the render on the external walls of the Parish Hall had started to delaminated, with areas where the render had totally failed and was no longer attached to the cob wall or had completely fallen off. The west elevation (front of the Hall) was affected the most and also serious signs of delamination on the south elevation. Action needed to be taken to preserve the cob wall and the overall integrity of the building. Mike Wye Associates undertook a condition survey and confirmed that the Hall required re-rendering.

Three different local contractors provided estimates for the work. Funding streams were explored to ensure we had the necessary finances to undertake the work. Fortunately grant funding was secured and the Trustees made a decision to proceed with the work. One of the contractors was commissioned to undertake the necessary work. The project started week beginning 23<sup>rd</sup> July 2018. The work is scheduled to take place mainly during August. This will reduce the disruption to use of the car park, especially for the school.

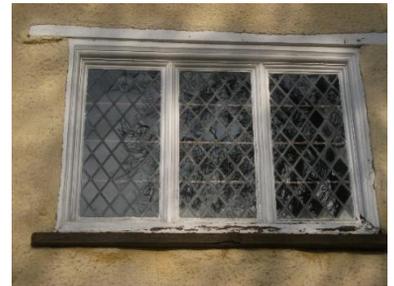
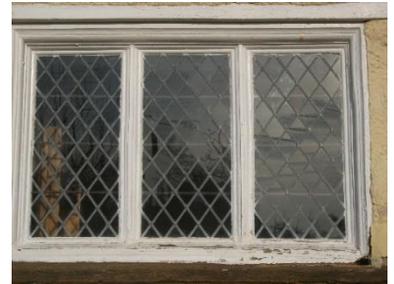
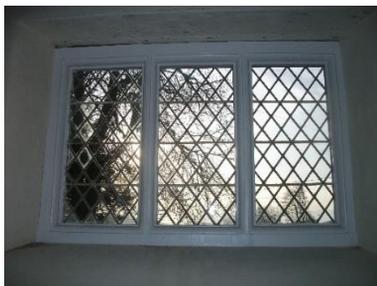
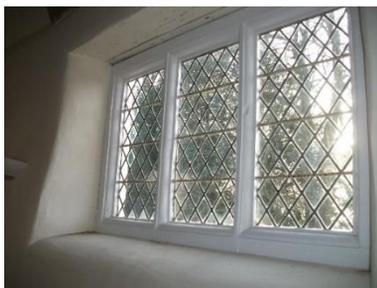
The two windows in the front elevation are not original to the barn. The barn would not have had windows. They are however 'old' windows shown by the moulding on the timber, the construction and the glazing. It is most likely they came from another building and were installed in the barn when it became a Hall for community use. Over the years the timber has become wet and started to rot. There is evidence of some repairing in the past but the current condition is very poor as shown on the photographs.

A survey of the windows was undertaken by Haydons who confirmed that it might be possible to repair the windows, however it would depend on a thorough investigation when the windows were removed from their locations in the wall. The Trustees have supported the action to replace the timber frame with like if repair is not possible. The local Conservation Officer has expressed a view that repairing is her preferred solution. We await further information about the conditions of the windows and the agreed actions. Haydons are commissioned to undertake the work in the same period of time as the re-rendering.
