MANOR FARM, RUISLIP

ARCHAEOLOGICAL DISCOVERY OF THE OLD ROAD SURFACE

by Colin Bowlt

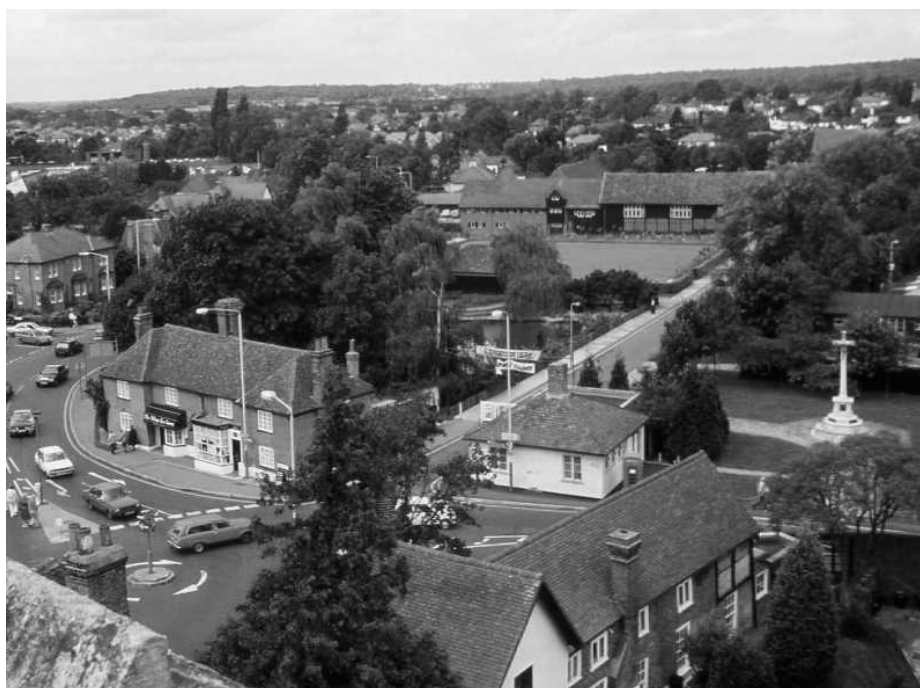
Fig. 1 - View (1988) from St Martin's Church tower showing entrance and road into Manor Farm

Most roads in early times appear to have been unmade. Manor Farm, however, was the most important site in Ruislip, apart from the church, and if any Ruislip roads were made-up one might expect it here (**Fig. 1**). In 2004 the Hillingdon Borough Council erected new lamp standards along the edge of the pavement beside the entrance road, as well as an additional three lamps on the north side of the 'stable block' and Guide Hut. Since part of the Manor Farm site is a Scheduled Ancient Monument and the work seemed to have archaeological implications I was commissioned, at short notice, to carry out an archaeological watching brief during the work.
