Treatment Report
Conservation Programme to Monuments
St Mary Magdalen, Fifehead, Dorset

1315

July 2018

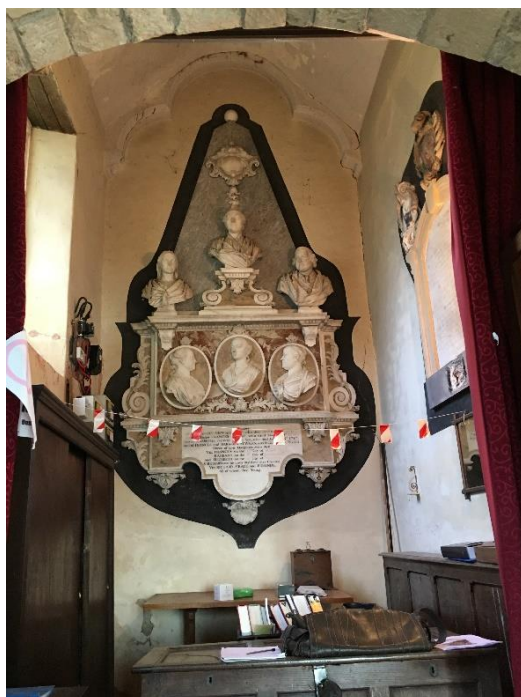
The electrics board located on the west elevation of the Newman was unfortunately positioned right next to the lower section of the Newman monument on the east elevation resulting in a significant eyesore. Philip Hughes instructed the board to be moved to the south end of the Newman chapel and covered with a cupboard in limed oak. The relocation of the board and installation of the meter cover made a significant improvement to the overall setting of the monuments.

Figure 1: The Newman chapel before the conservation programme showing the electric board on the west elevation and the numerous cupboards.

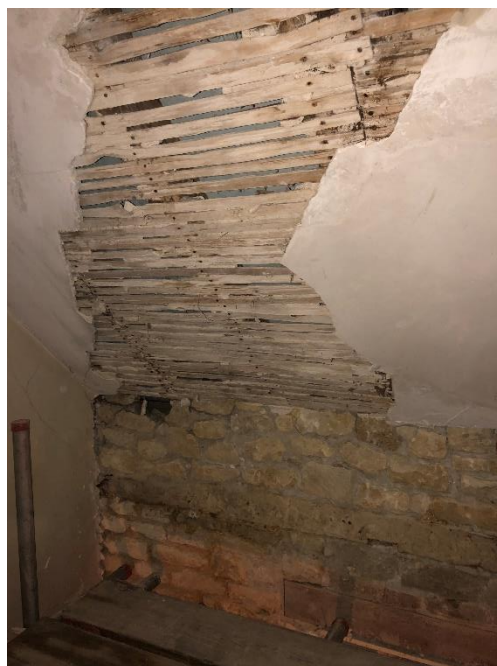
Figure 6: Section of the ceiling and wall on the west elevation after the removal of unstable sections of plaster

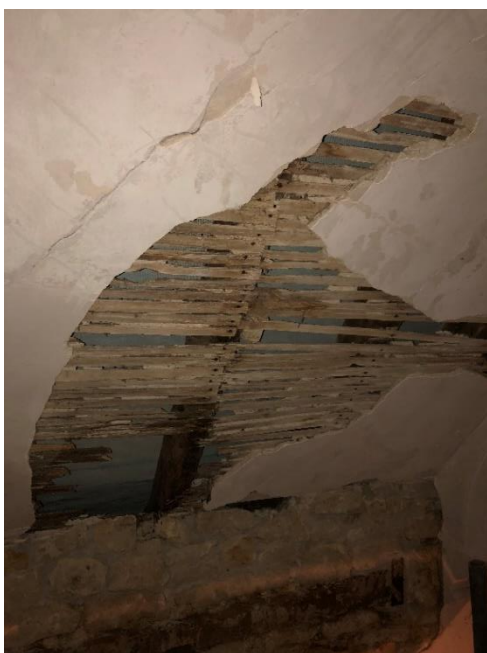
Figure 7: Further detail of the west side of the chapel after the removal of unstable sections of plaster

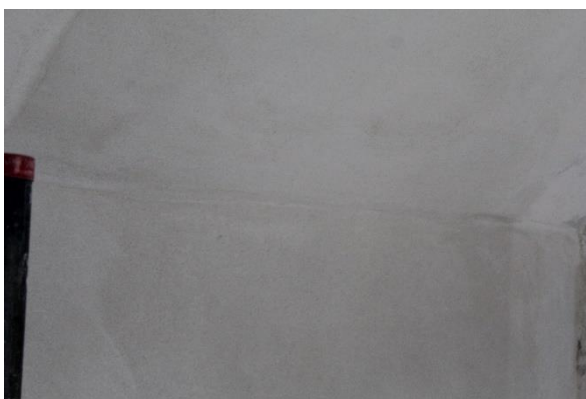
Figure 8: Reinstatement of plaster using a lime putty mix over area illustrated in Figure 7. New laths were used where necessary

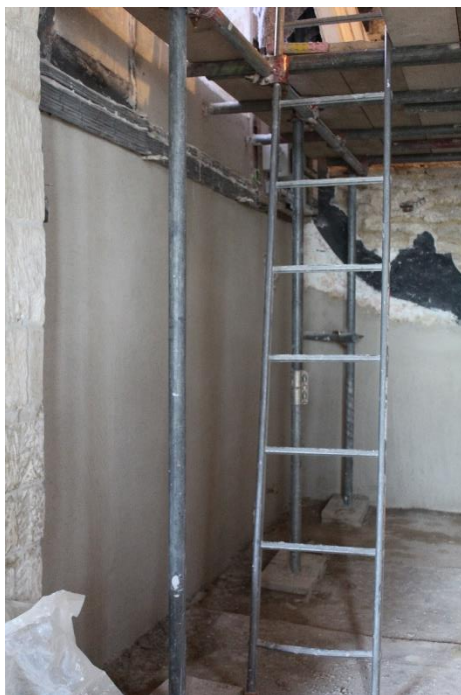
Figure 9: The west elevation showing the reinstatement of the plaster with a lime putty mix

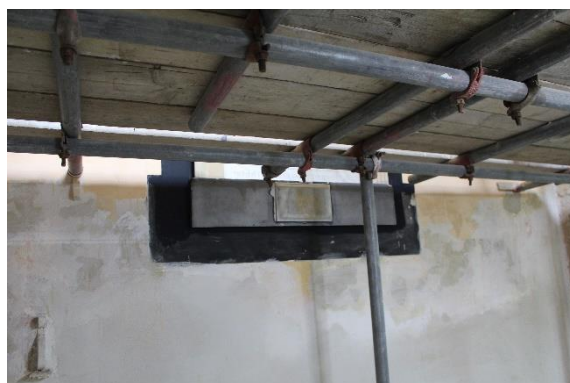
Figure 10: The east elevation illustrating the blending in of new to existing plaster. This proved to be problematic at first in creating a cohesive surface which would not detract from the monument above. Addition fine fillet repairs were applied with additional layers of limewash to achieve a satisfactory result

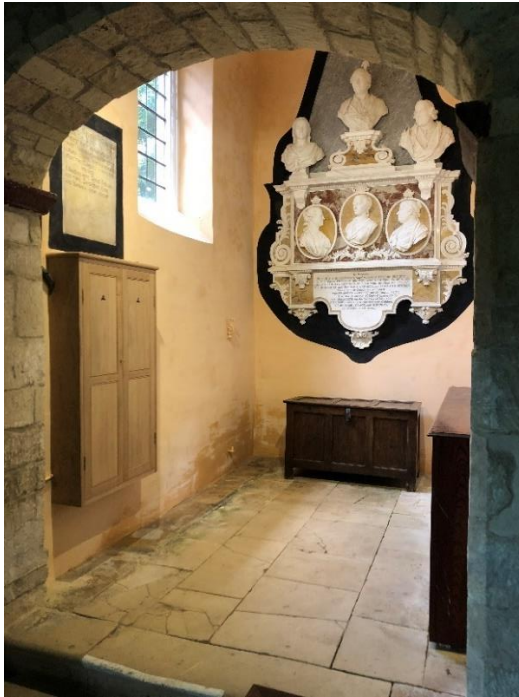
Figure 16: The Newman chapel after the conservation programme showing the electric board moved to the south end and covered with the limed oak cupboard. The monument above is now free of the water tank and piping. The damp areas at ground level is due to raised levels of moisture caused by faulty rainwater goods

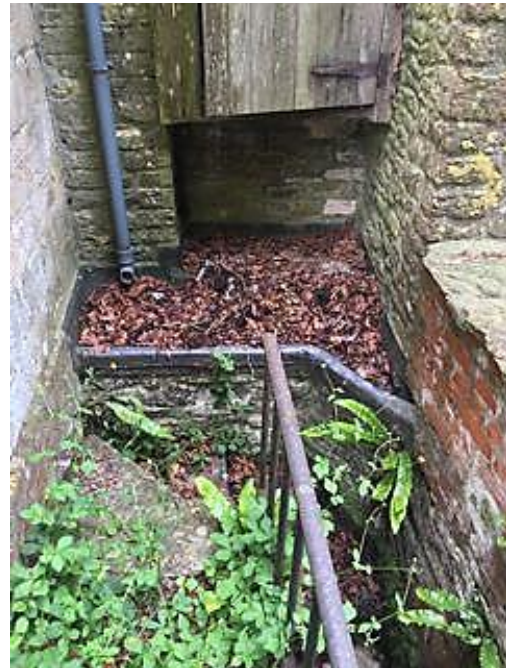
Figure 21: Image from the 2016 report showing the build up of leaves at the bottom of the downpipe on the west elevation

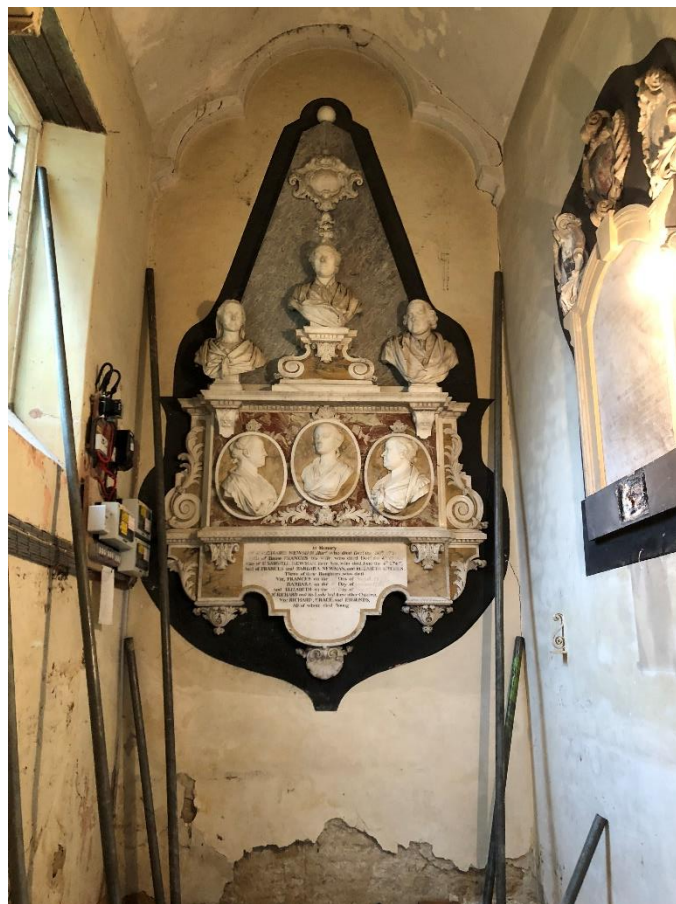
Figure 23: The Newman monument at the start of the project with the location of the electrics board and cables illustrated

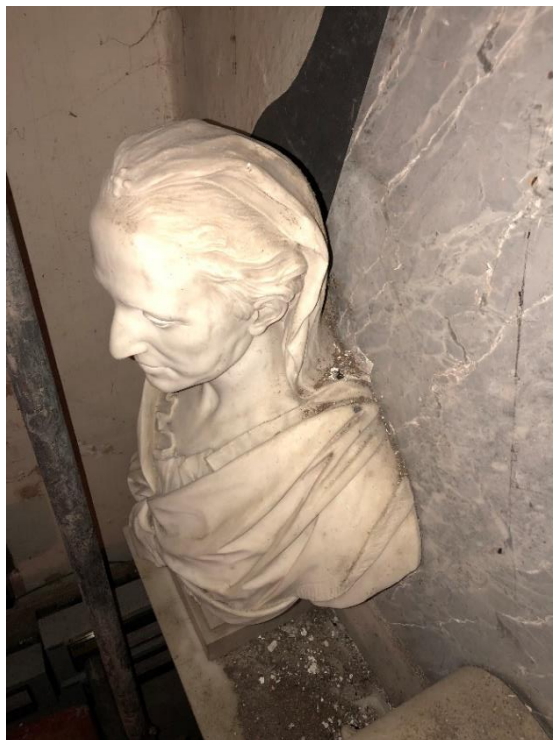
Figure 25: Beautifully carved portrait of Frances Newman before dismantling showing the ingrained dirt and surface soiling over the marble extent of dust and debris

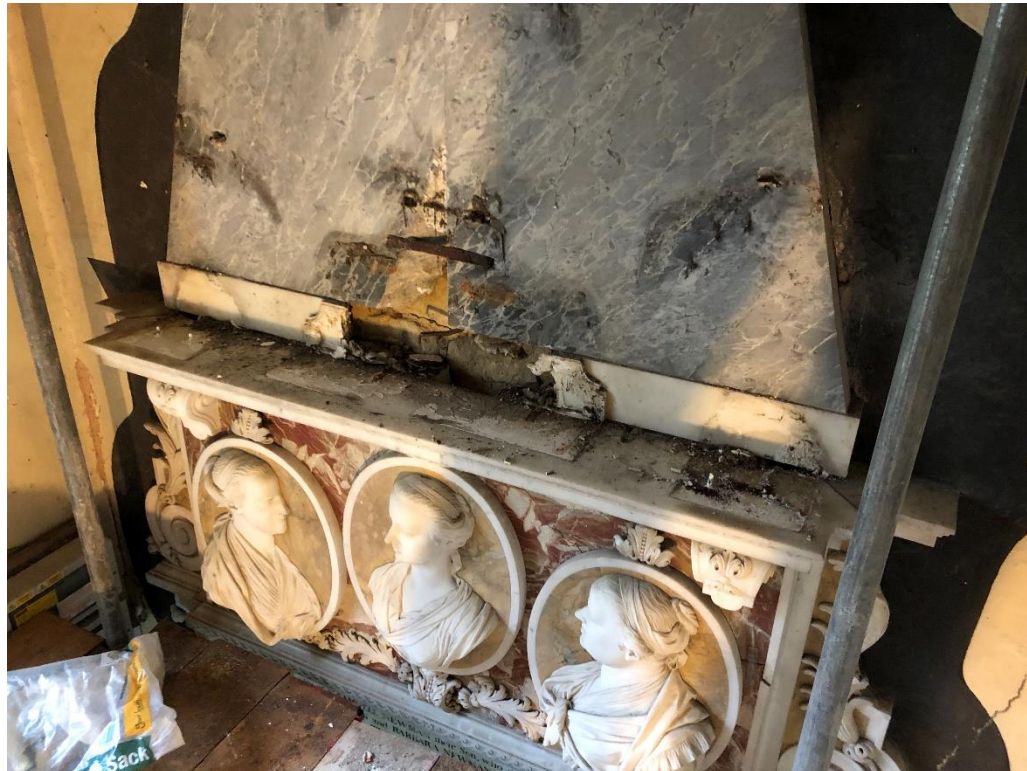
Figure 34: The three busts and plinths removed showing that the substantial sections of the obelisk appear to be unsupported

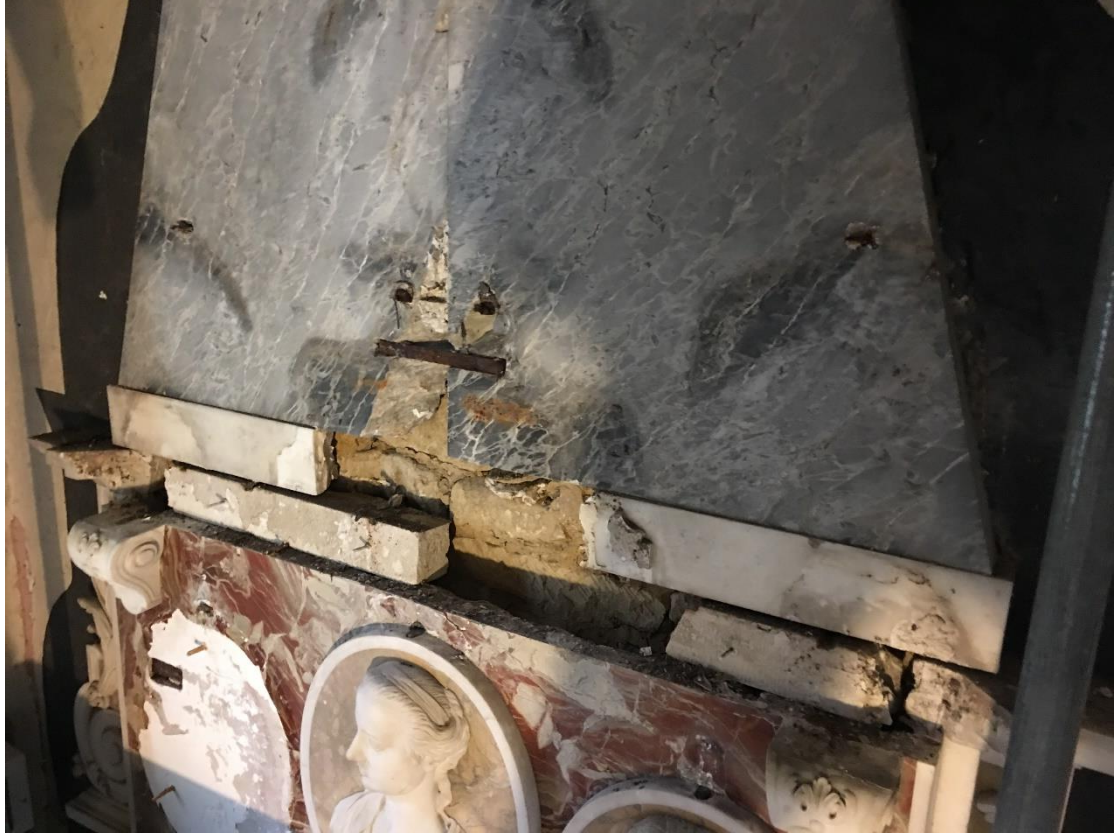
Figure 35: Closer view of the base of the obelisk stones with no structural support

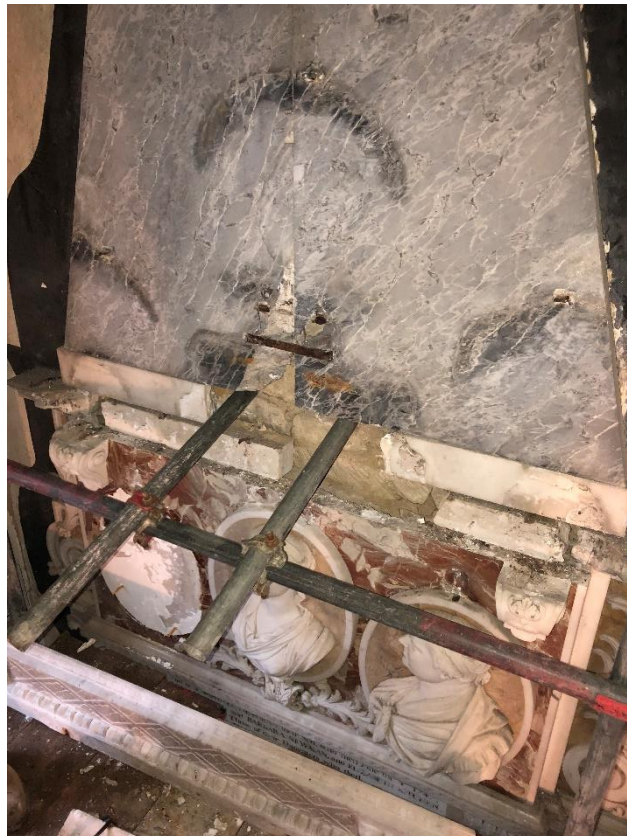
Figure 36: The temporary system being installed beneath the obelisk

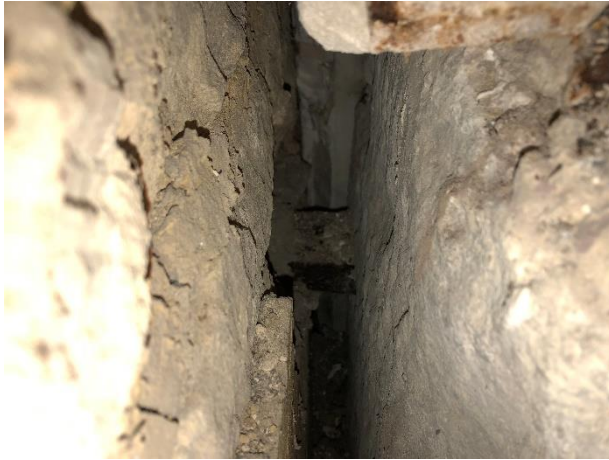
Figure 37: An image from the endoscope showing the gap between the two sections of the obelisk and the north wall of the chapel with no evidence of fixings to secure the sections to the wall

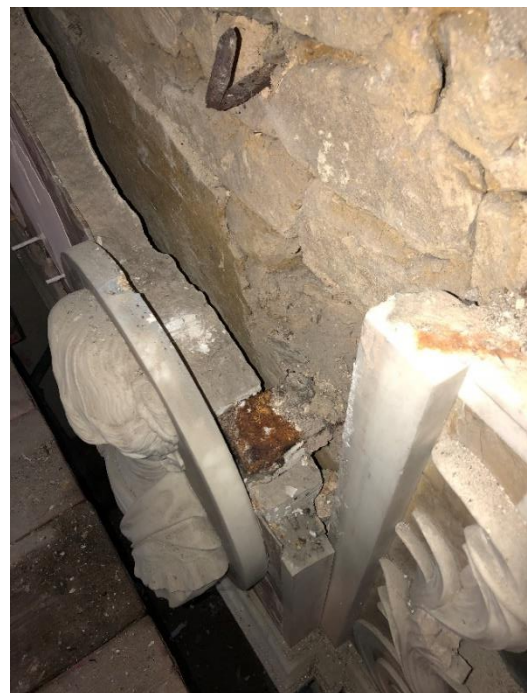
Figure 40: The large section of iron revealing itself as the dismantling progresses

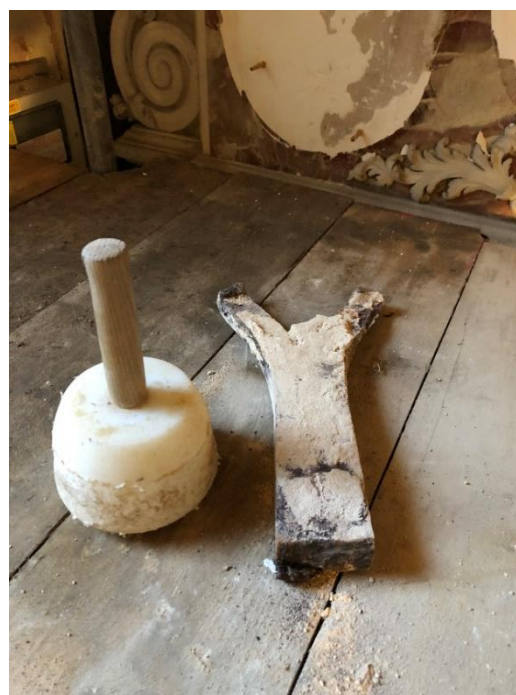
Figure 43: The iron section removed to show the fishtail design

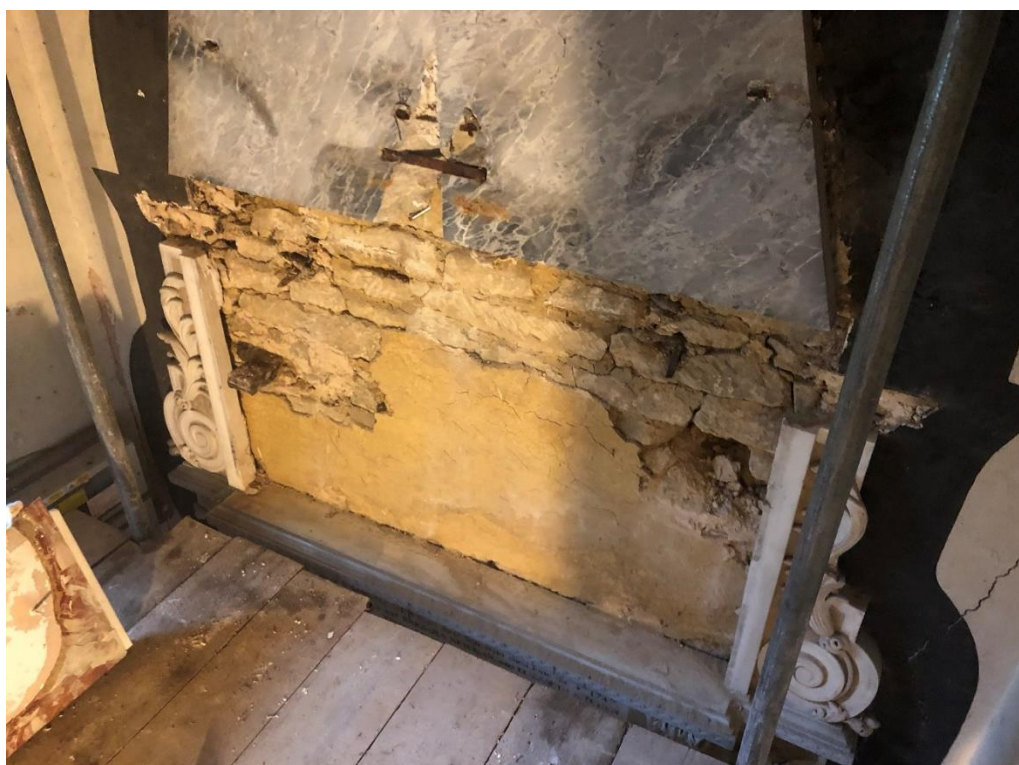
Figure 44: The middle section nearly removed with the sinistral iron fishtail section removed from the wall and the dexter still in situ

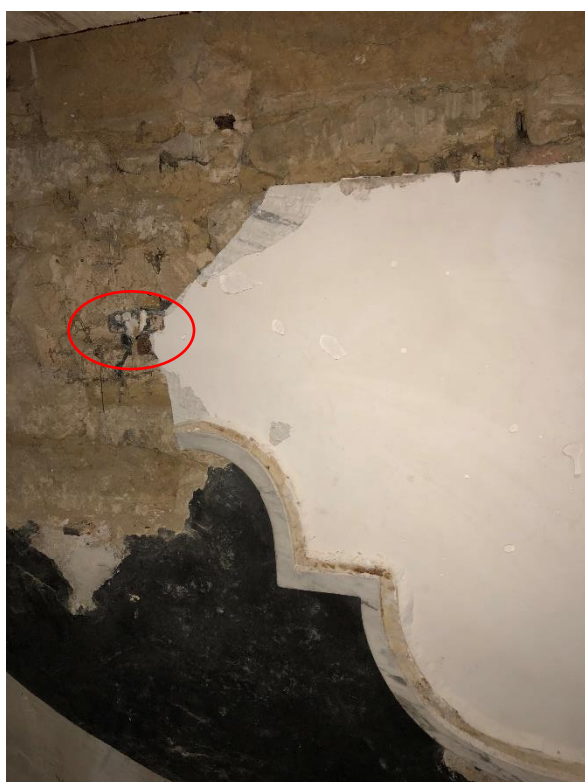
Figure 45: A large section of iron revealed during the removal of the bottom section

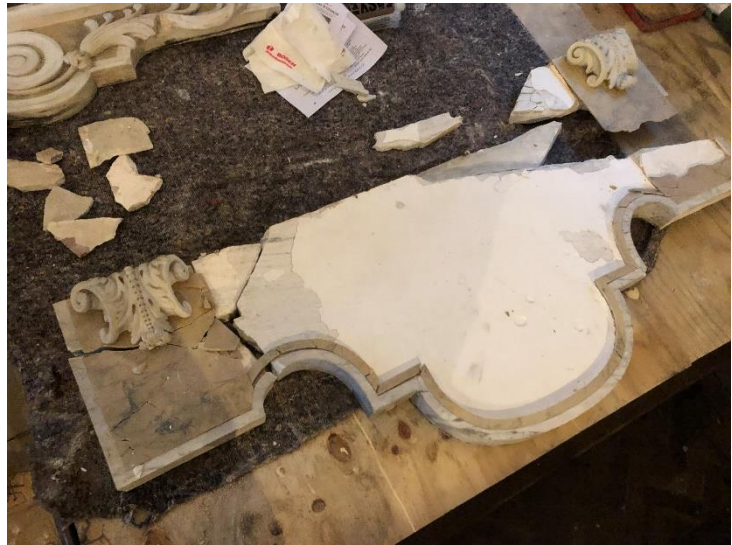
Figure 48: The fractured panel removed with all the broken sections and fragments being carefully recorded

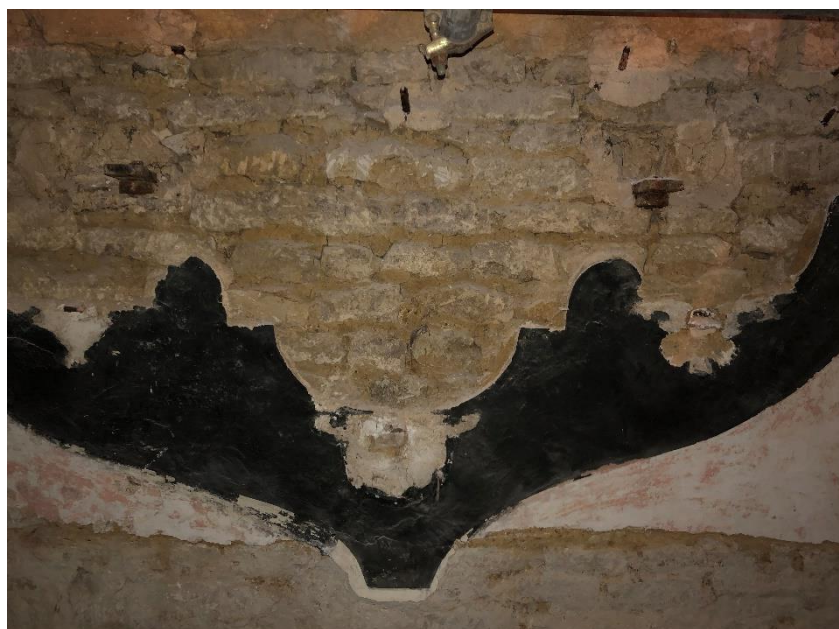
Figure 52: The wall and painted black border after the removal of the lower section of the monument with the large iron fixings visible

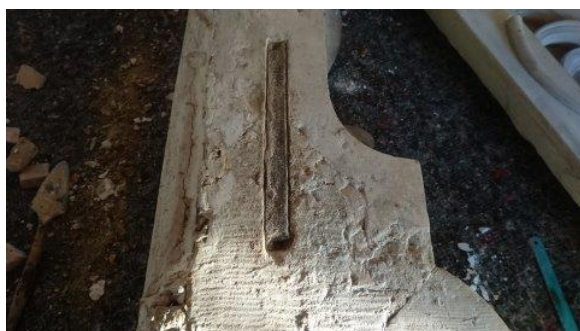
Figure 54: Example of a corroded fixing in the lower section of the monument

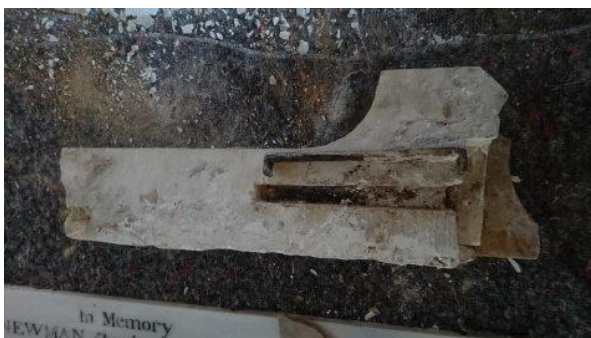
Figure 55: A corroded fixing removed

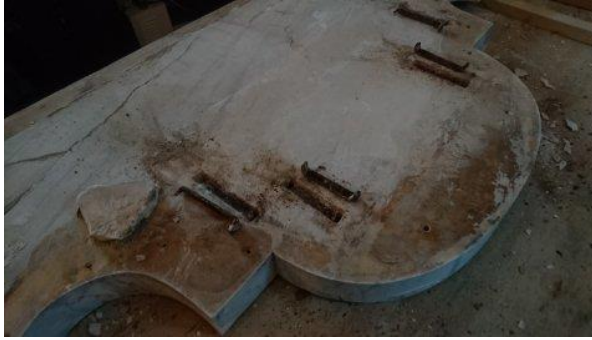
Figure 56: The back plate to the inscription panel with the corroded iron fixings being removed

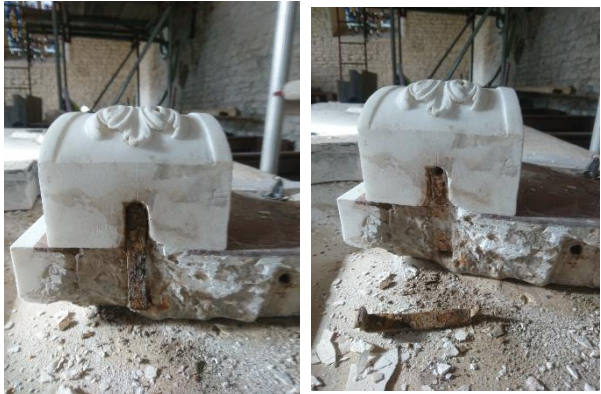
Figure 57: Example of corroded iron being removed from the dexter corbel to the pediment displaying the three busts

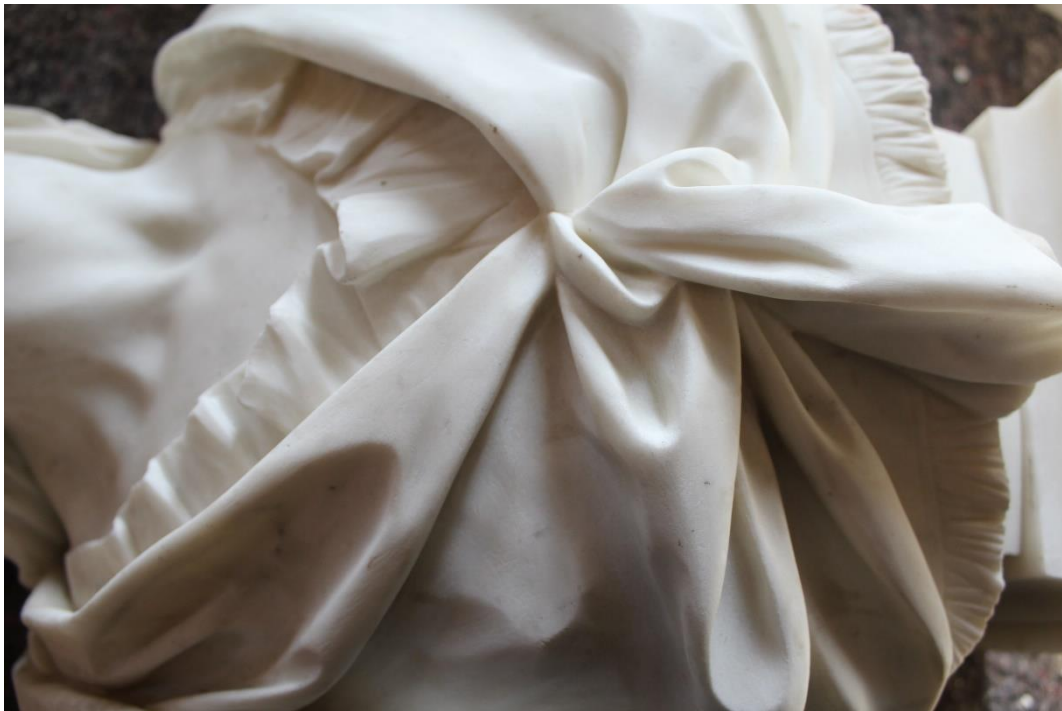
Figure 62: Detail of Lady Frances's drapery showing the quality of the marble and carving

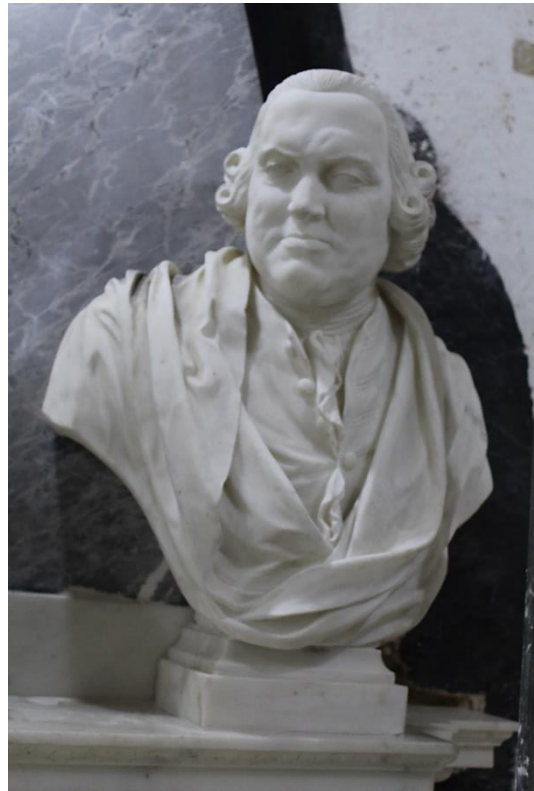
Figure 64: Bust of Samwell Newman after cleaning

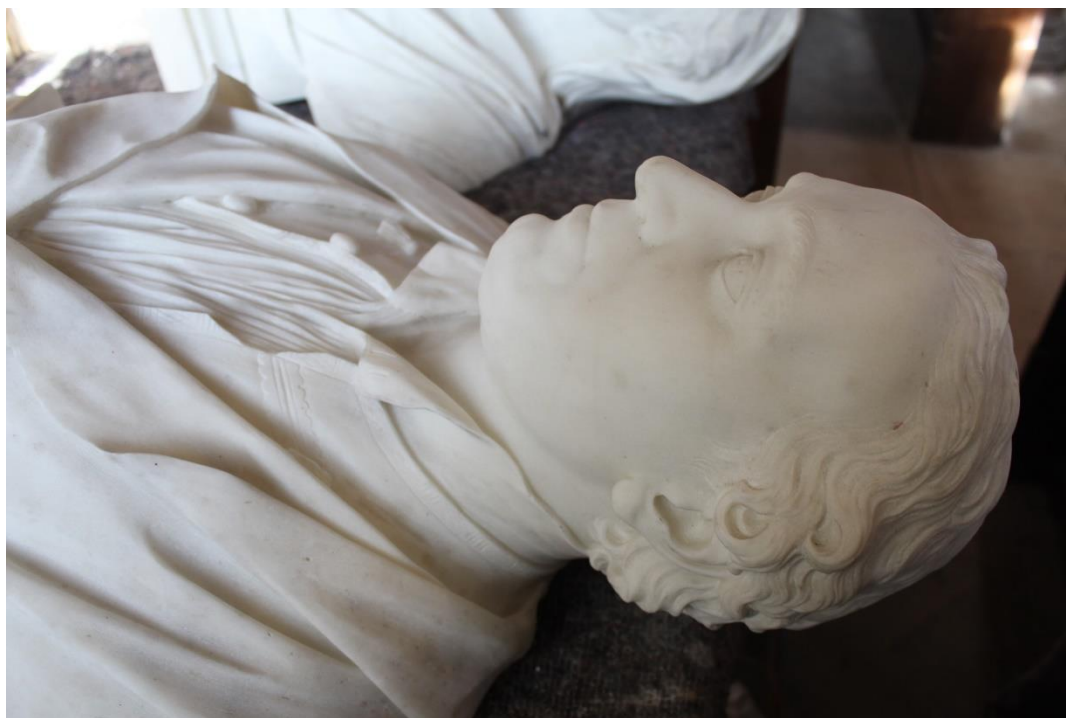
Figure 66: Sir Richard after cleaning illustrating the high quality of the carving and in particular the linen shirt and overcoat

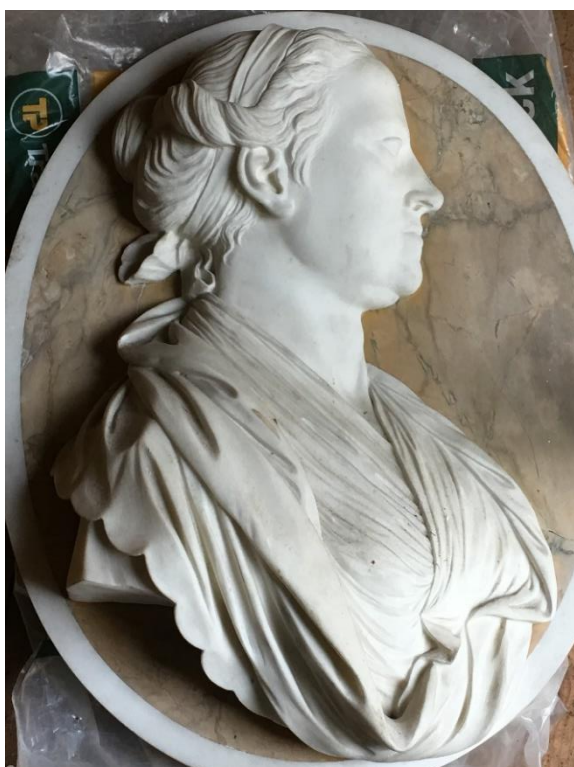
Figure 67: Dexter medallion portrait during the removal of surface dust and debris

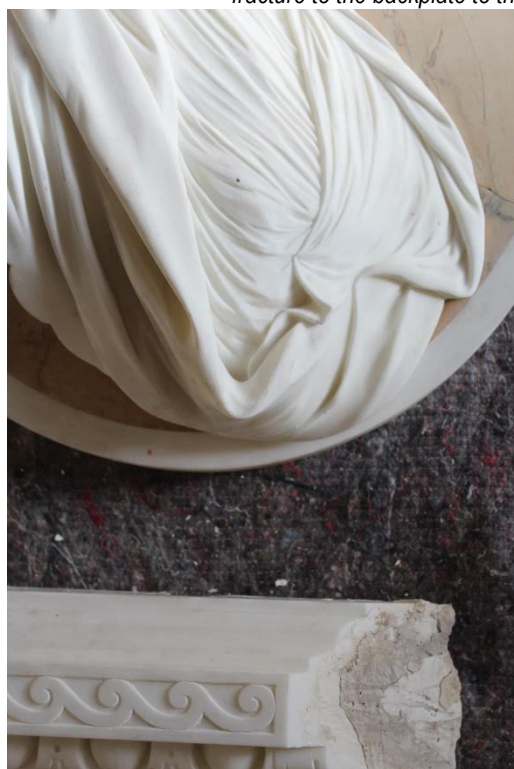
Figure 71: Detail of the drapery to the dexter medallion portrait after cleaning showing the beautifully carved drapery

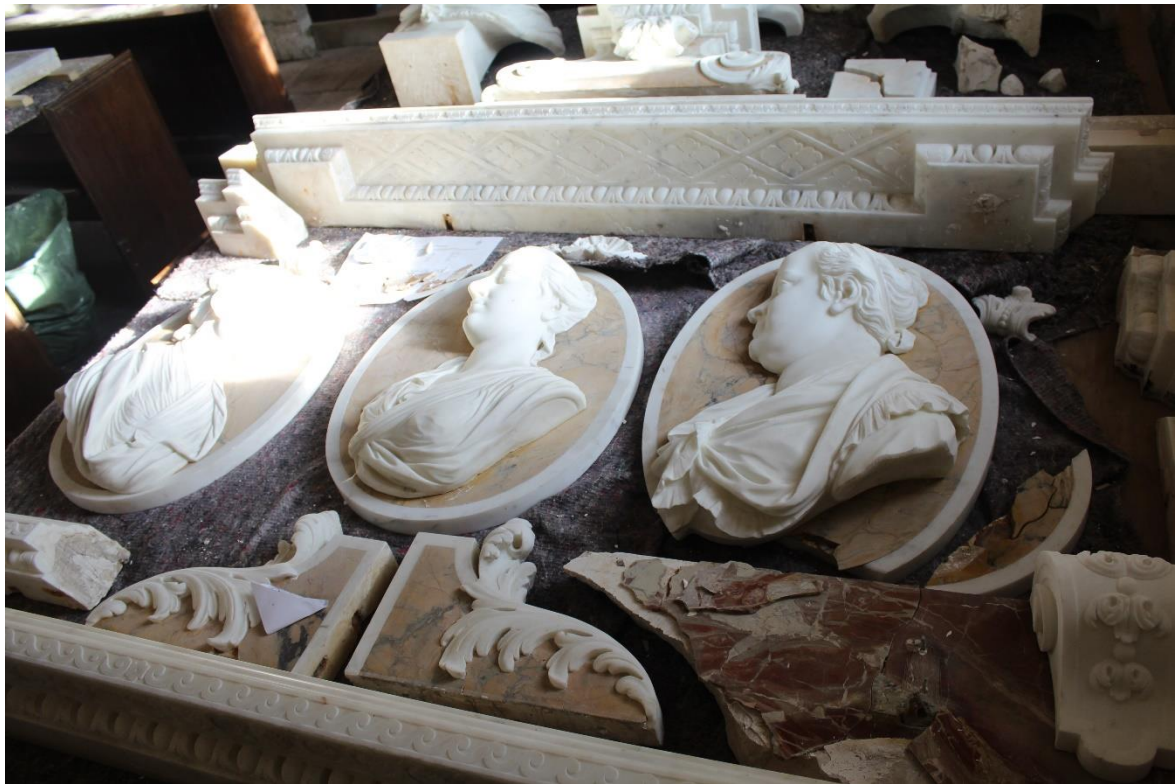
Figure 72: Overview of elements towards the end of the cleaning programme

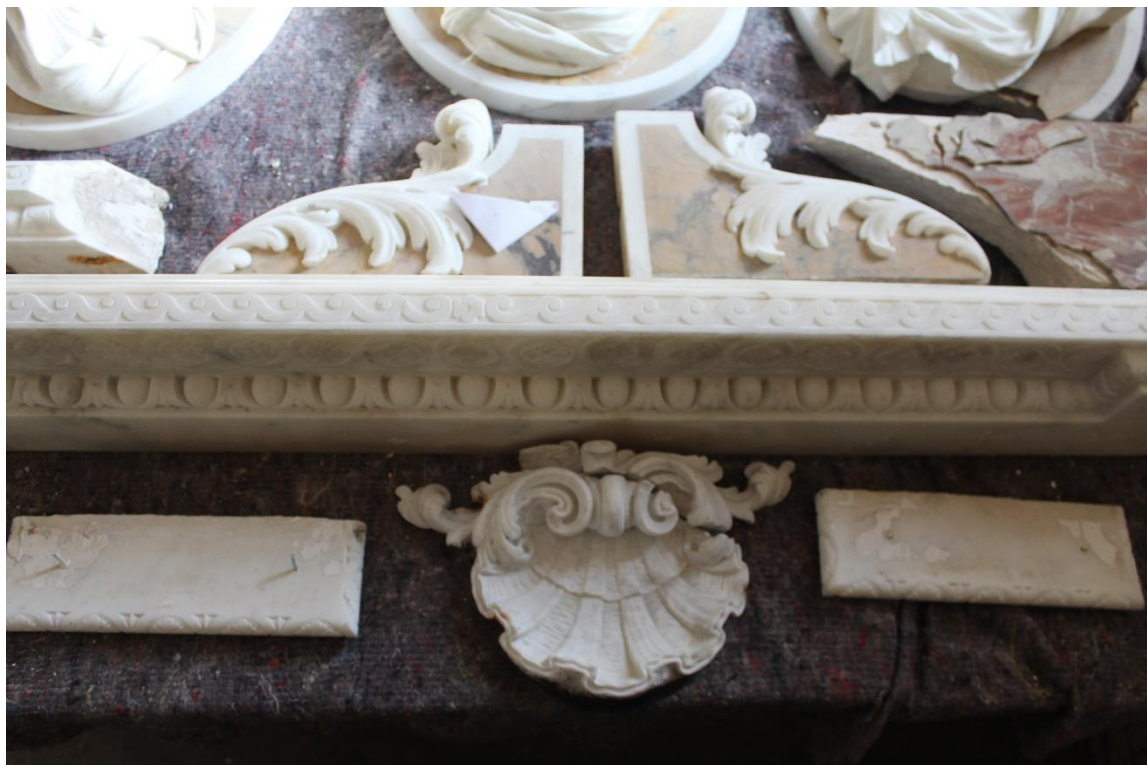
Figure 73: Detail of architectural elements after cleaning

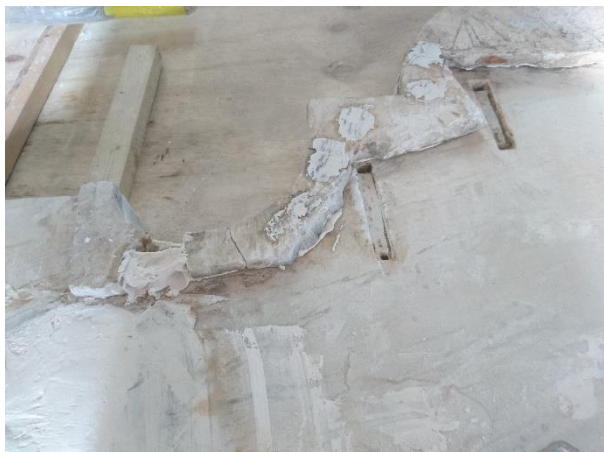
The inscription panel was made of white marble, set onto a white and grey backing stone. The inscription panel was only 10mm thick. The corroded iron fixings behind the panel had put considerable pressure on the marble which had also been weakened by the high levels of damp within the surrounding fabric. This combination of decay mechanisms had caused the thin section of marble to fracture.

Figure 79: Iron fixings removed from behind the inscription panel and repairs to the frame being applied with plaster of Paris

All fractured sections of the veneers were retained and recorded before they were reinstated using plaster of Paris after the inscription panel was set in place.

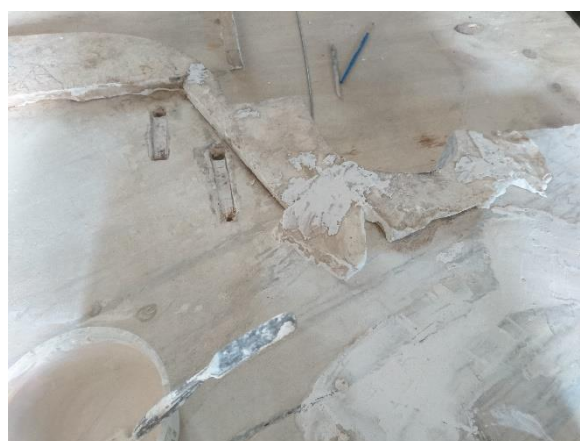
Figure 80: Iron fixings removed from behind the inscription panel and repairs to the frame being applied with plaster of Paris

The sections were re assembled by using a combination of stainless steel fixings, resin and plaster of Paris to strengthen the cracked sections.

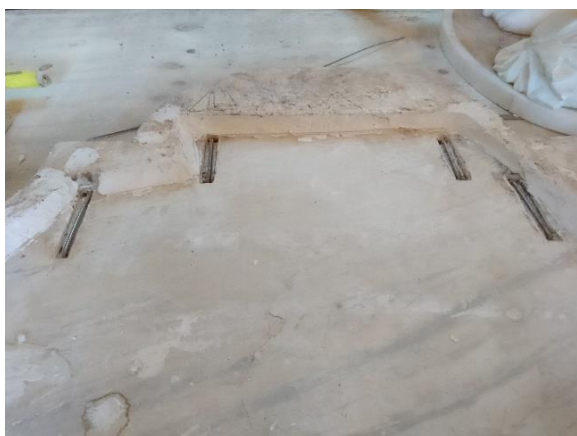
Figure 81: Stainless- steel cramps fitted

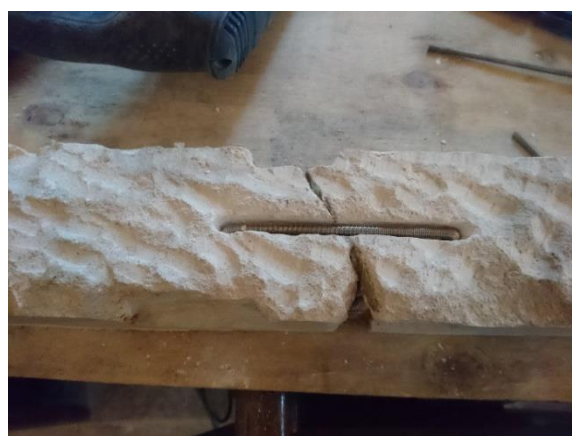
Figure 82: Threaded stainless-steel cramp stitching two sections of the backing stone together

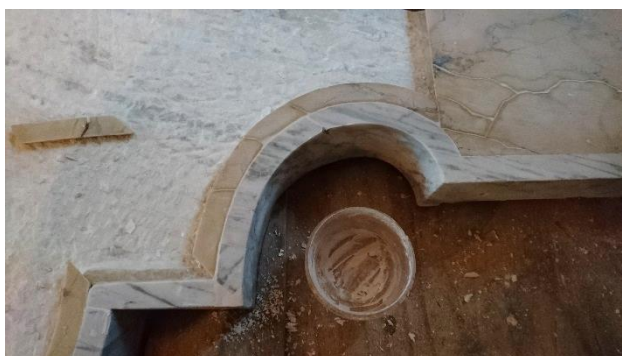
Figure 83: The sections of the veneer being reattached using Plaster of Paris

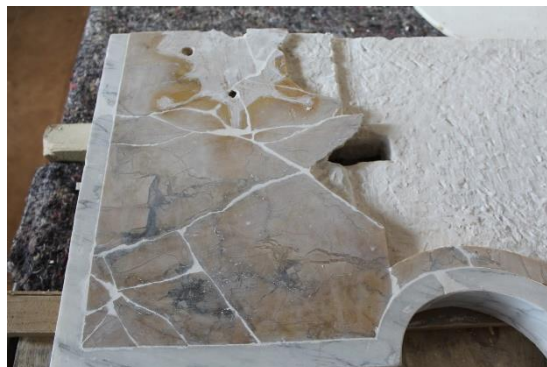
Figure 84: Section of reattached veneer on the dexter side next to the fixing hole for the large sections of iron

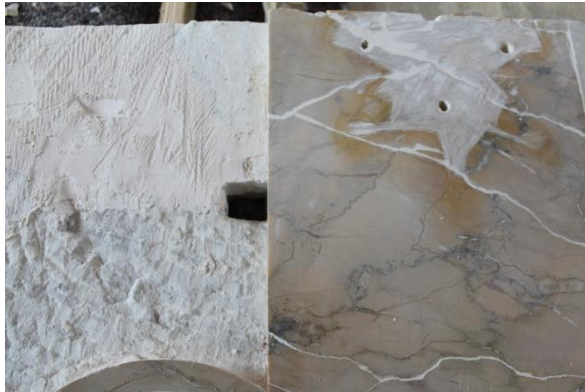
Figure 85: Sinister side of lower section with sections of veneer reattached and pin holes for the surface mounted decorative corbels visible

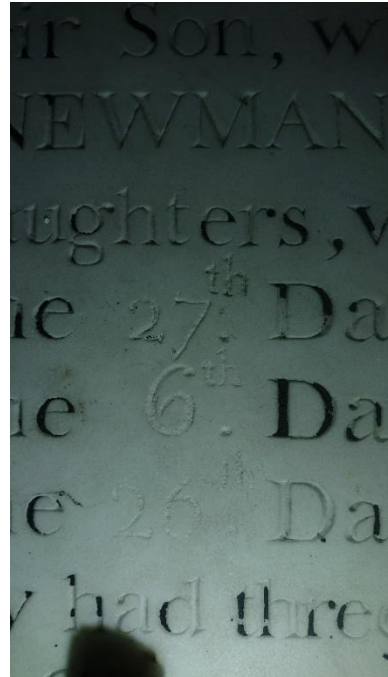
Figure 86: Scribed dates of death of the daughters on the inscription panel

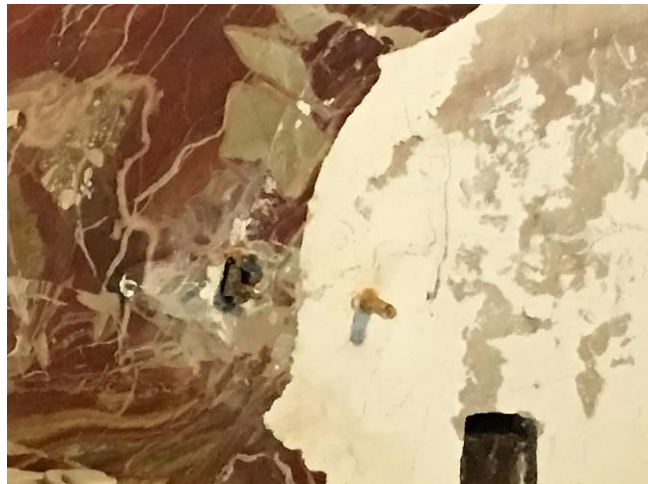
Figure 88: The veneer during the removal of the three medallion carvings

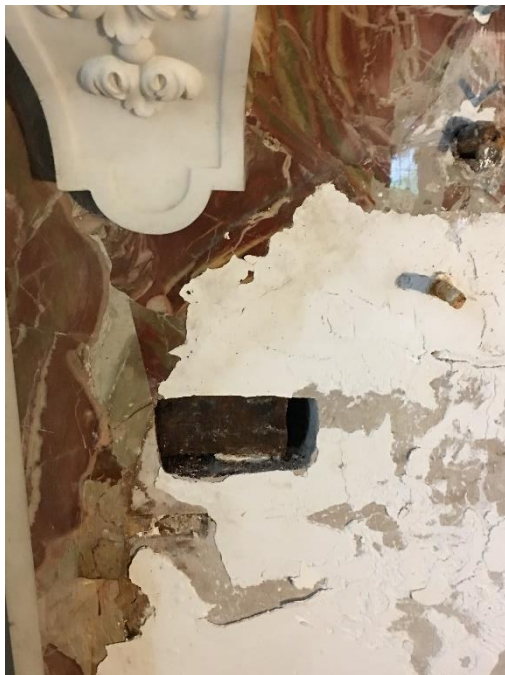
The red marble veneer was fixed to a bath stone backing plate and flanked by marble scrolls displayed on an ochre veneer. This veneer was originally fixed in place with shellac, whereas the white marble sides were fixed using plaster of Paris. The Bath stone backing because of the iron fixings had broken into sections with a higher level of damage on the sinister side.

Figure 89: The fish-tail iron fixings revealed behind the veneer

The broken sections were pinned together with stainless steel threaded bar set in resin. For extra support the cracks were filled with plaster of Paris.

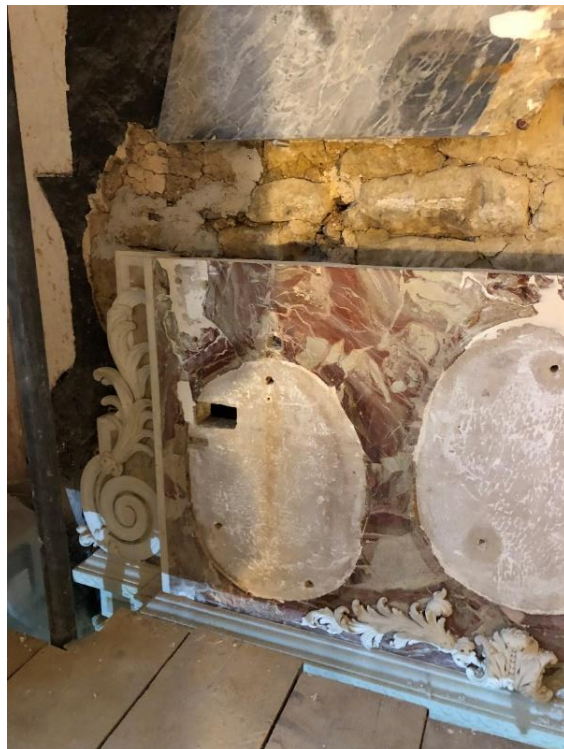
Figure 90: The red veneer being reinstated with plaster of Paris during the rebuilding of the monument.

This fragmentation of the backing plate had caused the veneer to become detached from their substrate. The loose sections were removed, logged and stored for reattachment. The white marble sides were also removed for cleaning.

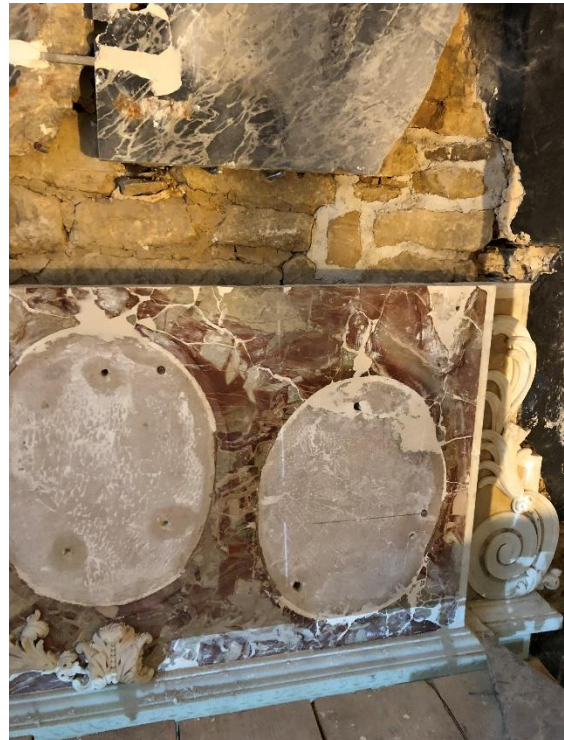
Figure 92: The sinister side of the middle panel during rebuilding showing the veneer being reinstated and surface repairs.

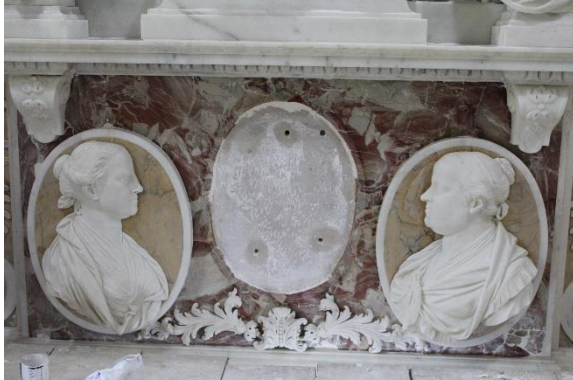
Figure 95: The medallion carvings during the rebuilding process with the sinister portrait repaired

The sinister portrait needed the portrait resetting on a bed of plaster and the lower section of the oval, which had become detached, re-fixed. The latter was achieved using stainless steel fixings, resin and plaster of Paris.

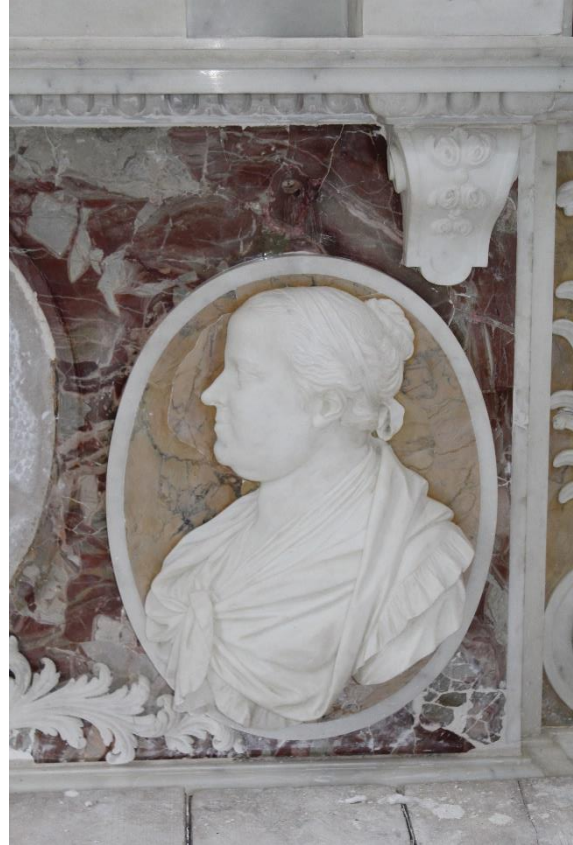
Figure 96: The sinister but showing the repairs to the roundel and surface repairs to the surrounding red veneer

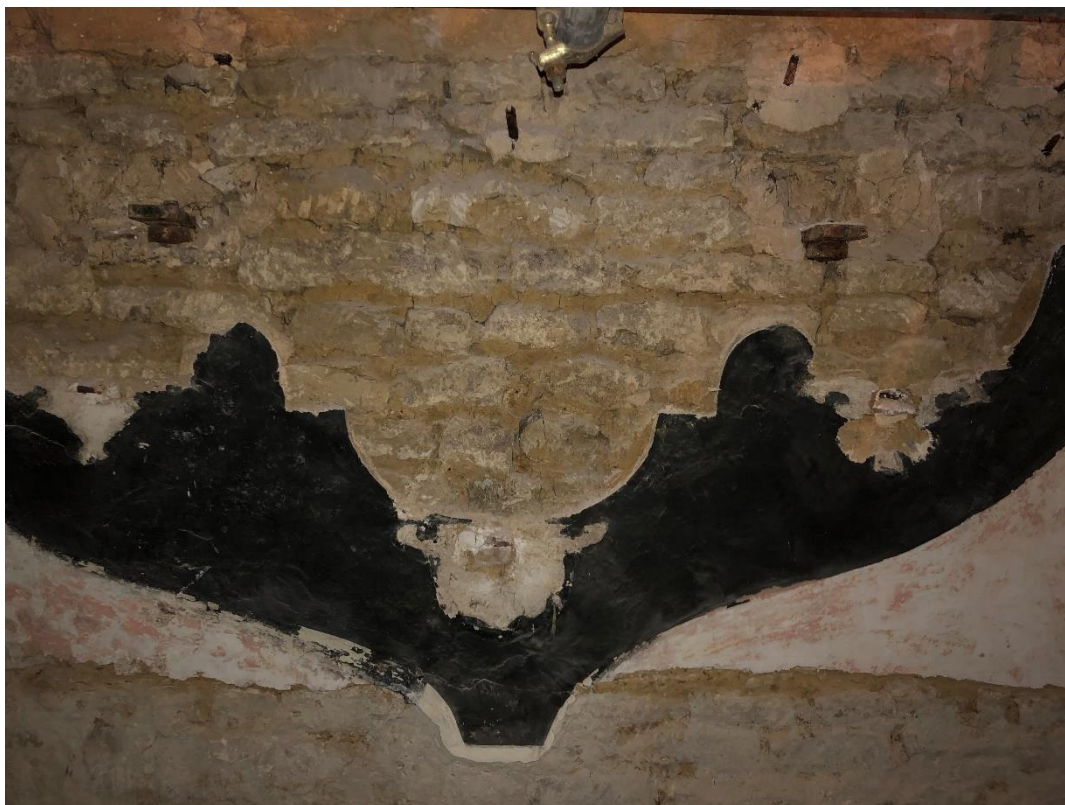
Figure 102: The wall behind the inscription panel section showing the rubble construction and with the iron sections still in place

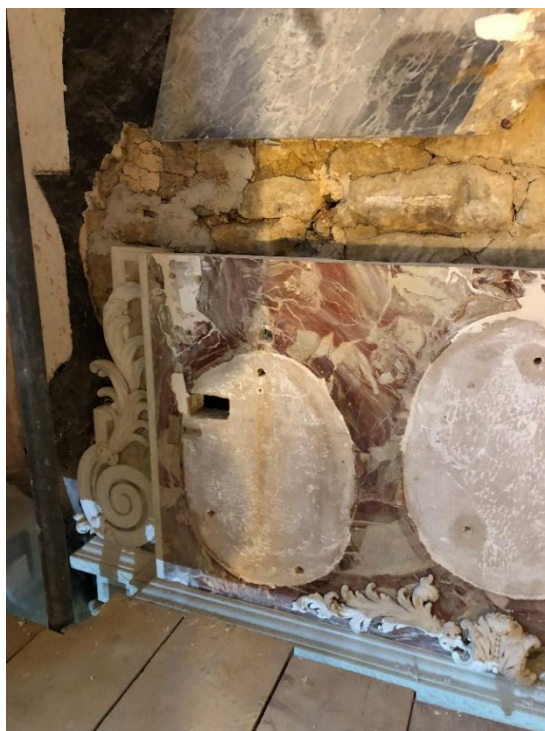
Figure 105: The middle section reinstated

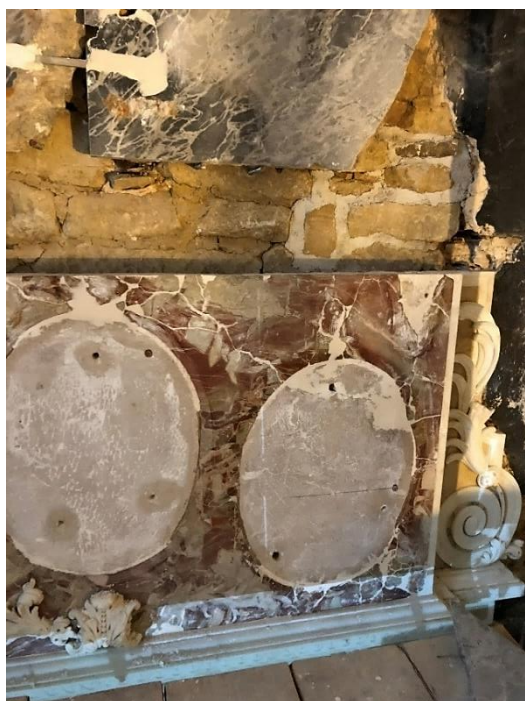
Figure 106: The sinister side of the middle section reinstated including the scrolled side wings. The new supporting fixings to the grey limestone obelisk can be seen above

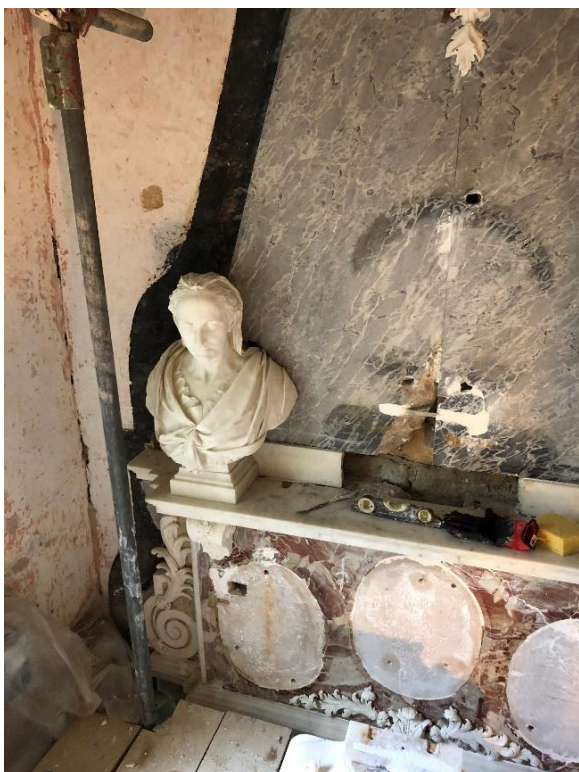
Figure 108: The middle section, bust of Frances Newman and the marble blocks beneath the grey obelisk all reinstated

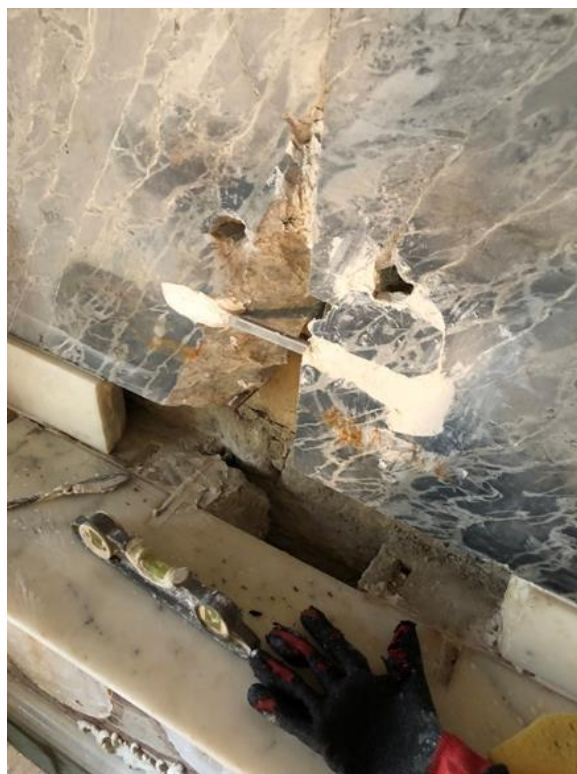
Figure 109: Detail of the stainless-steel strap between the two sections of the obelisk and the air gap behind the middle section
