Treatment Report
Conservation Programme to Monuments
St Mary Magdalen, Fifehead, Dorset

1315

July 2018

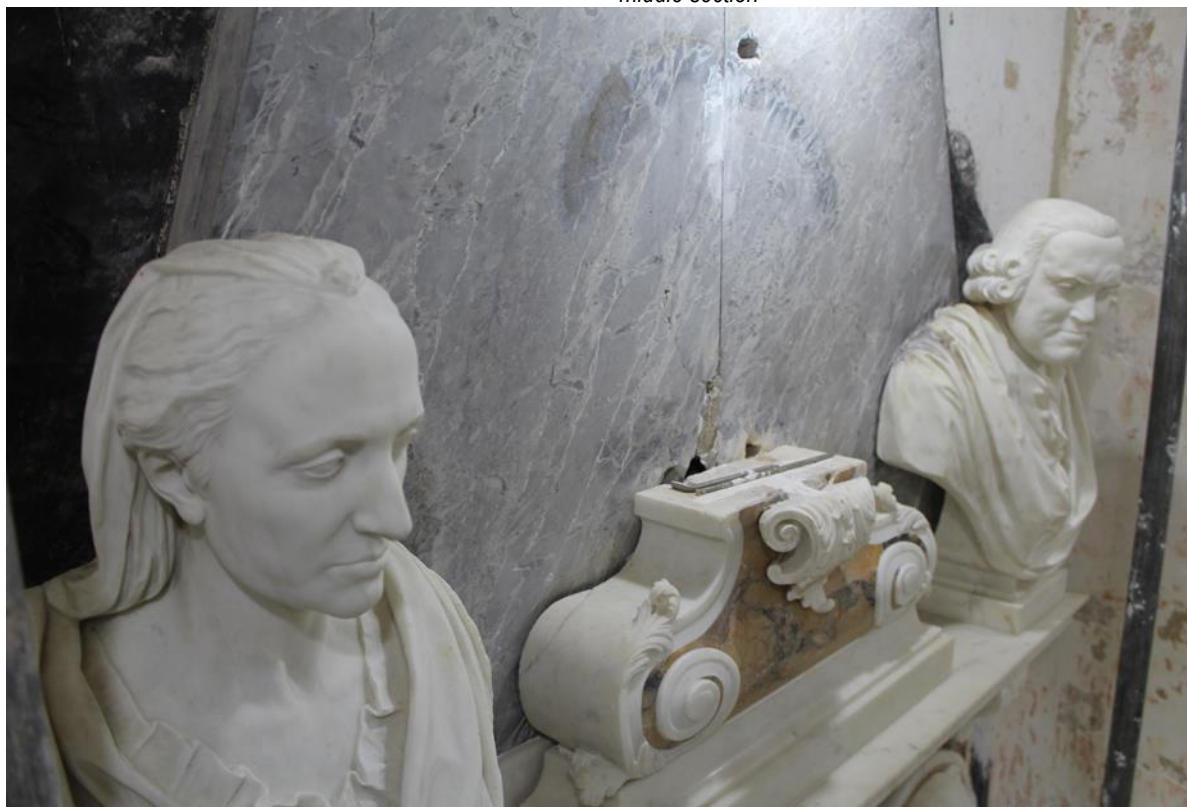
Figure 110: The busts of Frances and Sir Richard Newman and the central plinth reinstated with stainless-steel cramps ready to be installed to tie the sections of the obelisk together

- Pediment supporting the central bust was bedded and cramped with stainless steel fixings.
- The three portrait busts were re-fixed with pins into their bases and cramps from their shoulders back to the wall.

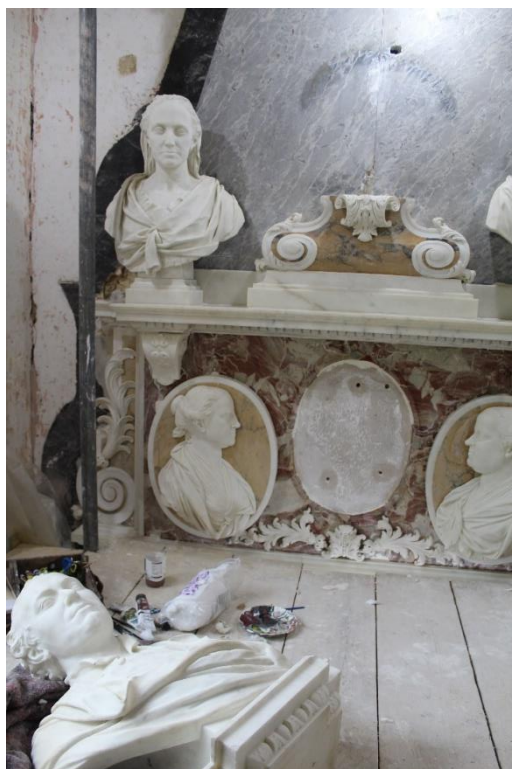
Figure 111: The bust of Samwell Newman about to be installed. Two of the three medallions have been reinstated

- The three medallion carvings of the sisters were re-fixed to the panel with three pins each.
- The retaining cramp at the top of the obelisk was replaced with a stainless-steel cramp set in resin with the surmounting marble ball secured on top.

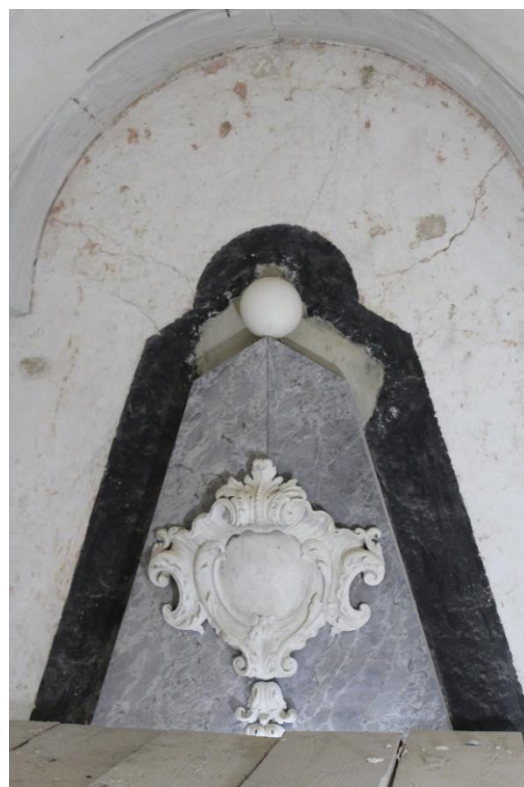
Figure 113: The retaining cramps replaced with stainless steel and the surmounting marble ball reinstated. The coat of arms can be seen after cleaning

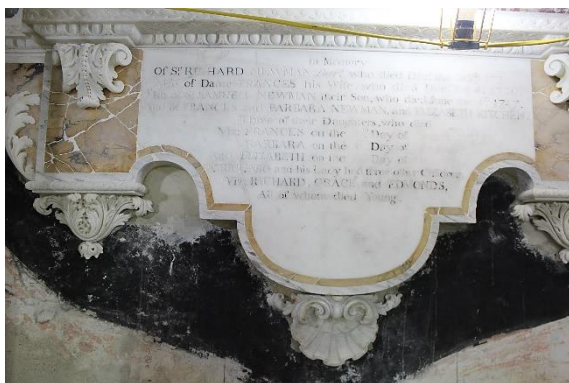
Figure 114: The lower section of the monument after reinstatement showing the surface repairs to the veneer

As the sections of the monument were reinstated the final repairs to the veneers on the lower and middle panels could take place. The surface repairs to the veneers were carried out with plaster of Paris.

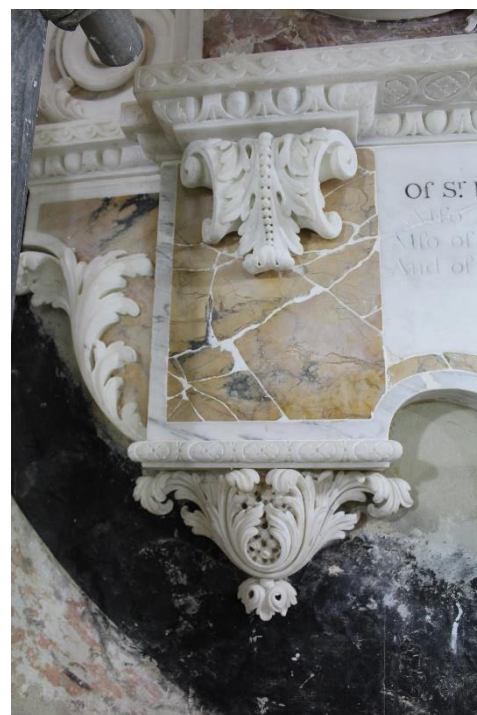
Figure 115: Detail of the reinstated and repaired veneer

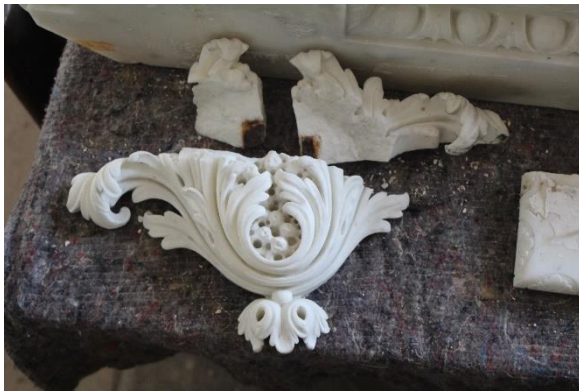
Figure 116: Fractured dexter decorave corbel adjacent to the inscription panel during the removal of the corroded iron

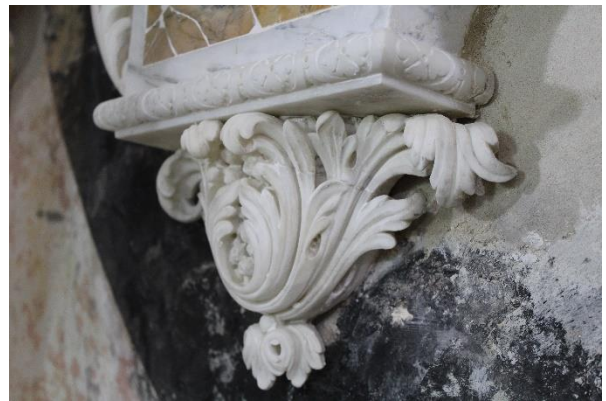
Figure 117: The dexter corbel pinned and repaired

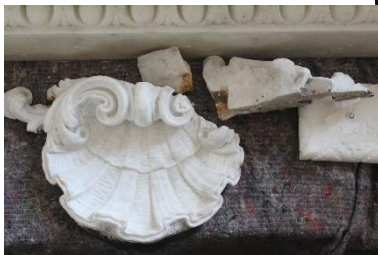
Figure 118: Central corbel below inscription panel which was cracked through the upper section repaired and reinstated

- The central bottom 'corbel' was then re-fixed with stainless steel pins.
- The two side wings were secured to the panel with stainless steel dog cramps and tied to the wall behind with stainless steel cramps.

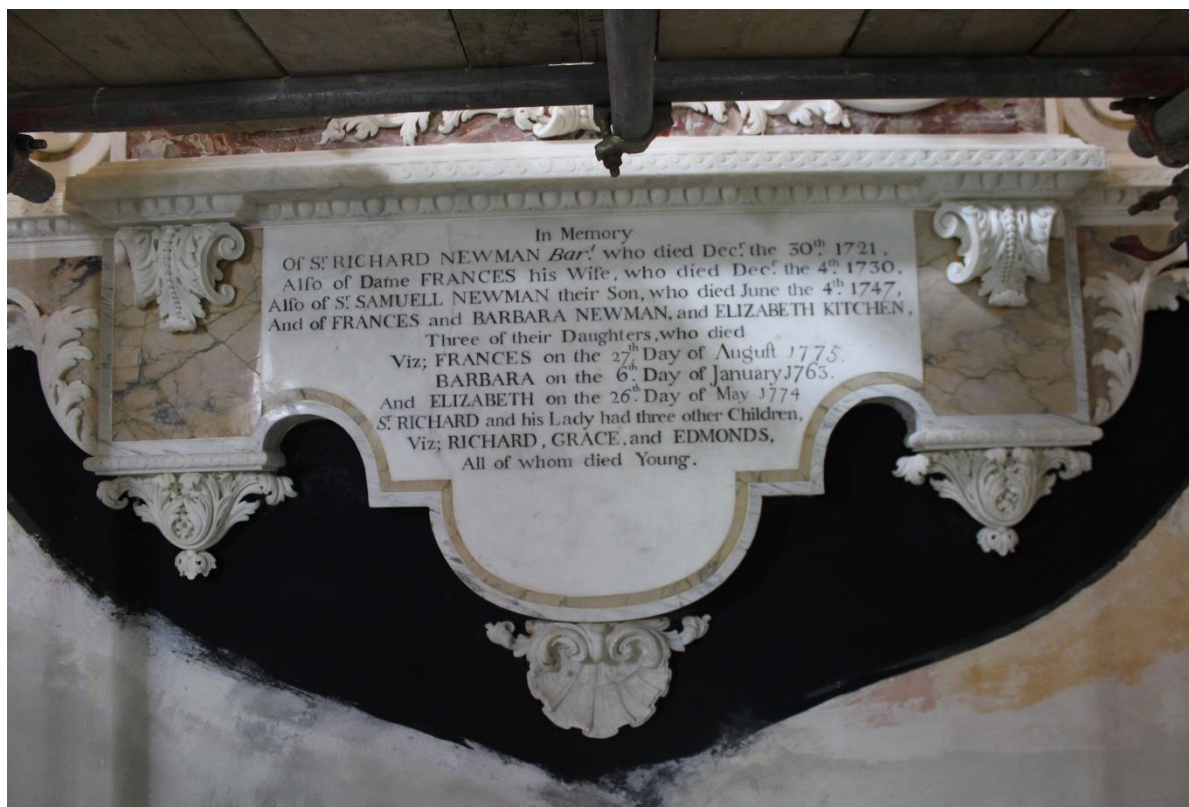
Figure 119: The lower section after surface preparation, toning in and application of microcrystalline wax

All elements of the monument were given a protective coat of microcrystalline wax.

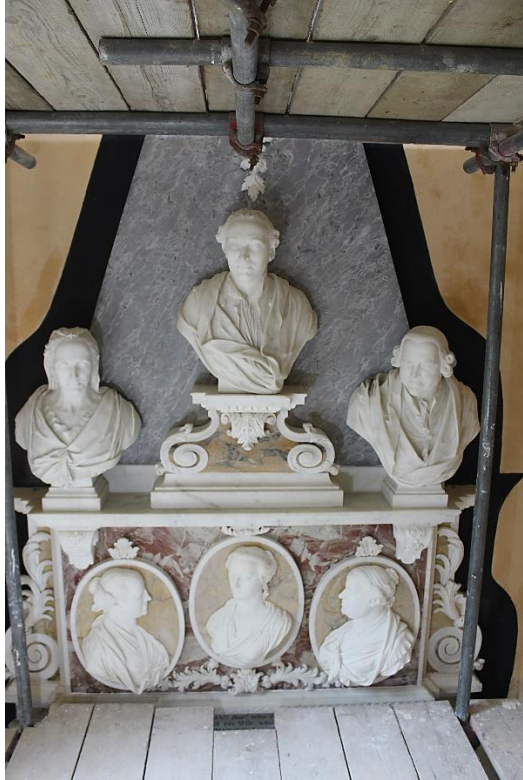
Figure 121: Overview of the busts and medallion carvings after waxing

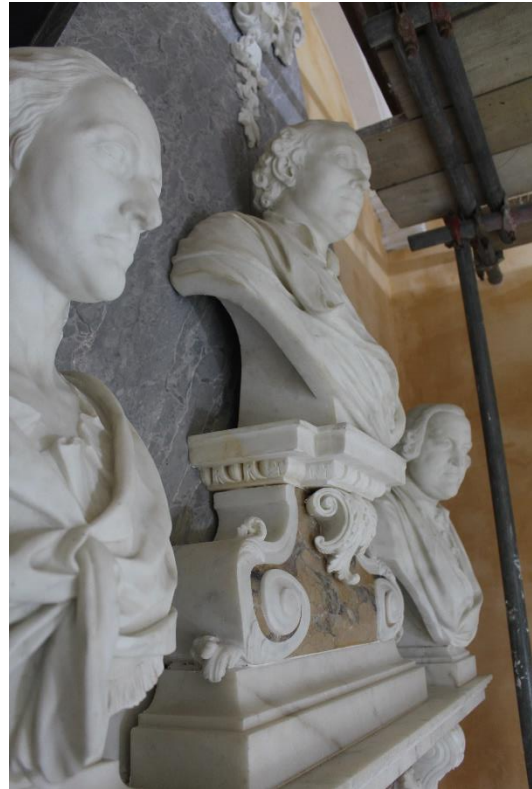
Figure 122: Side view of portrait busts after waxing

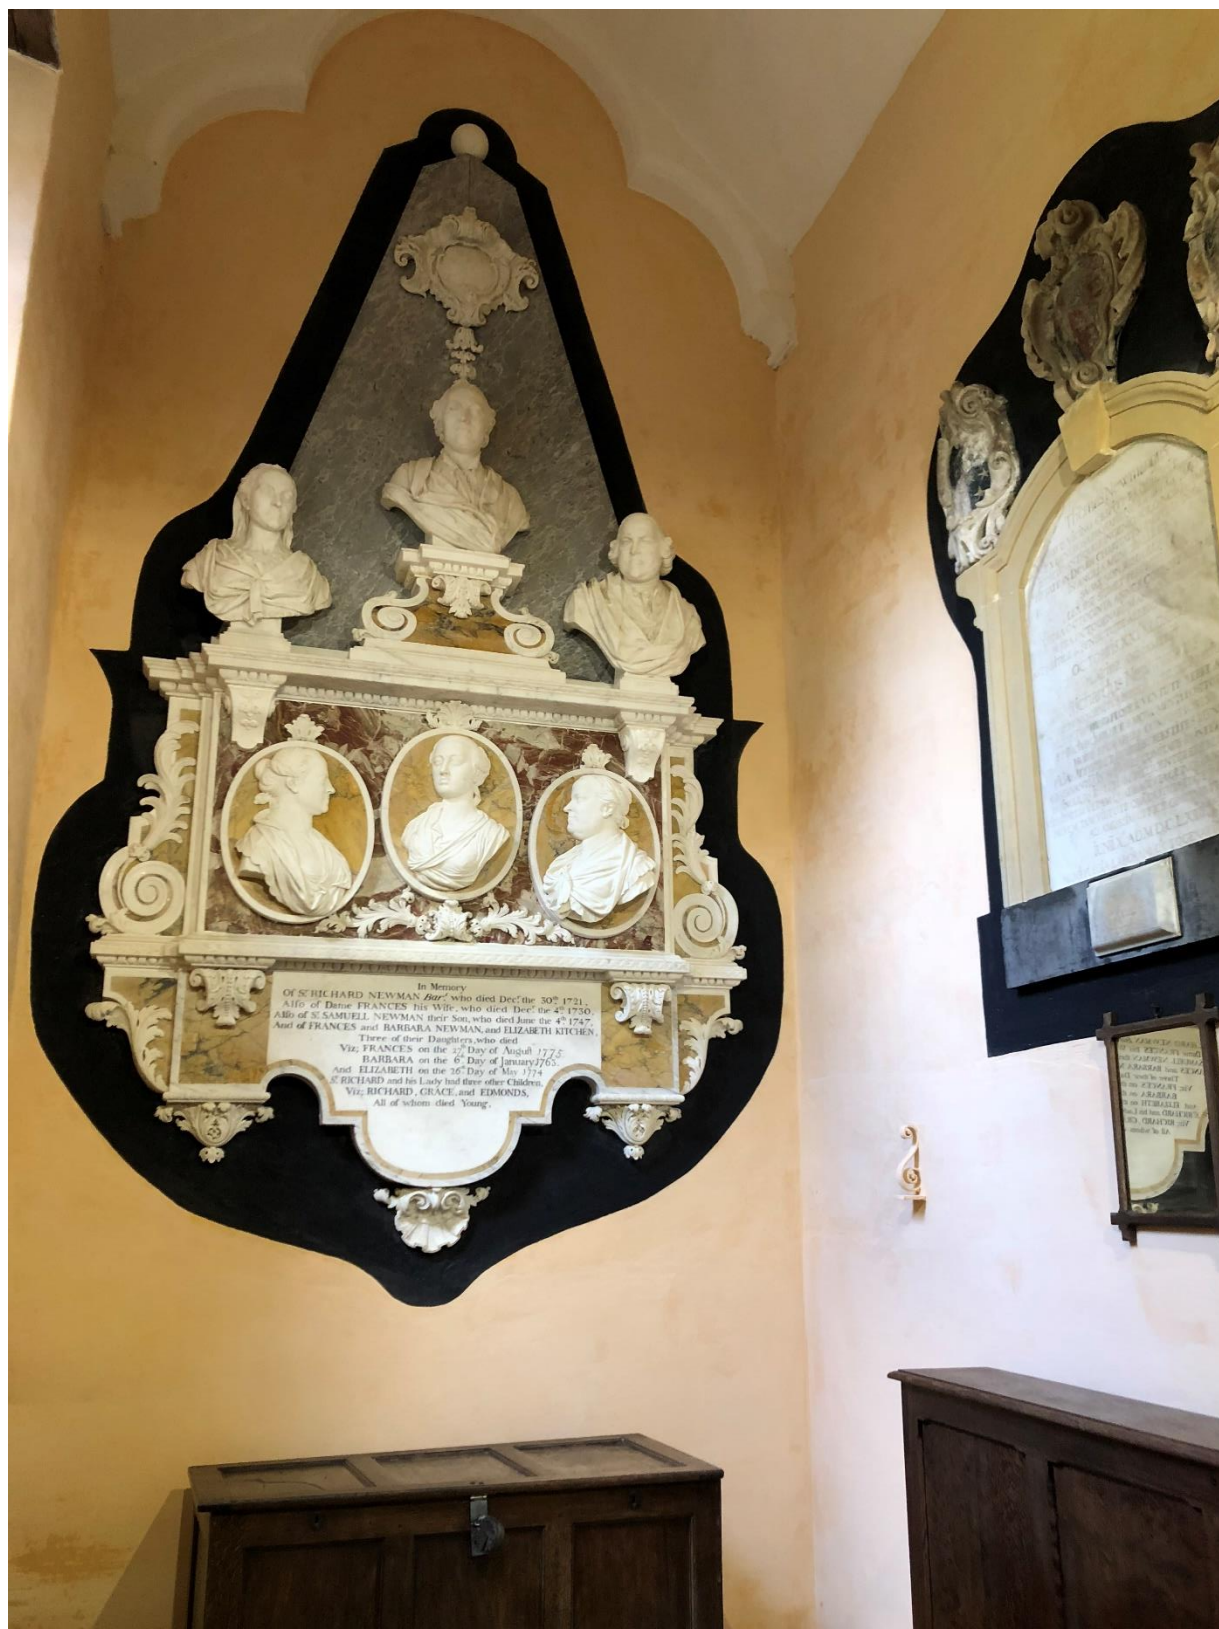
Figure 125: Monument after conservation programme and redefinition of black border

The painted black border was reinstated with black gouache as it was the closest pure material with a binder to black pigment and would not react adversely with the original scheme.
